Masterarbeit

Investigation of glass panel failure
of a high rise building through
monitoring based system identification

Felix Wenzel

Wien, Mai 2015

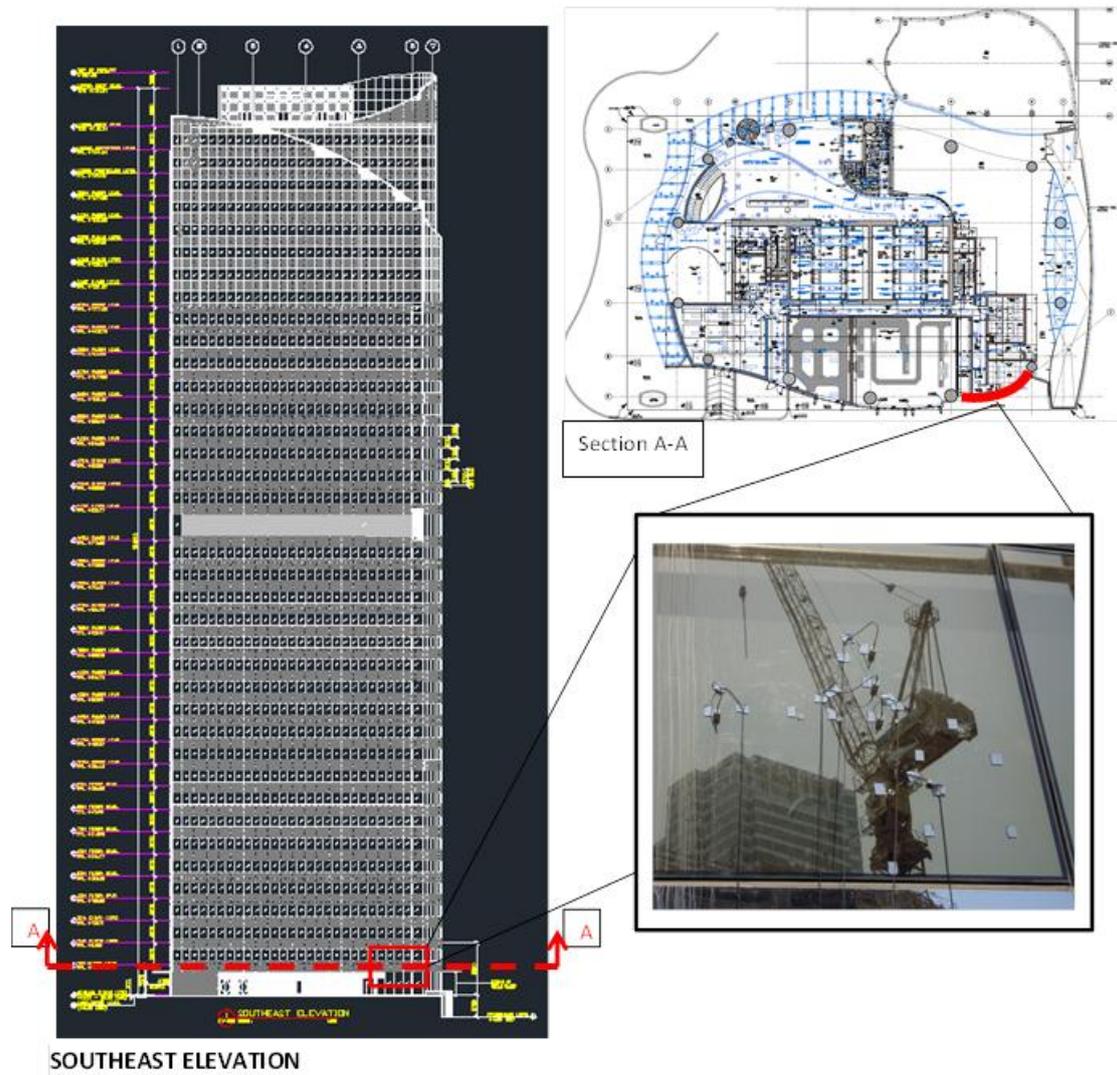
Figure 38: Measured glass element at ground floor

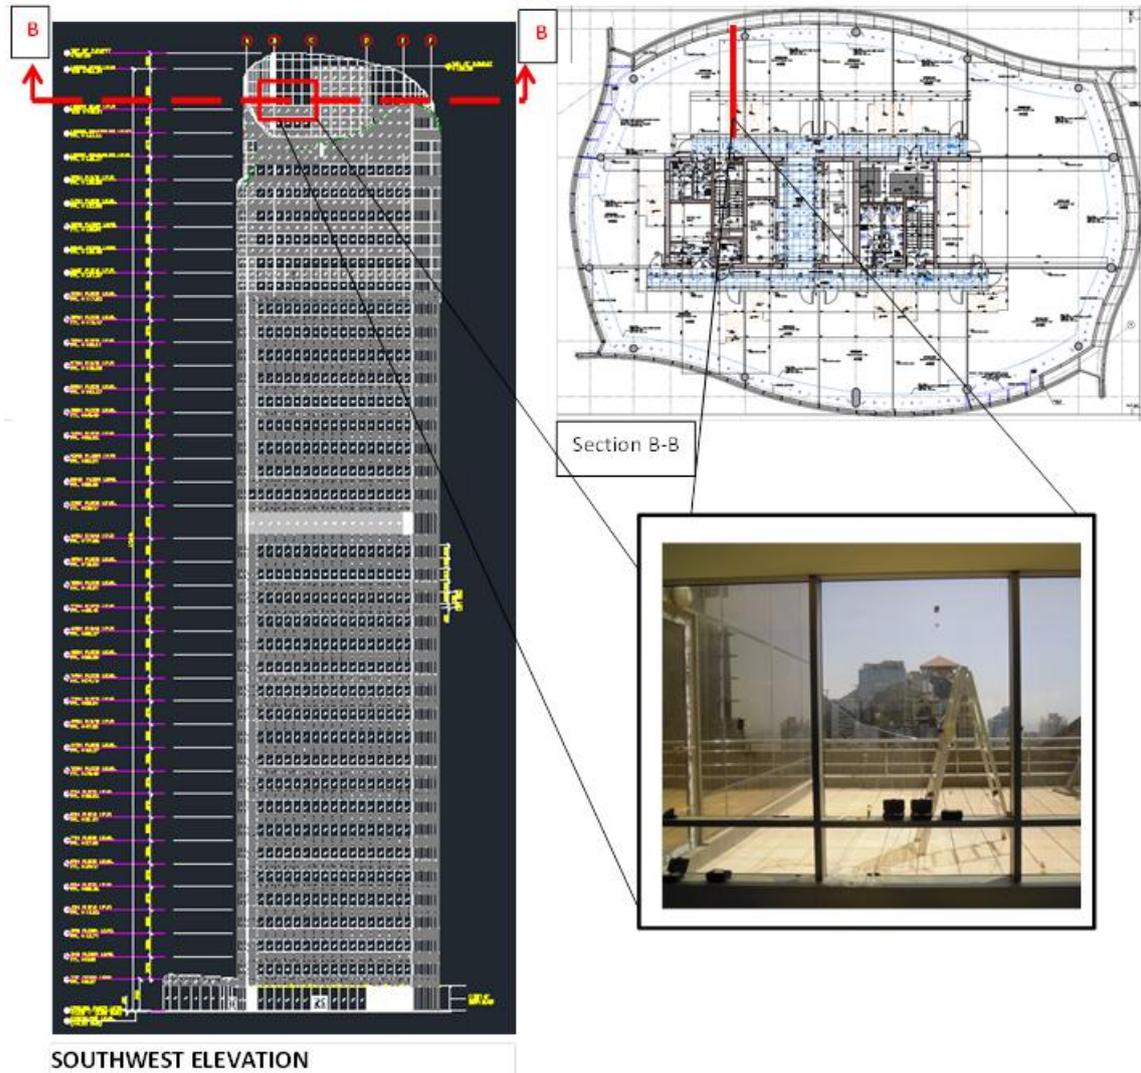
Figure 39: Measured glass element at 35th floor

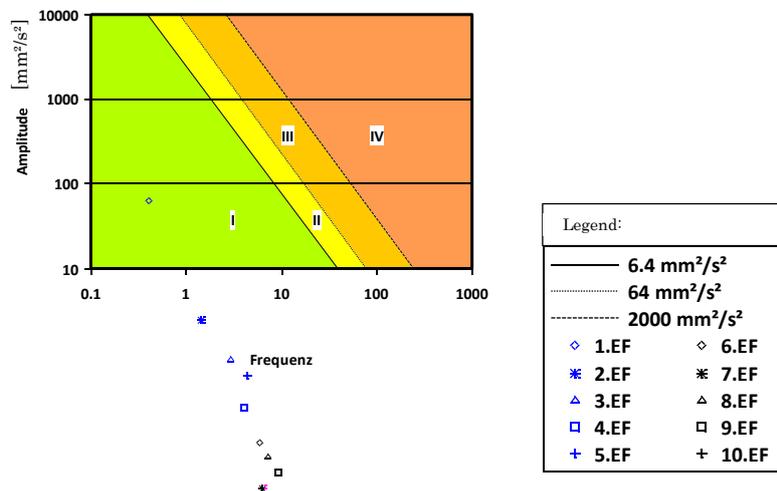
The measured values of amplitude are exclusively in Zone I for all points of measurement. This indicates a low level of impact in terms of dynamic stressing for the current loading.

Figure 49: Vibration intensity longitudinal – all points of measurement

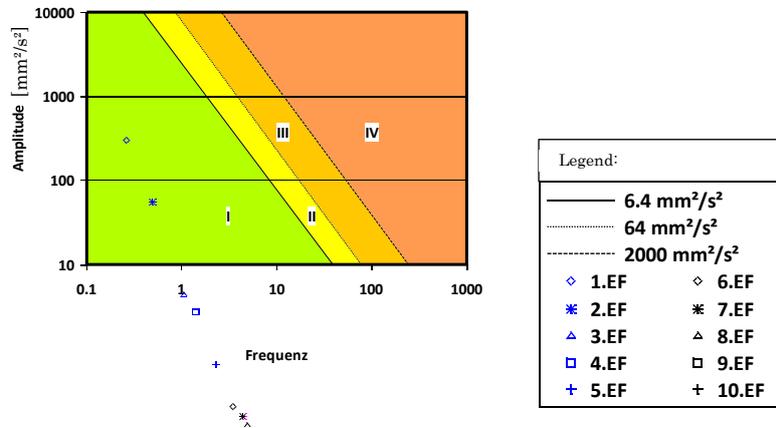
Figure 50: Vibration intensity transversal – all points of measurement

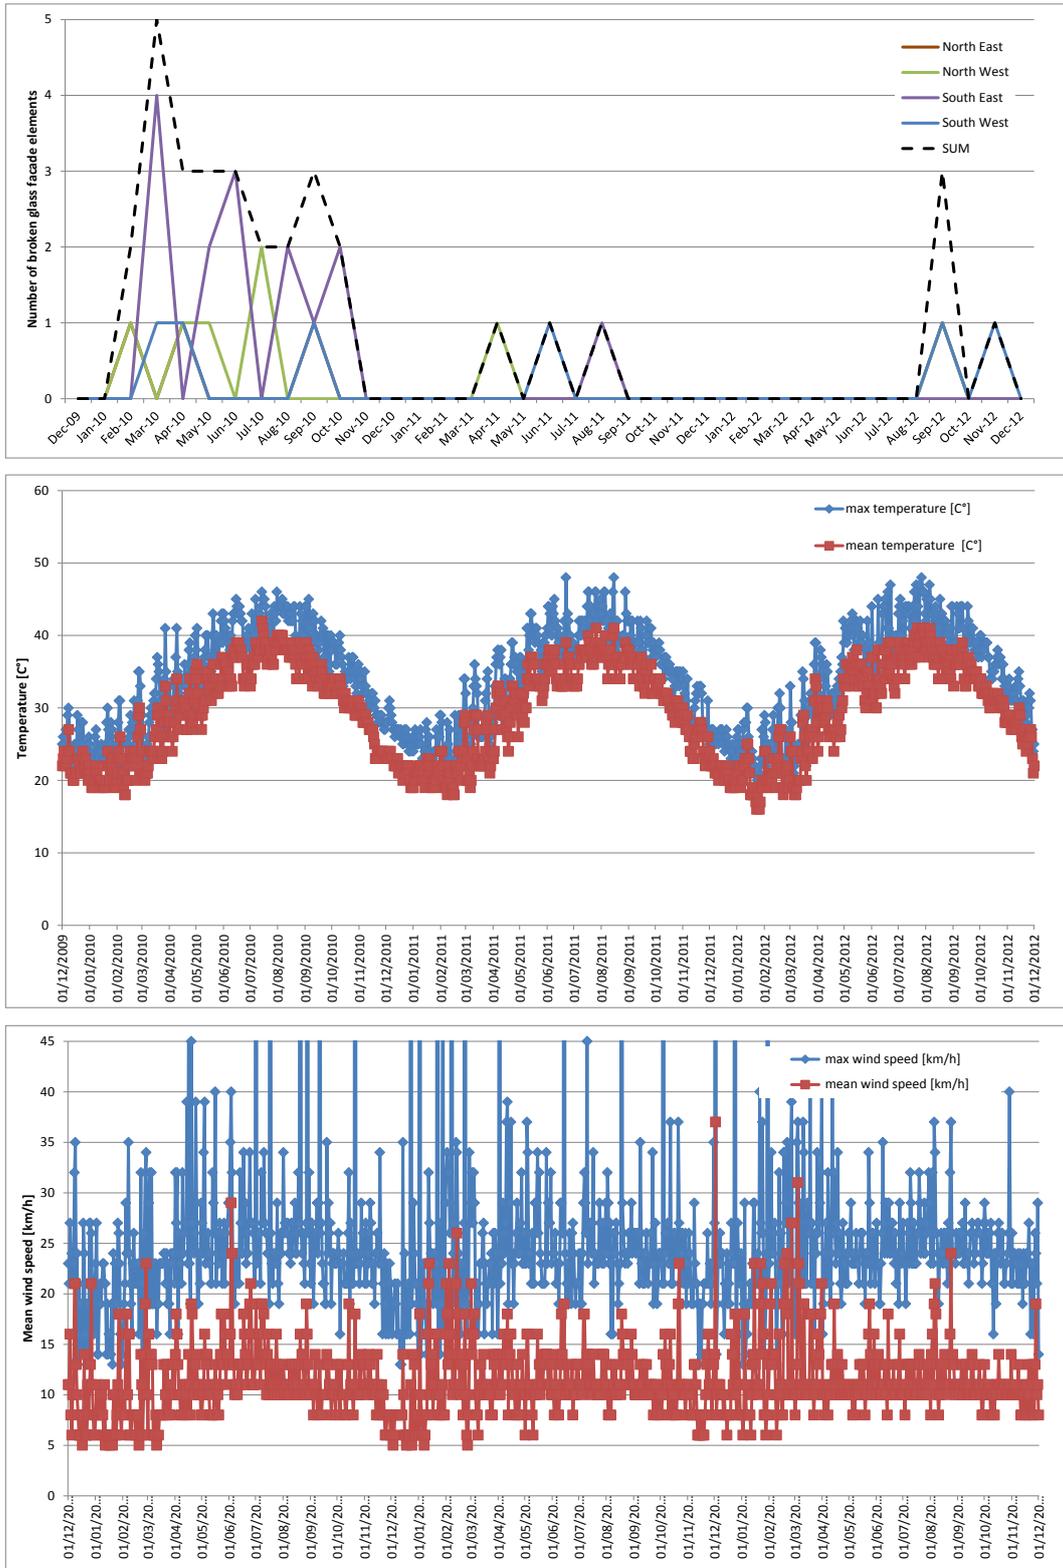
Figure 62: Distribution of broken glass façade elements (top) compared to meteorological data (temperature (middle) and wind speed (bottom))

In Figure 62 the correlation between temperature and glass failure is clearly visible. Glass failure only happens in summer when the air temperature and solar irradiation is highest. Furthermore the number of failing glass elements decreases dramatically over time, which indicate production failure of the glass.
