UNIVERSITÄT FÜR BODENKULTUR  
INSTITUT FÜR GEOTECHNIK

**GEOLOGICAL AND GEOTECHNICAL  
CHARACTERIZATION OF GROUND CONDITIONS IN  
BADONG COUNTY, CHINA**

2013

DIPLOMARBEIT NR. 360

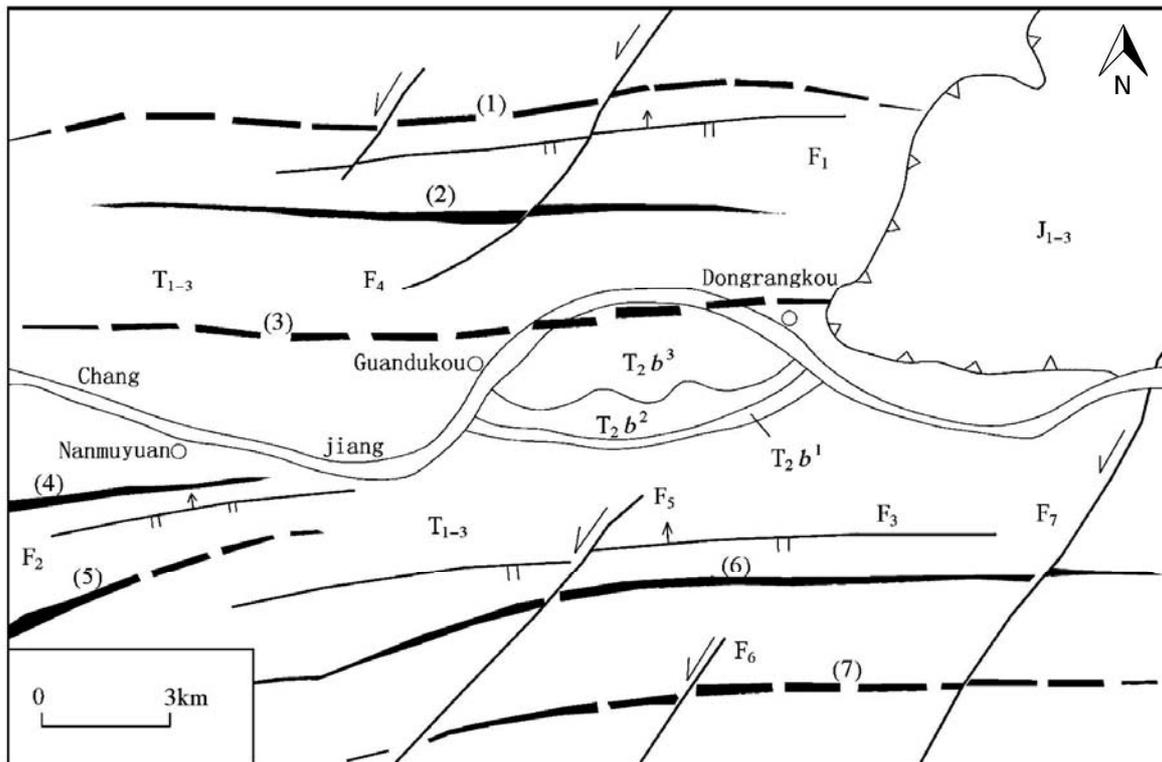
Figure 3: Areal structure sketch of Badong slope in the Three Gorges of the Yangtze River; 1-Jurassic System; 2-Triassic System; 3-continental deposit basin; 4-anticline structure axis; 5-syncline structure axis; 6-reversed fault; 7-shift fault  
 (1)-Huofeng syncline; (2) Xiaogaoshan anticline; (3)Guanducou syncline;(4)Namuyuan anticline; (5)Duping syncline; (6)Baifuping anticline; (7)Fengcuiya syncline.  
 F<sub>1</sub>-Fuangyintang fault; F<sub>2</sub>-Bingshuijing fault; F<sub>3</sub>-Maluchi fault; F<sub>4</sub>-Gongqiao fault; F<sub>5</sub>-Yeluchi fault; F<sub>6</sub>-Meiziya fault; F<sub>7</sub>-Niukou fault (Wang 2009, p. 26)

In the area around Badong the river flows along the Guandukou syncline. The slopes are made up of a monoclinical mountain and some small-scale relaxed folds or fold distortion, with strong extrusion in some parts. It is a broad and relaxed syncline with an axial plane inclined slightly to the south. The dip angle of the north wing is 10°-25° and the south wing between 20° and 48° (Wang 2009, p. 25). Therefore all layers dip towards the river according to the natural slope. This implies a hazard of downhill-sliding, upon human activities combined with water-influence (Figure 3).

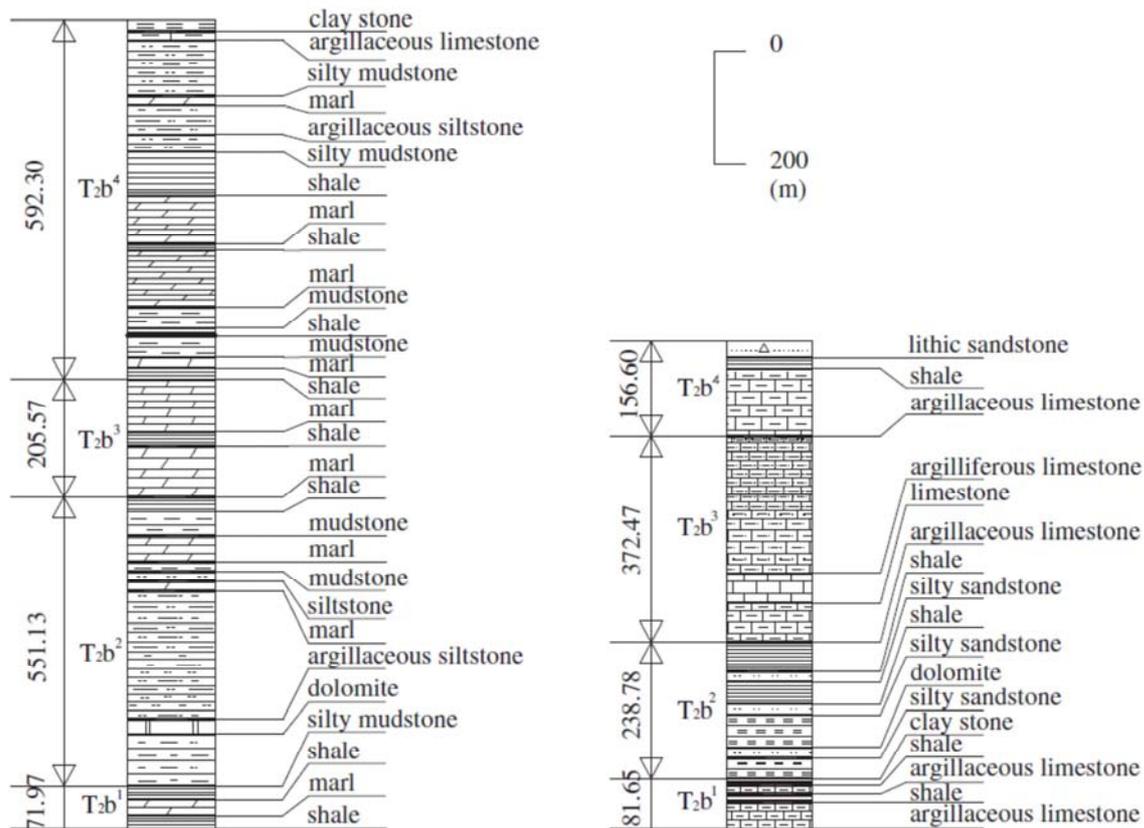
Figure 4: Two typical stratigraphic columns showing the group of argillaceous limestone rocks (Qi et al. 2009, p. 933)

The following figure shows the stratigraphical structure with different thicknesses in Changhan (left) and Dawoshan (right) regions of Badong.

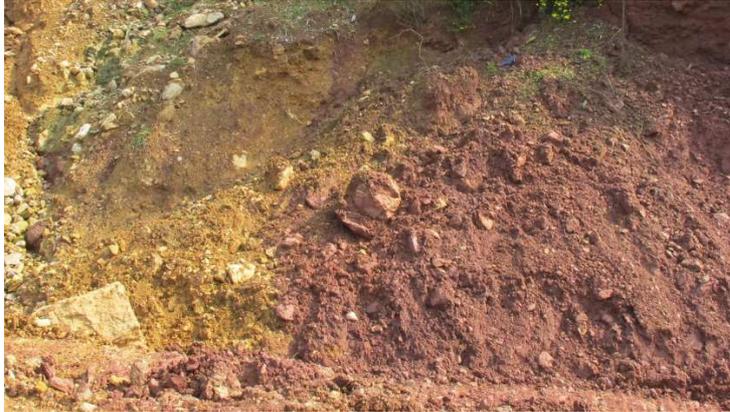
Figure 6: Transitional zone between residual soil of  $T_2b^3$  (left) and  $T_2b^2$  (right) (Photo: Mayrhofer 2012)

The residual soil of  $T_2b^3$  is brownish red, yellow grey or apricot coloured. It is particularly the apricot argillite layer in the residual soil which tends to cause slope instabilities. If the rock is in completely weathered conditions, it appears as buff coloured stratified soil or bedded disintegrated rock blocks (see left side of Figure 6).

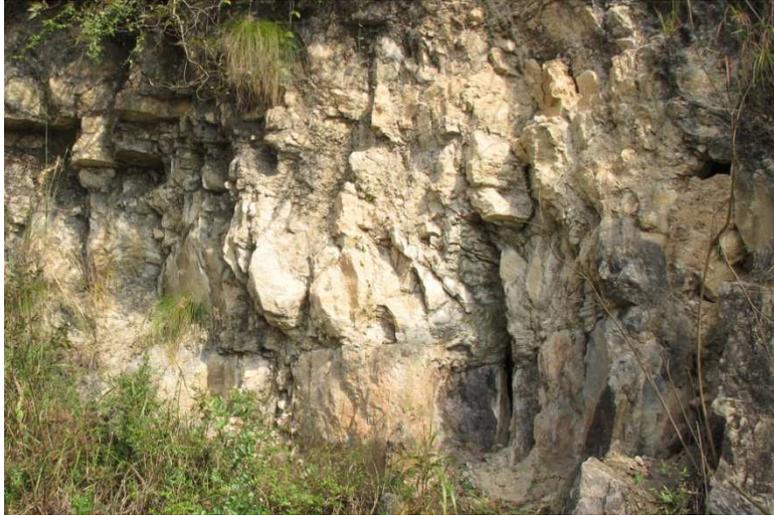
Figure 9: Highly weathered  $T_2b^3$  (Photo: Mayrhofer 2012)

Figure 9 and Figure 10 show highly weathered argillaceous limestone. After cutting, cracks form easily, due to solubility and unloading. Joints are densely developed and cut the rock into small pieces. The occurrence of toppling and falling stones is frequent (Qi et al. 2009, p. 934).

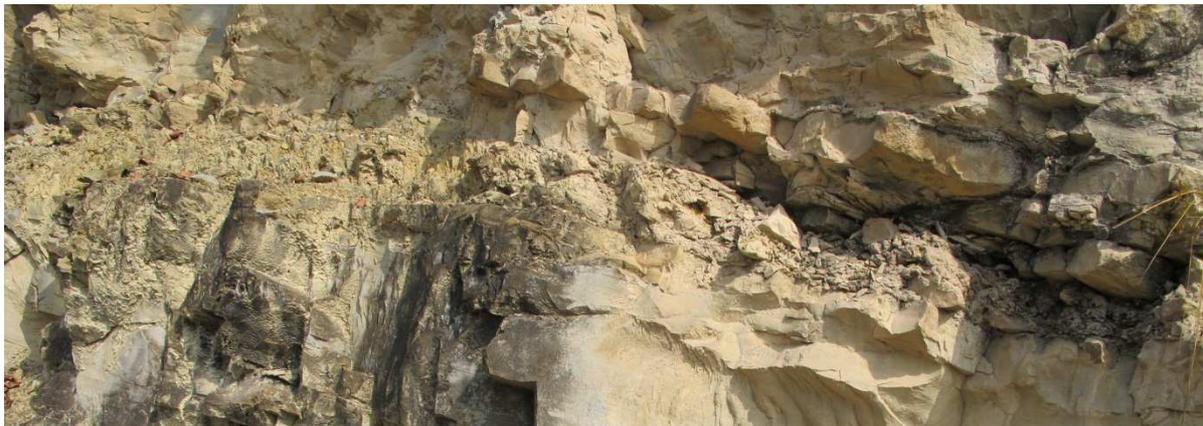
Figure 11: Weak layer in  $Tb3$  (Photo: Mayrhofer 2012)

Figure 11 shows a 20 cm thick layer of intercalated calcareous clay-stone which is highly decomposed. Due to chemical weathering, the strong limestone with a  $\text{CaCO}_3$ -content of 90% changes its composition. However, with slight weathering the limestone changes to a  $\text{CaCO}_3$ - content between 65 and 70% (Qi et al. 2009, p. 935). So the name changes to mudstone, as illustrated in Figure 12.

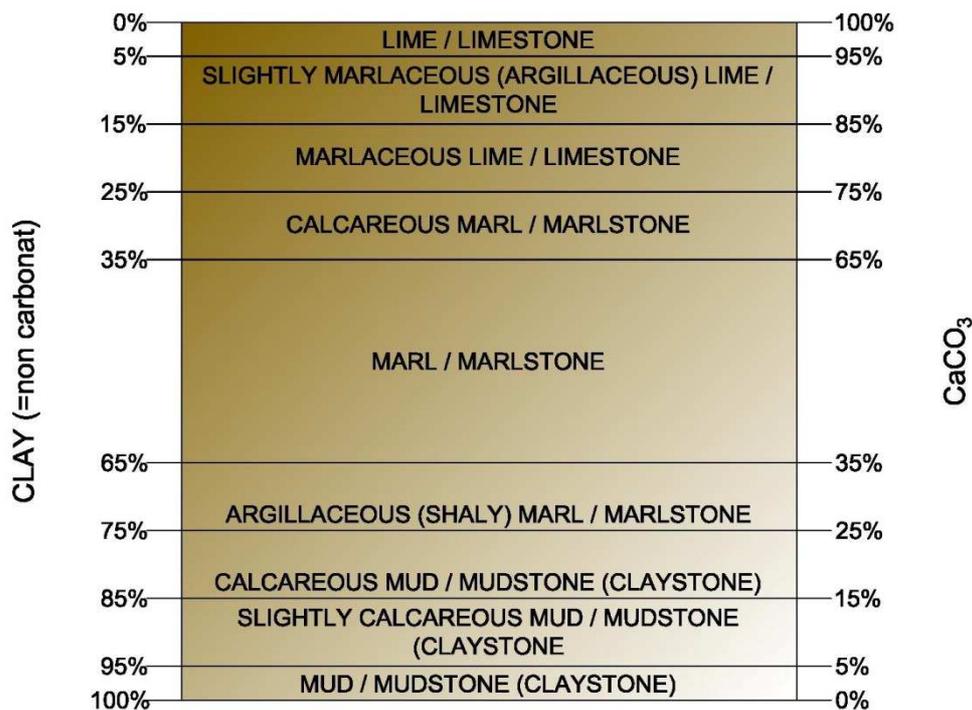
Figure 12: Distinction of claystone, marlstone and limestone by means of content of clay- and CaCO<sub>3</sub>

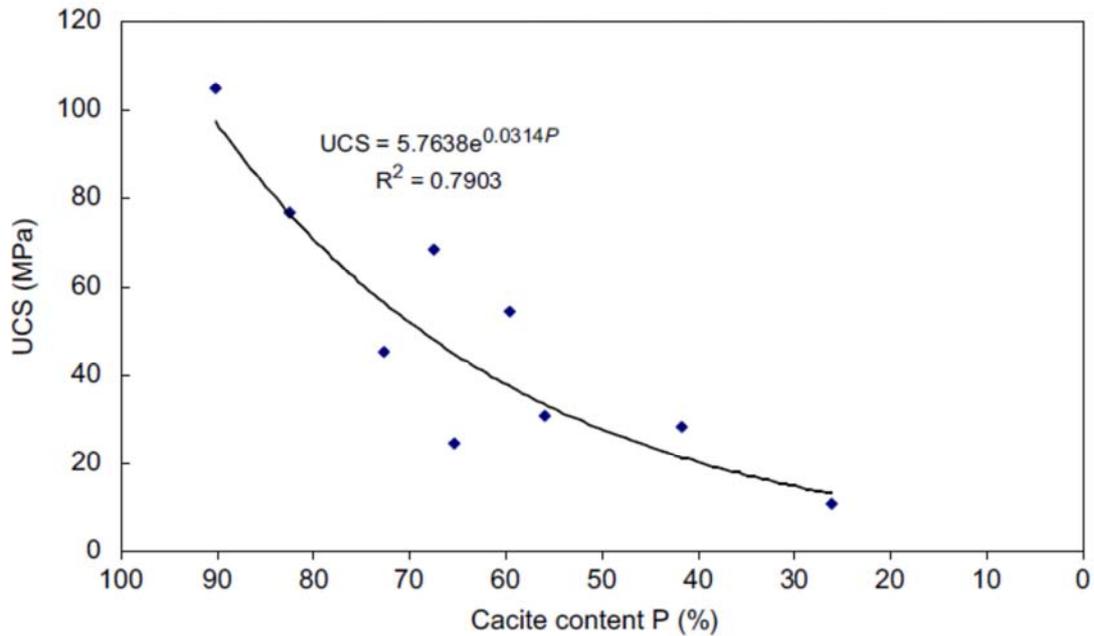
Figure 13: Relationship between uniaxial compressive strength (UCS) and calcite content of weathered argillaceous limestone rocks (Qi et al. 2009, p. 938)

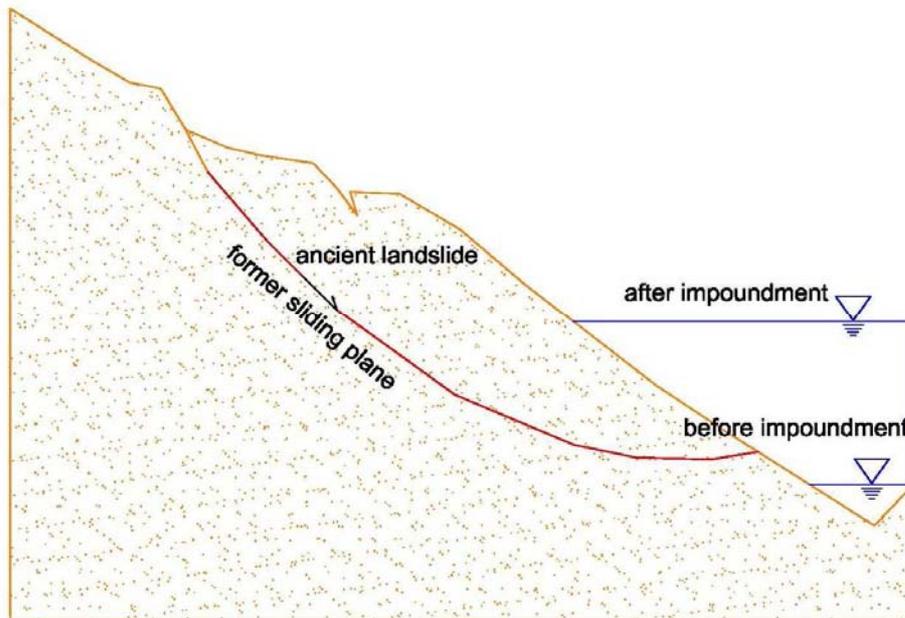
Figure 16: Sketch of ancient landslide revivification (Wang 2009, p. 151 modified by the author)

Through reservoir impoundment formerly stable or almost stable sliding slopes reactivate and slide partially or collapse (see Figure 16).

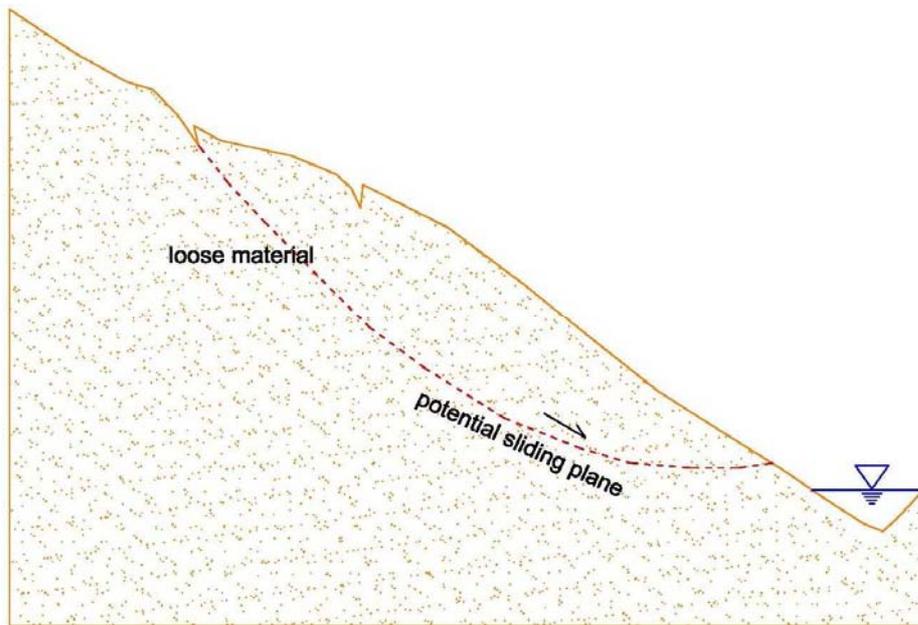
Figure 17: Sketch of surficial slip of thick loose deposit material (Wang 2009, p. 151 modified by the author)

Parts of some stable or almost stable thick accumulations become unstable by the sliding of the plane layer of the superficial part of this loose deposit. This loose deposit can be classified due to different causes such as collapse and slide deposit, slope wash deposit, proluvial deposit, artificial storing and so on. This mass creeps downward and deforms, or the front edge partially becomes unstable through sliding (see Figure 17).

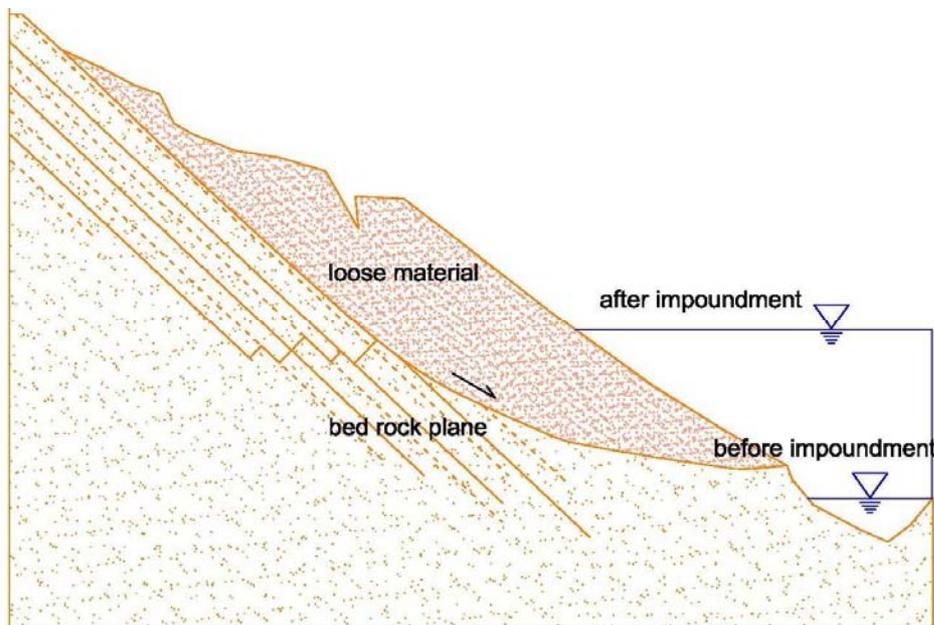
Figure 18: Sketch of a slide along the bed- deposit interface (Wang 2009, p. 151 modified by the author)

This occurs commonly on a deposit which is not thick and the depth of the bed-deposit interface is not high. The accumulation moves as a whole along the bed-deposit plane (see Figure 18).

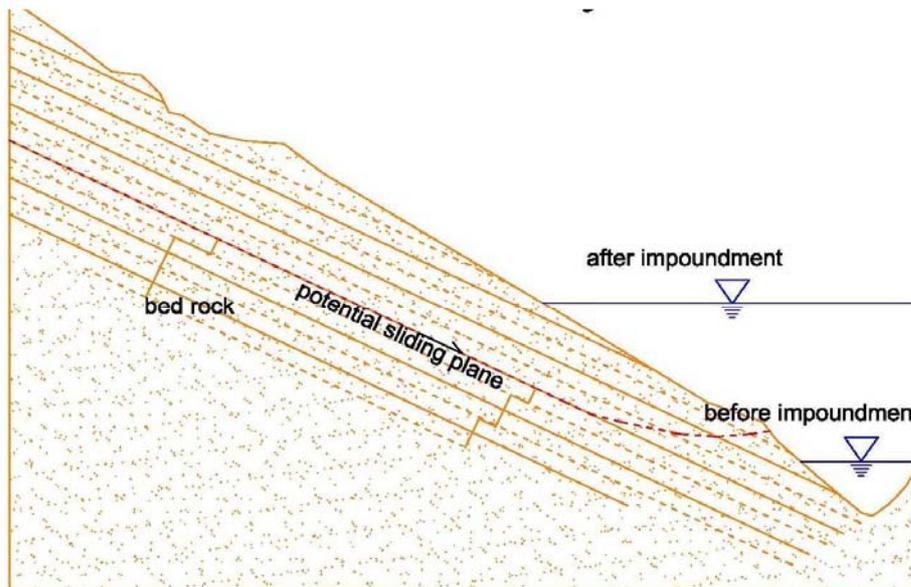
Figure 19: Sketch of bed rock sliding along the weak accordant layer (Wang 2009, p. 151 modified by the author)

reduction in shearing resistance greatly. The whole landslide mass along the weak layer moves. Especially if the upper part of the accordant slope is precipitous and the lower part inclined to slide, according to the principle of effective stress ( $\sigma'$ ), the gently slanting toe of the slope, though with original friction, will slide as a whole, as the skid resistance through the immersion is reduced. The aforementioned Qianjiangping Landslide in Zigui County of Hubei Province in July, 2003 and the tragic Vajont Landslide in Italy are examples of this type of landslide.

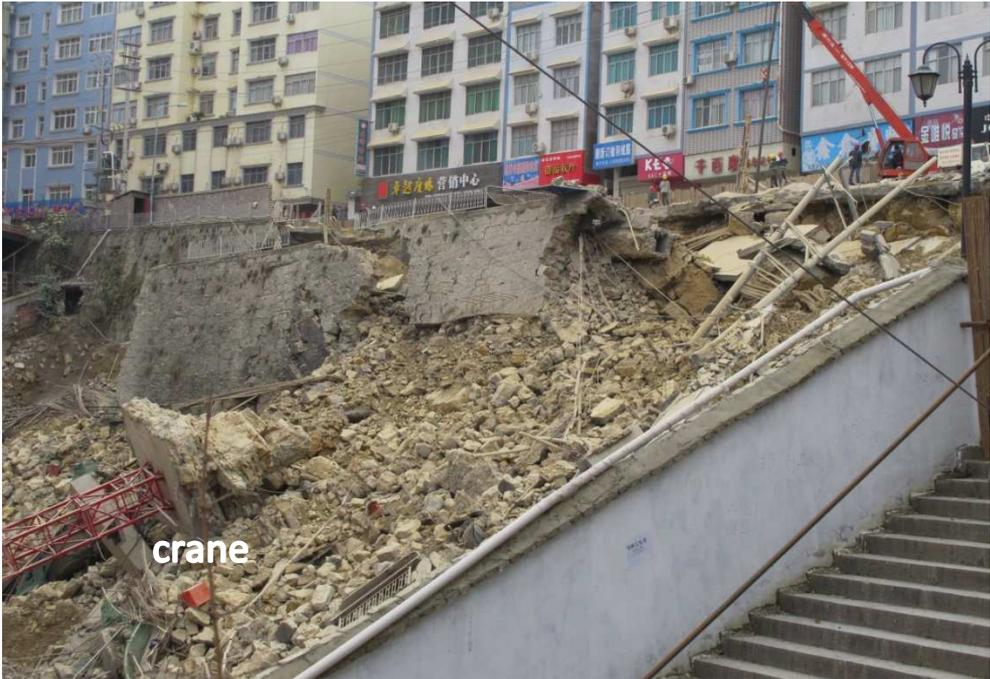
Figure 21: Slope failure in urban area of Badong (Photo: Mayrhofer 2012)

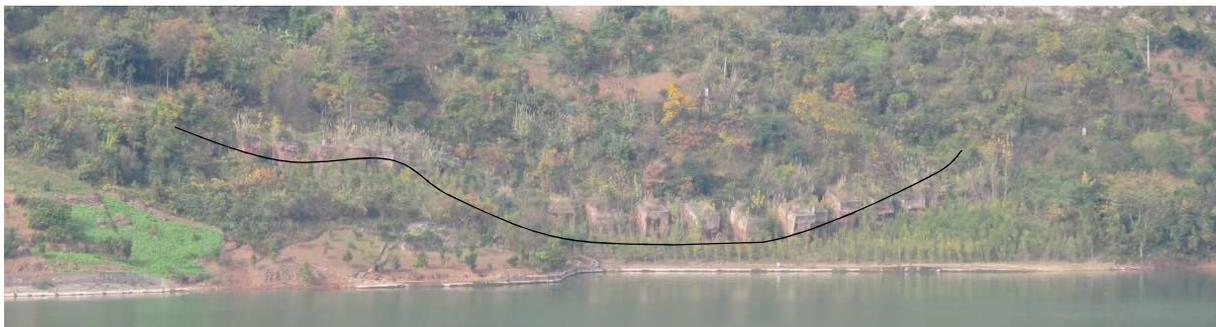
*Figure 23: Shi-jia-po landslide; black line: row of stabilising piles foundation (Photo: Mayrhofer 2012)*

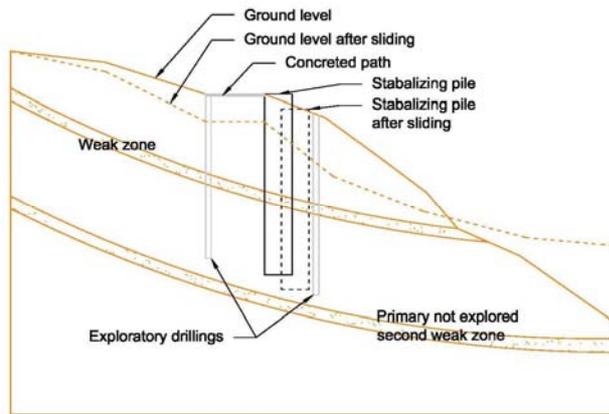
Figure 24: Sketch of the Shijiapo landslide

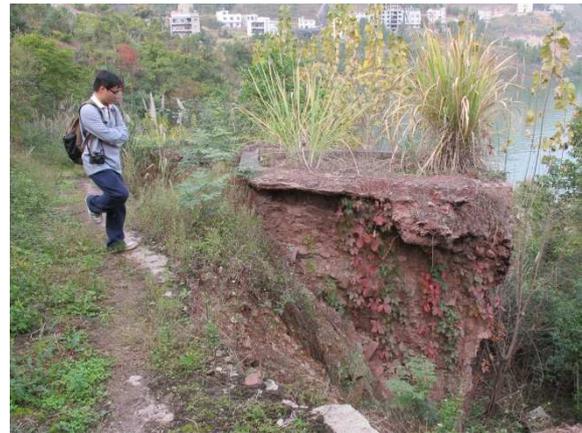
Figure 25: Shijiapo landslide (rest of concreted path and stabilising pile (Photo: Mayrhofer 2012)

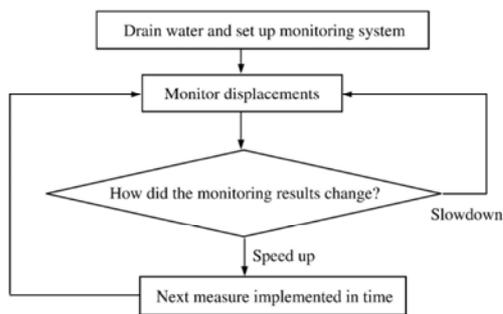
Figure 26: Control measures for landslide control (Zuoan et al. 2006, p. 9)

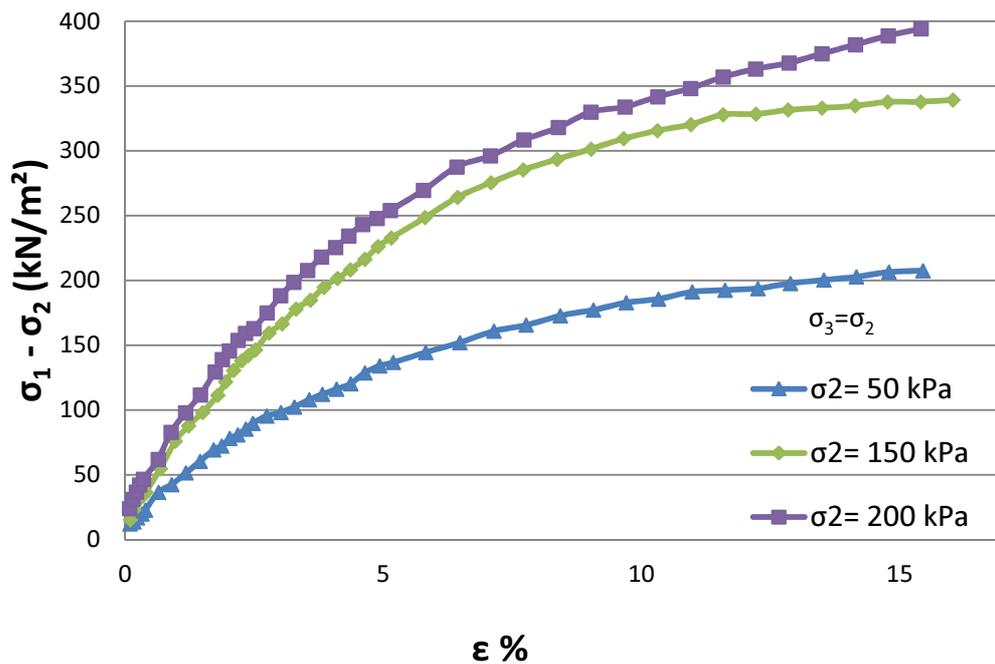
Figure 47: Triaxialtest (2012)

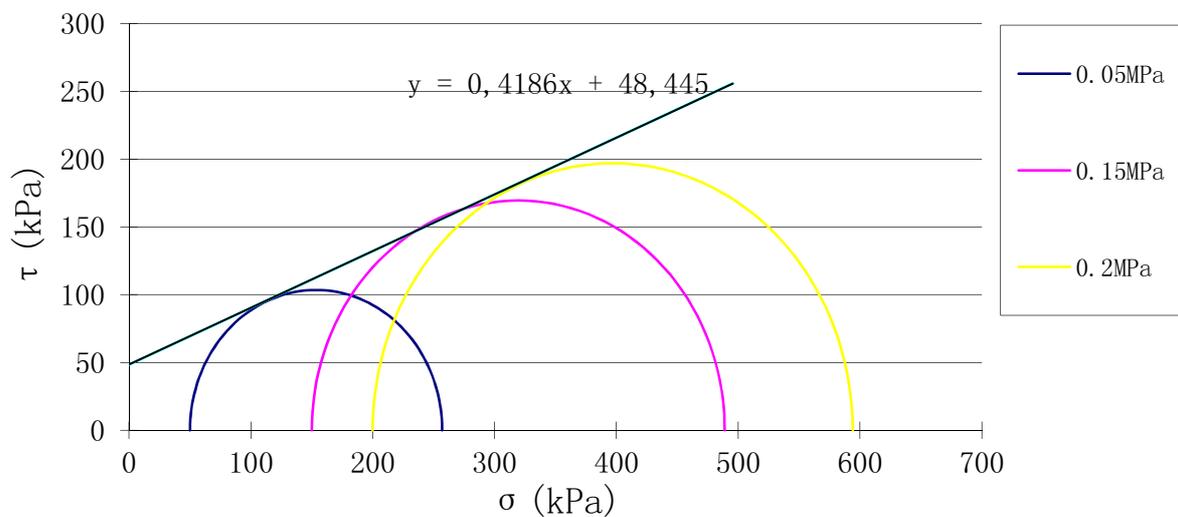
Figure 48: Mohr circles of the triaxial tests

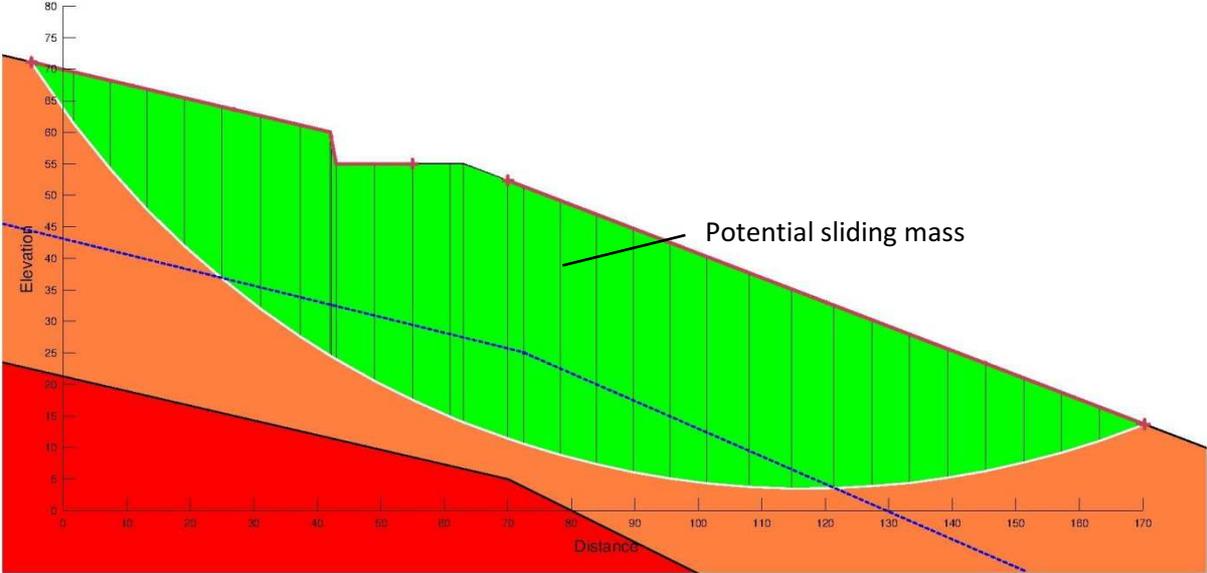
Figure 49: Simulation: Slide mass of ancient landslide on Xirangpo; FOS: 1.699

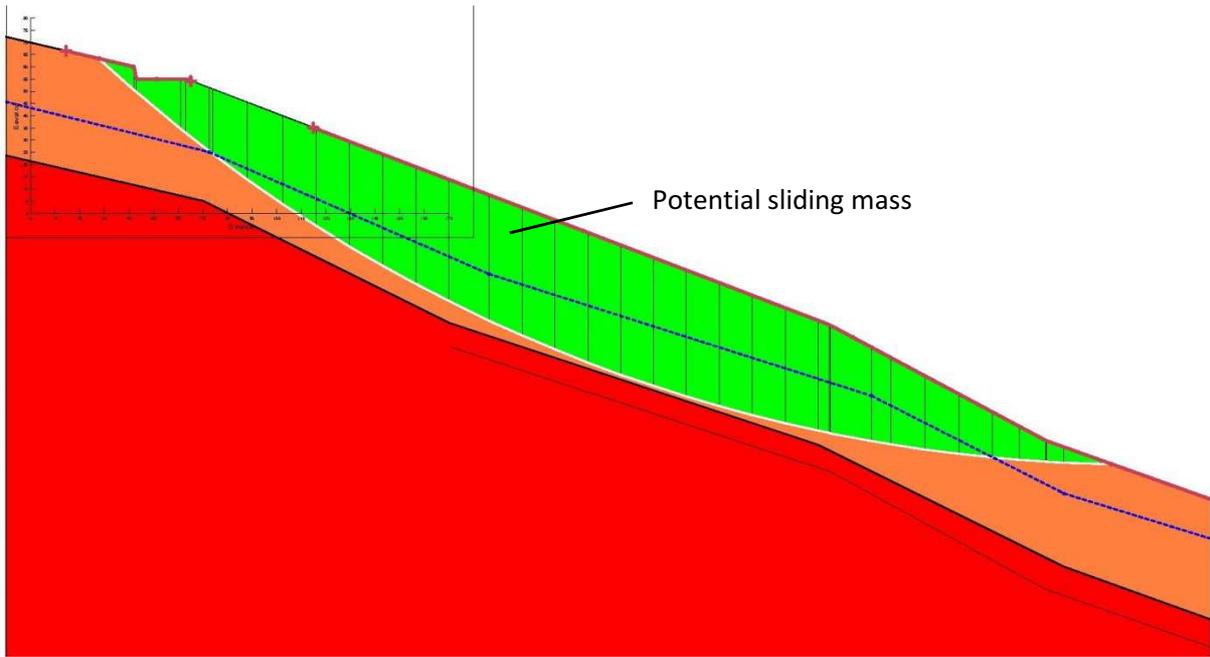
Figure 50: Simulation: Slide mass of ancient landslide at Xirangpo with wide entry-exit ranges; FOS: 1.022

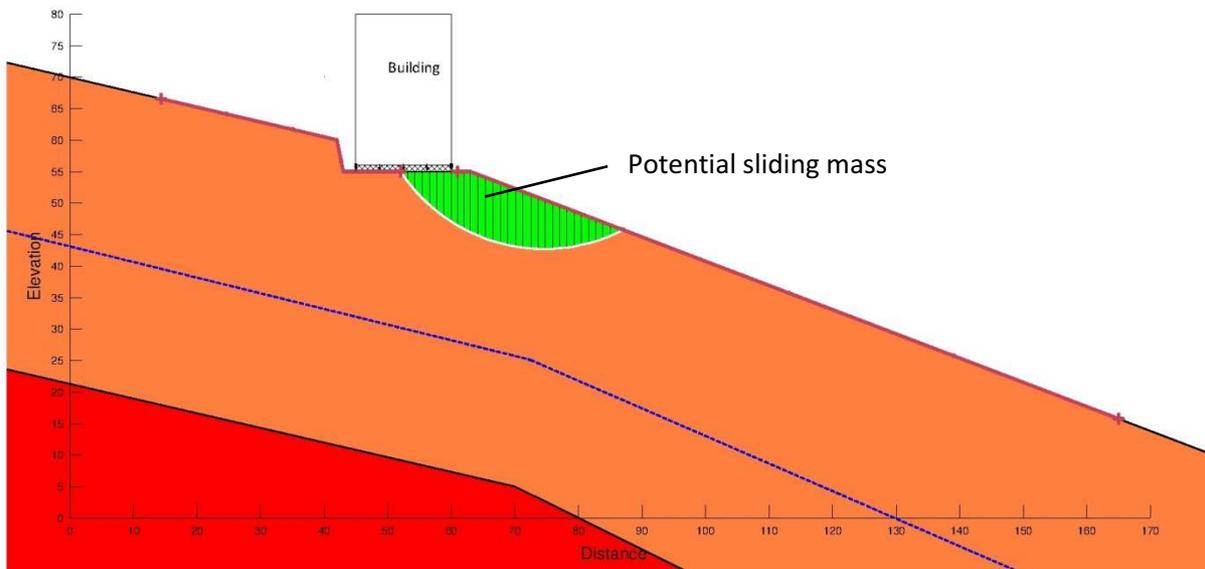
Figure 51: Simulation: Building on slide mass of ancient landslide on Xirangpo; FOS: 1.341

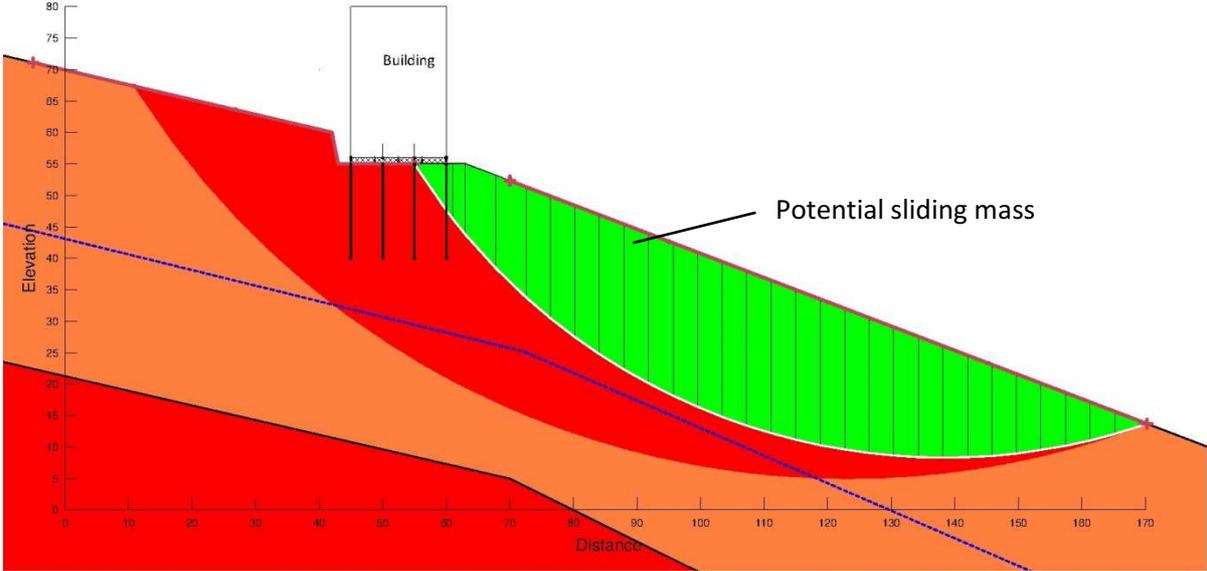
Figure 52: Simulation: Building and stabilisation piles on slide mass of ancient landslide at Xirangpo; FOS: 1.605

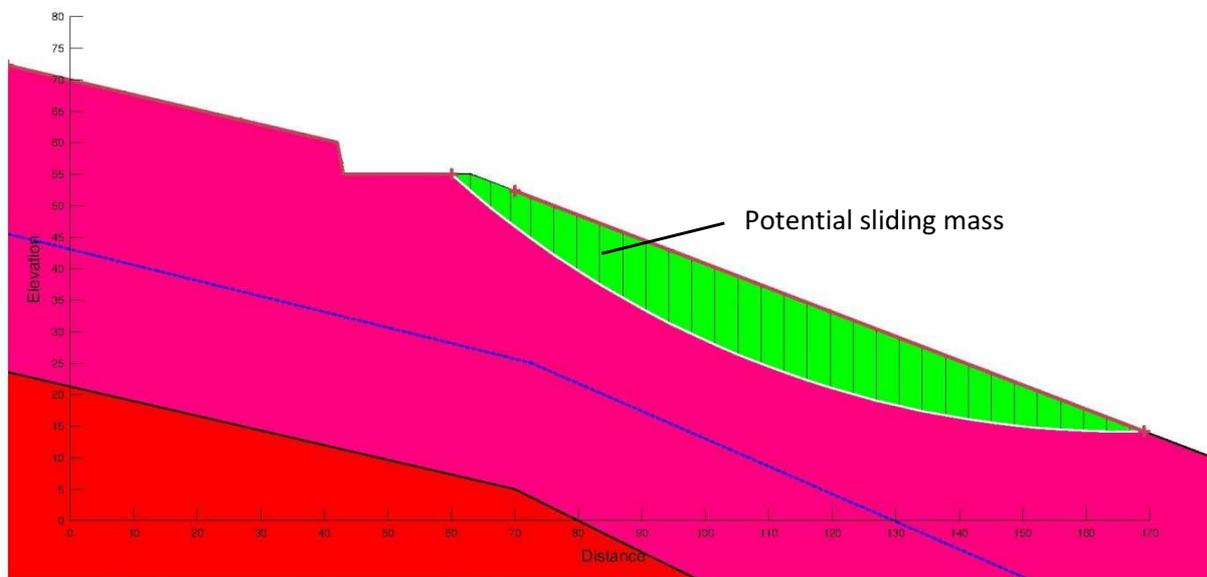
Figure 58: Simulation:  $T_2b^2$  highly decayed rock; FOS: 2.316

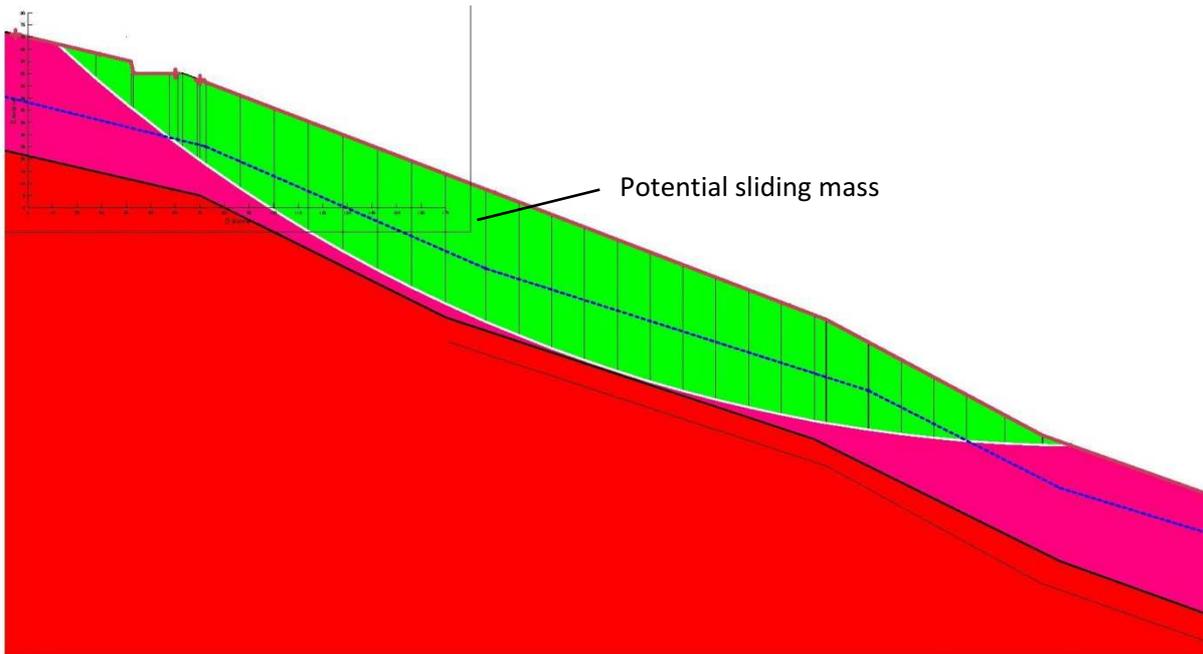
Figure 59: Simulation:  $T_2b^2$  highly decayed rock with wide entry-exit ranges; FOS: 1.728

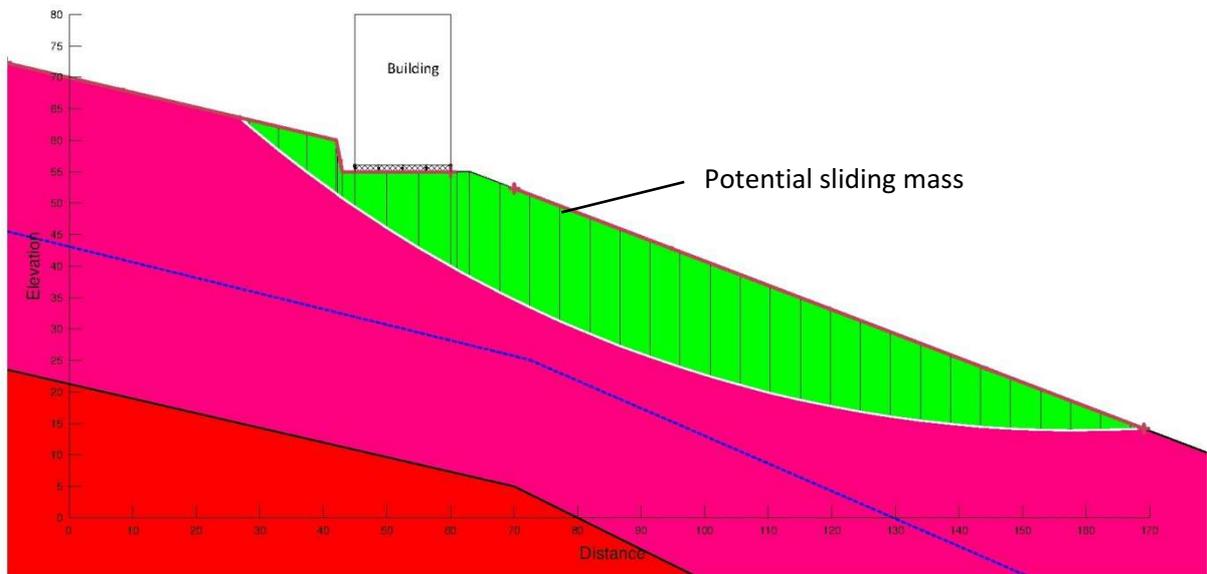
Figure 60: Simulation: Building on  $T_2b^2$  highly decayed rock; FOS: 2.225

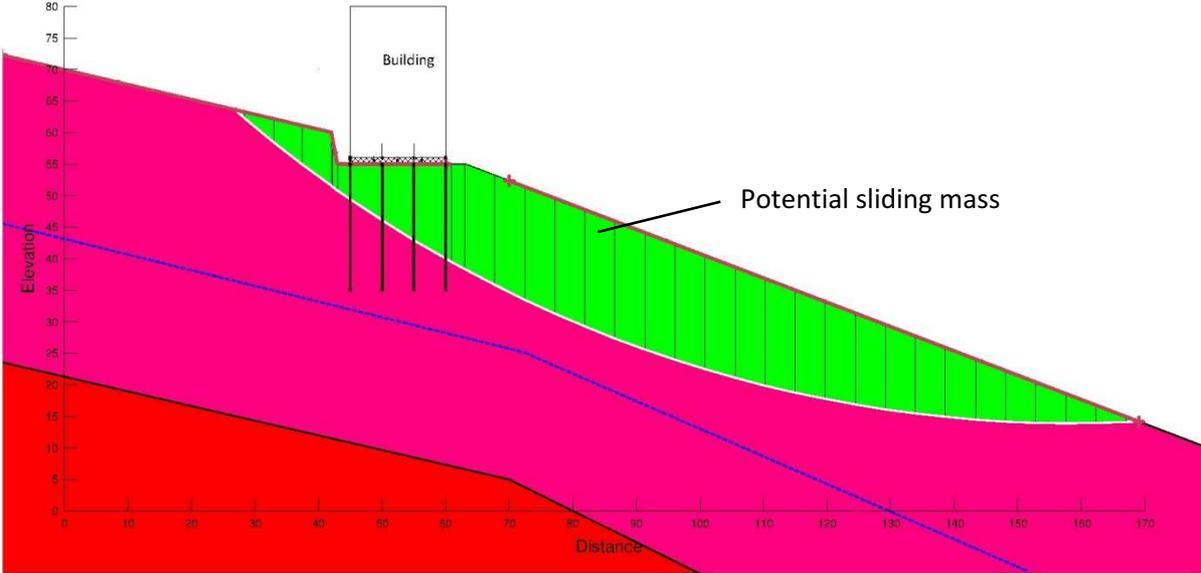
Figure 61: Simulation: Building with stabilisation pile on  $T_2b^2$  highly decayed rock; FOS: 2.396

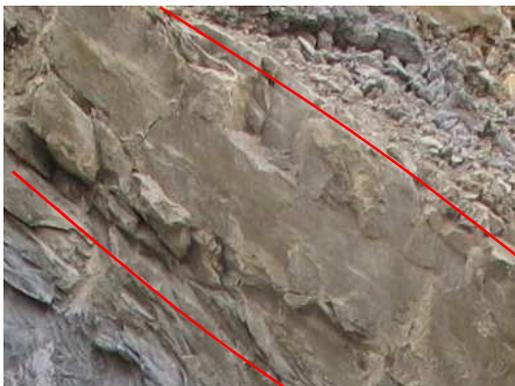
The first layer of the Artificial opening is a brown- grey coloured marlstone with a scratch hardness of 1-2. The total dimension is 0.4 m. The fracture plane appears rough. Smith hammer measurements show strength of 41 MPa. The transmission zone of layer 1 and 2 is undisturbed.

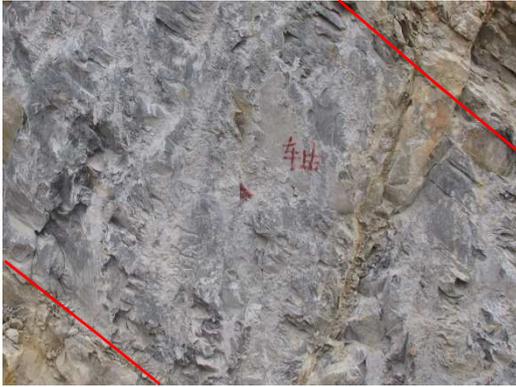
2

This grey interbedding has a dimension of 1.7 m. The fracture plane is between smooth and slightly rough. A slight reaction of HCl shows a medium carbonate content. The scratch hardness reaches 4 with a measured strength of 52.7 MPa.

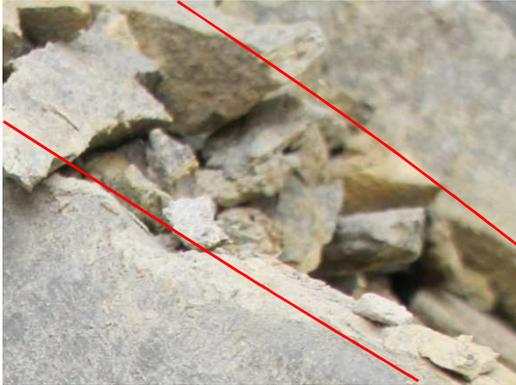
3

A weak interlayer of two centimetre thickness is between layer 2 and 4. It consists of flattened small gravel as the main grain size with sand and silt/clay in between. The granular skeleton of the gravel is not blasted.

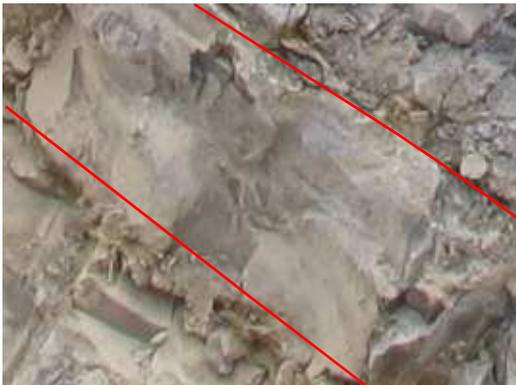
A 27 cm thick grey layer is similar to layer 2 but a bit darker grey coloured. It also displays a slow HCl reaction. The scratch hardness of 4 and the slightly rough fracture plane indicates similar properties like layer 2. Just the measured strength is with 52.5 MPa a bit higher.

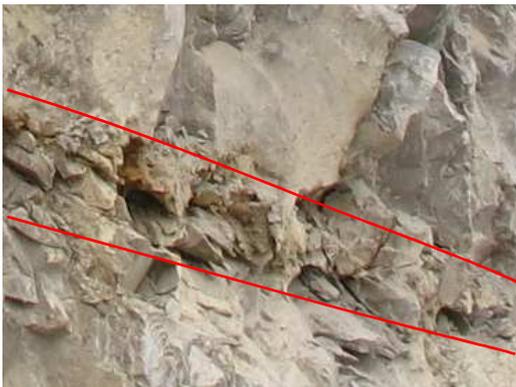
Layer 5 is a similar thin weak layer like interlayer 3 of 4 cm thickness. It consists mainly of gravel and sand with silt/clay in between. The granular skeleton of the gravel is not blasted.

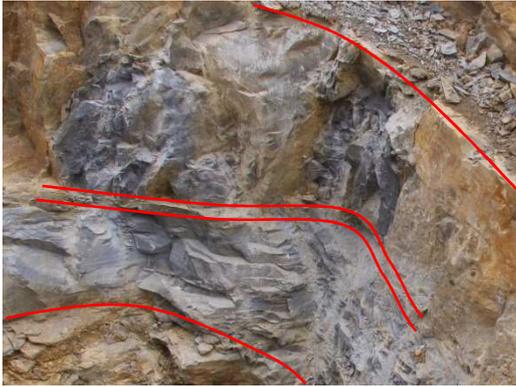
Layer 6 is a grey 95 cm thick layer, similar to layer 4 and 2. The fracture plane appears smooth like a wood plate- The scratch hardness reaches 5. The measurements with the Schmidt hammer display a higher strength of 59.5 MPa.

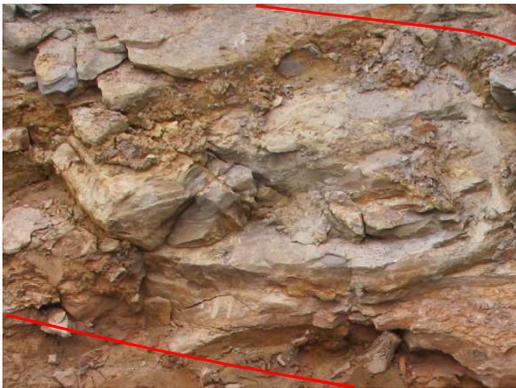
Layer 9 is a reddish, 60 cm thick layer of mudstone. With strength of 14.4 MPa it has a weak appearance as also the scratch hardness is only 1. It is interposed with cracks and loose rock topples out. The HCl test displays a slow reaction. The fracture plane appears from soft to slightly rough.

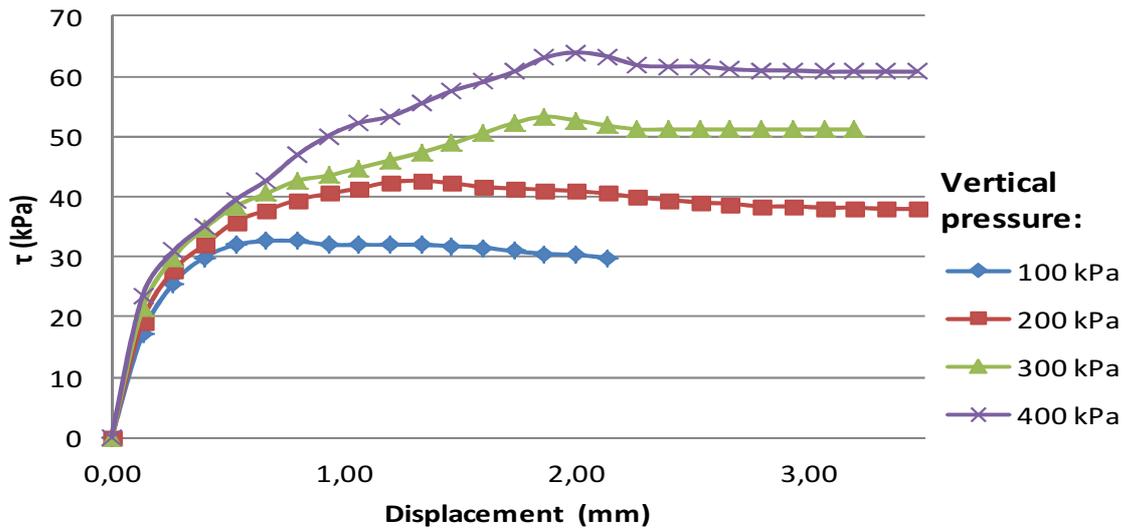
Figure 64: Relation curve of shear stress and shearing displacement

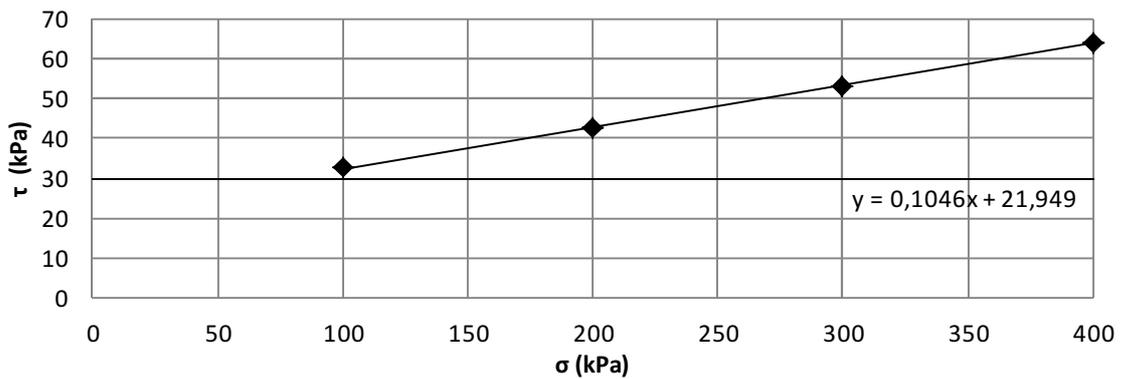
Figure 65: Relation of shear strength and vertical pressure

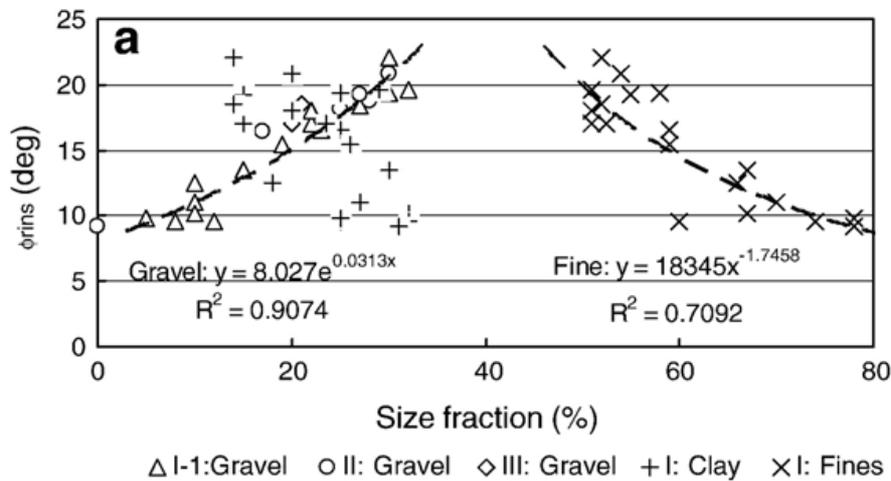
Figure 66 Relationship between residual friction angle and particle size fractions (Wen et al. 2007, p. 93)

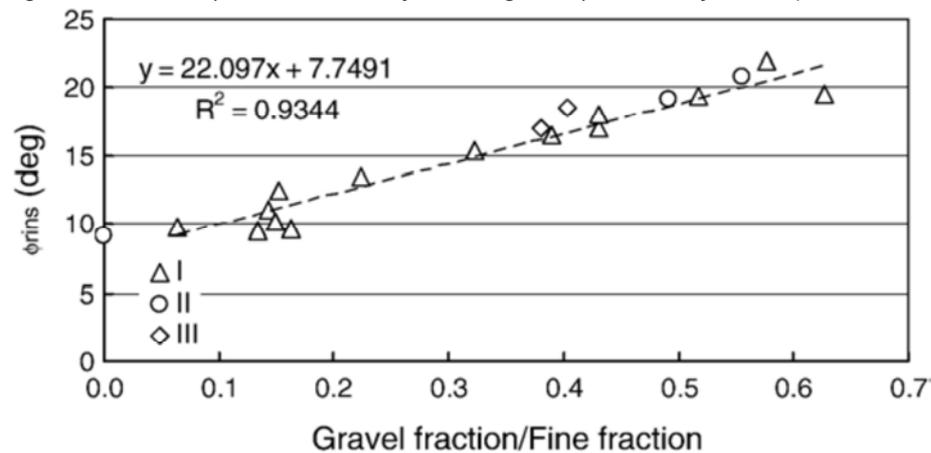
Figure 67: Relationship between residual friction angle and ratio of gravel of fine contents (Wen et al. 2007, p. 94)

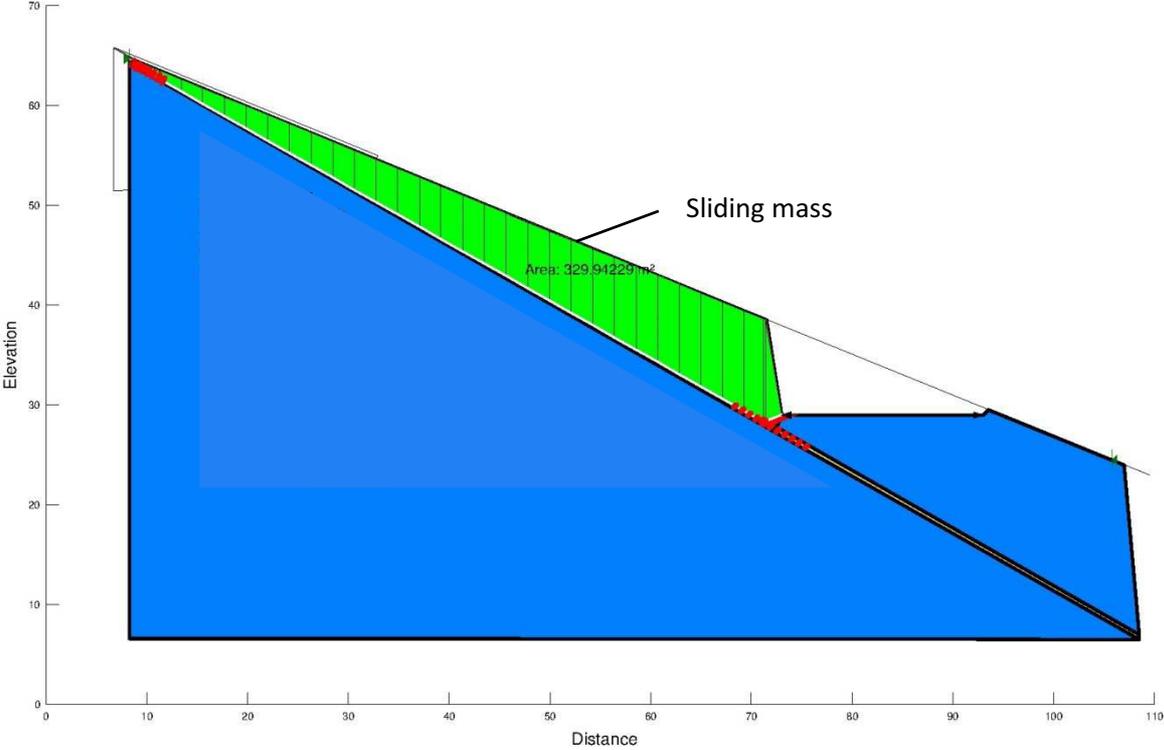
Figure 68: Simulation:  $T_2b^3$  slightly weathered rock with a weak clay layer; FOS: 0.706

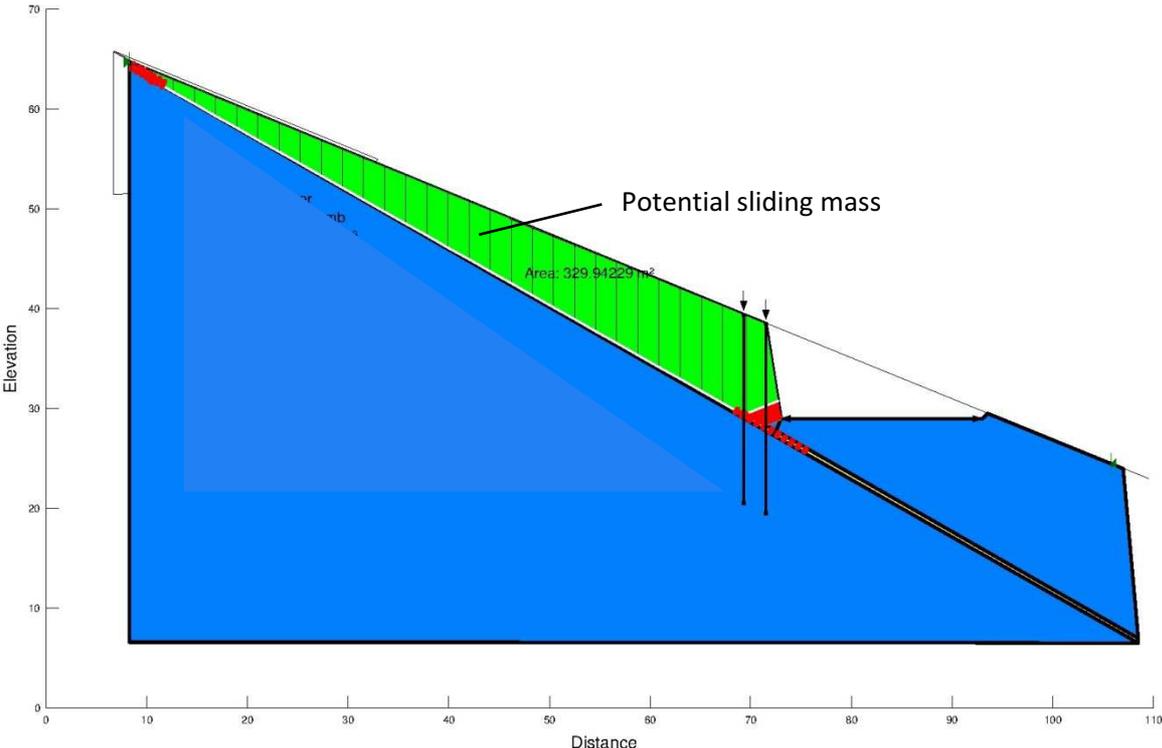
Figure 69: Simulation: Stabilisation piles on  $T_2b^3$  slightly weathered rock with a weak clay layer; FOS: 1.111
