UNIVERSITÄT FÜR BODENKULTUR  
INSTITUT FÜR GEOTECHNIK

**GEOLOGICAL AND GEOTECHNICAL  
CHARACTERIZATION OF GROUND CONDITIONS IN  
BADONG COUNTY, CHINA**

2013

DIPLOMARBEIT NR. 360

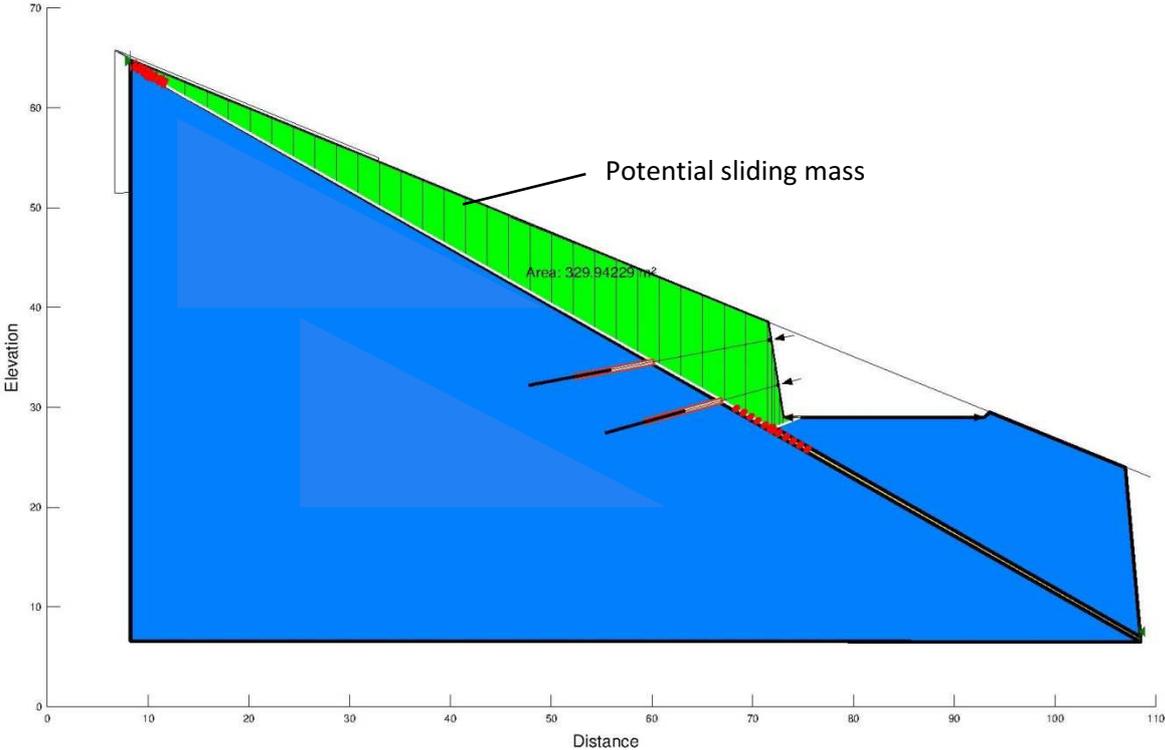
Figure 70: Simulation: Anchor stabilisation in  $T_2b^3$  slightly weathered rock with a weak clay layer; FOS: 1.101

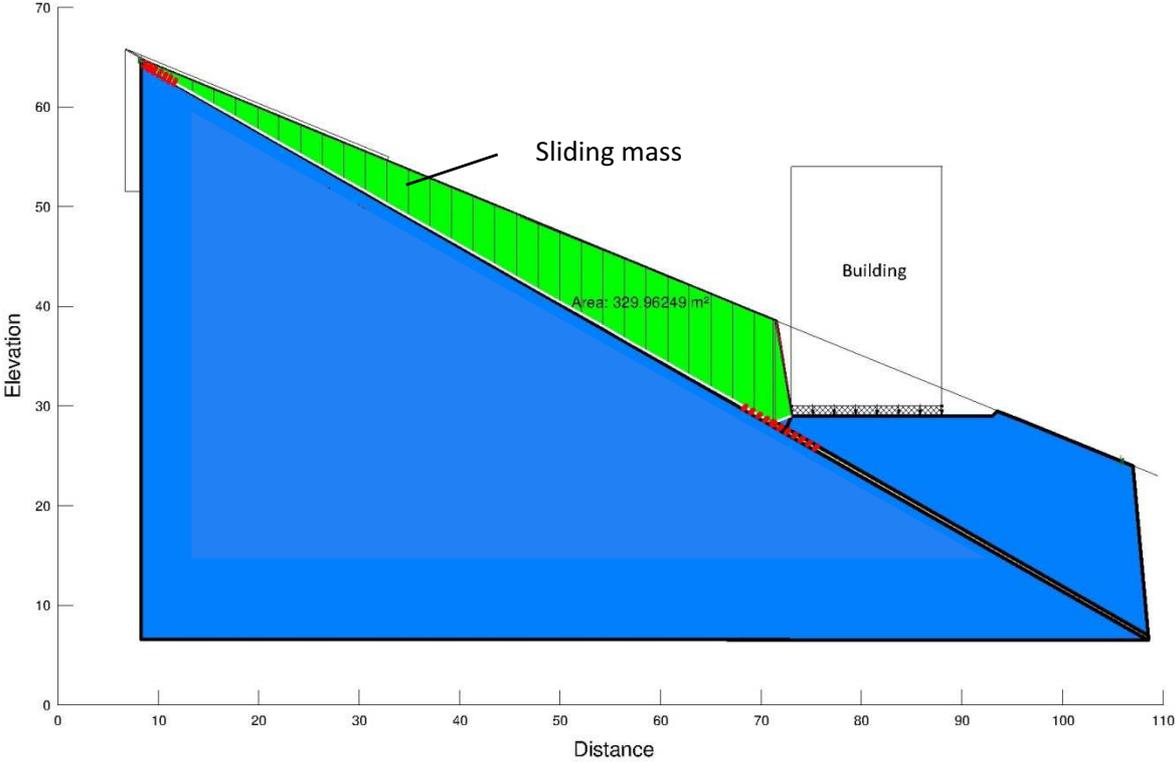
Figure 71: Simulation: Building on T<sub>2</sub>b<sup>3</sup> slightly weathered rock with a weak clay layer; FOS: 0.710

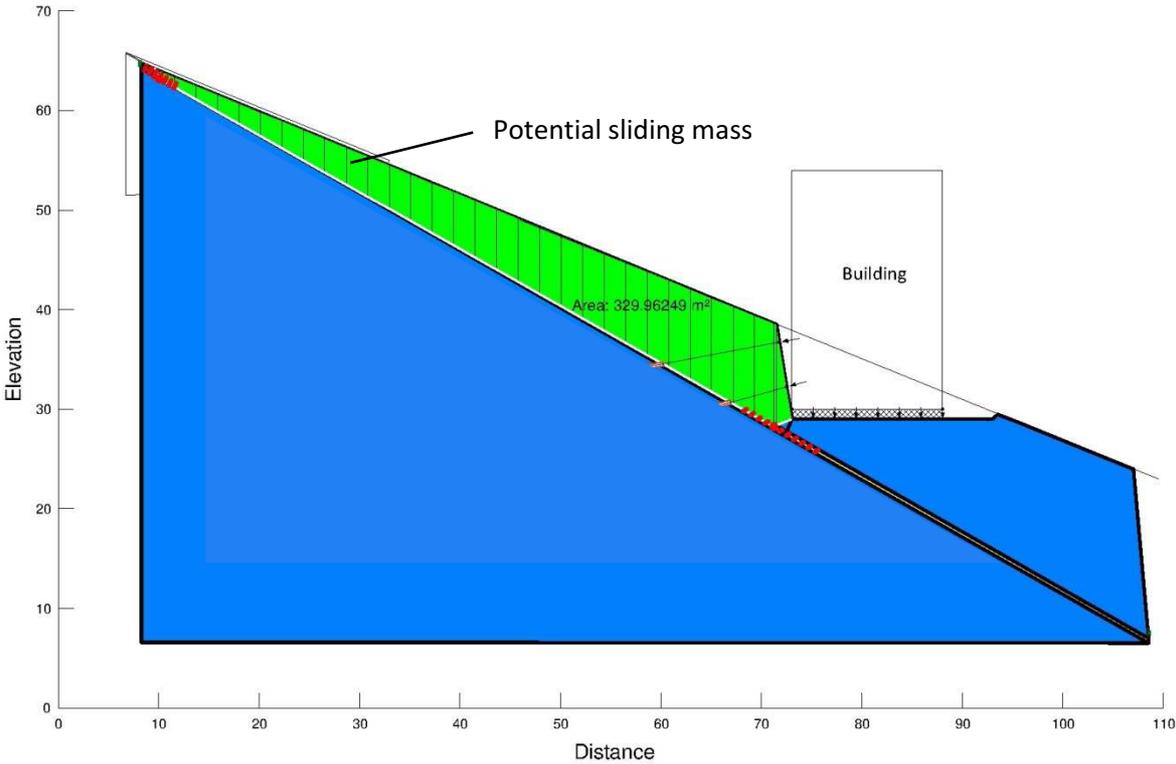
Figure 72: Simulation: Building and anchor stabilisation on  $T_2b^3$  slightly weathered rock with a weak clay layer; FOS: 1.116

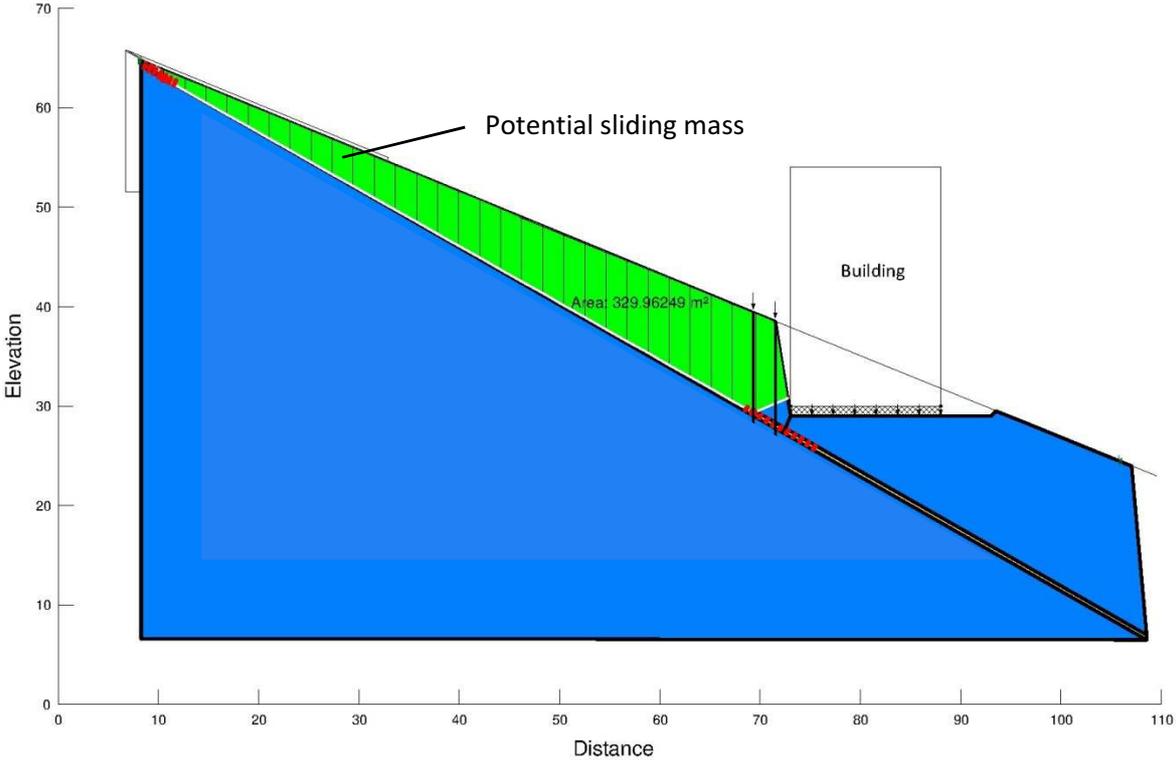
Figure 73: Simulation: Building and pile stabilisation on  $T_2b^3$  slightly weathered rock with a weak clay layer; FOS: 1.111

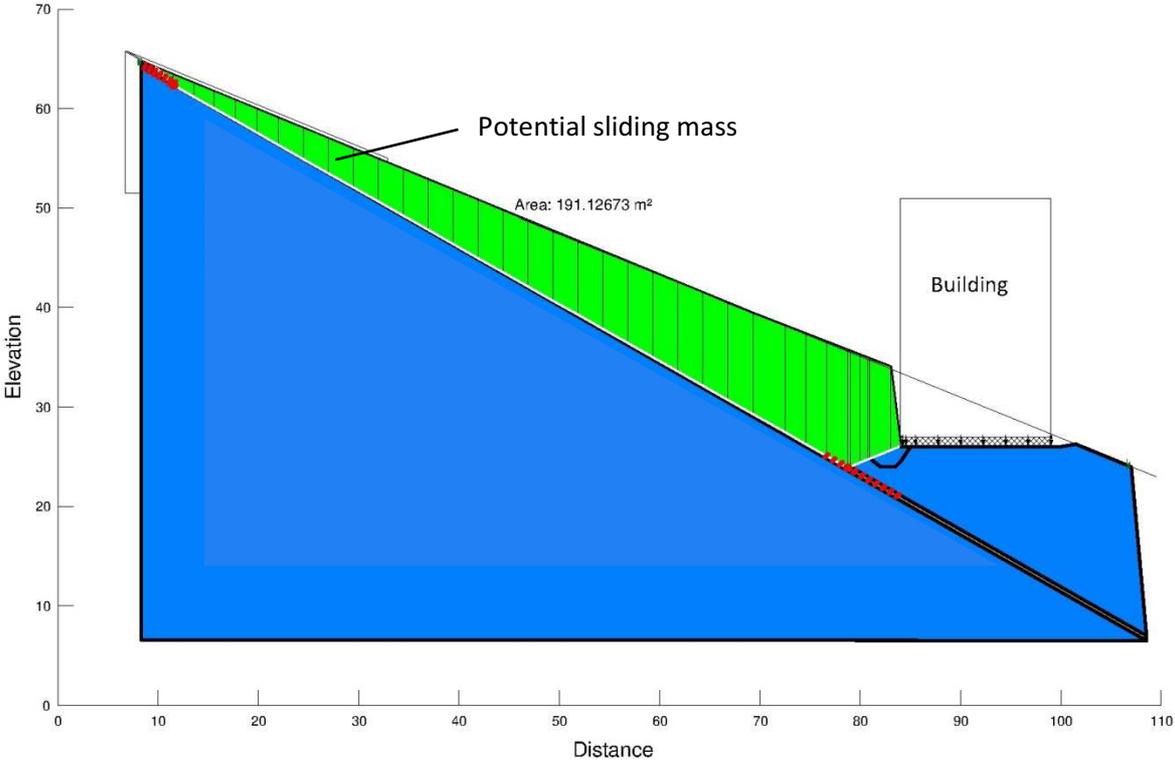
Figure 74: Simulation: Building on  $T_2b^3$  slightly weathered rock with a weak clay layer; FOS: 1.244

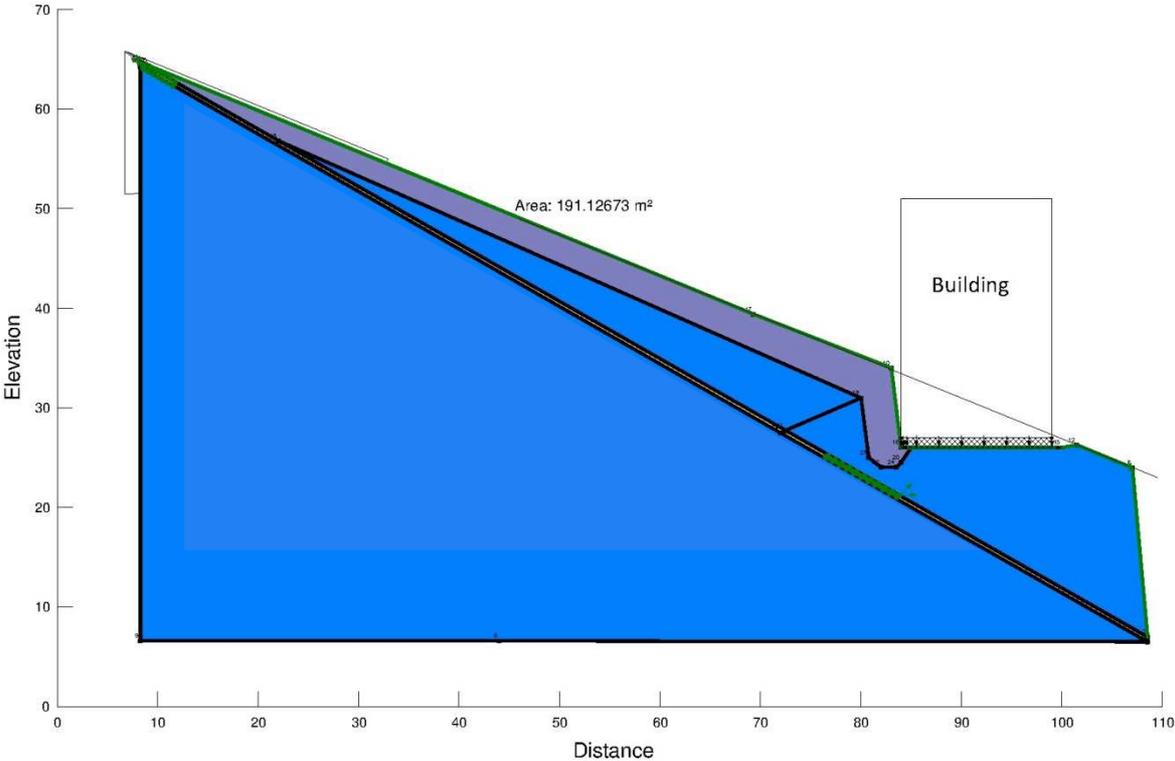
Figure 75: Building on  $T_2b^3$  highly weathered rock on the surface, and a weak clay layer under ground.

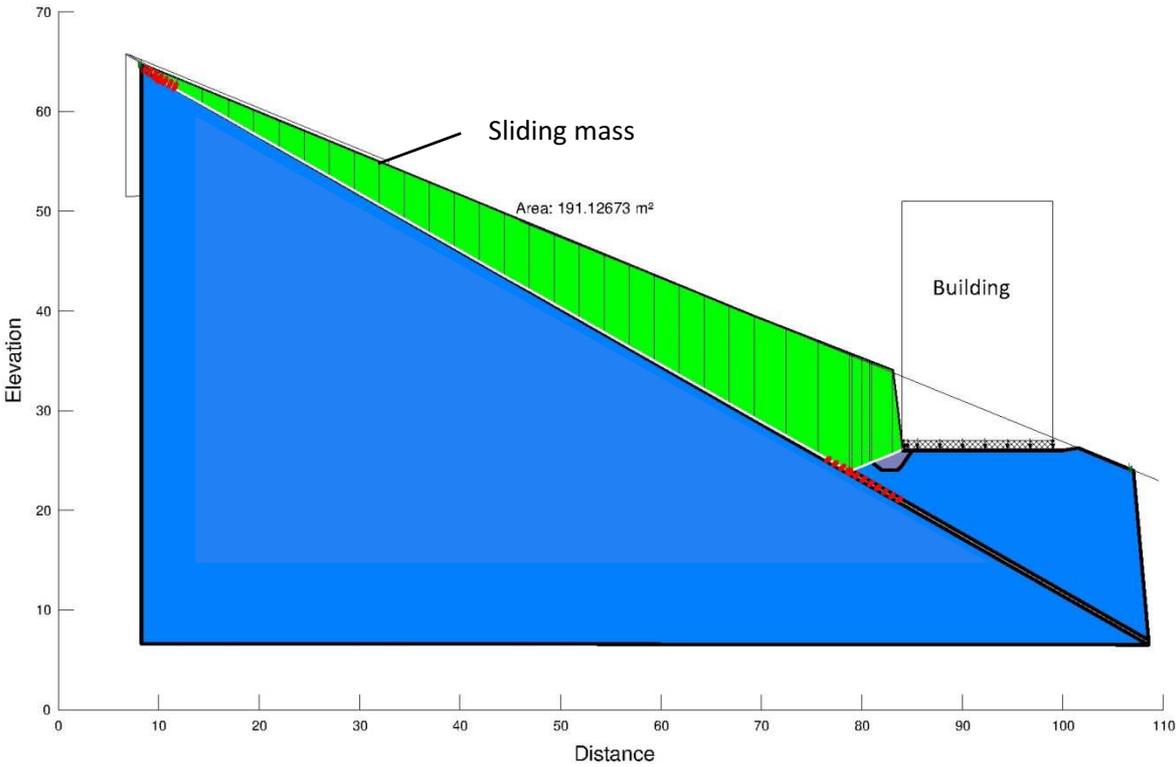
Figure 76: Simulation: Building on  $T_2b^3$  highly weathered rock on the surface, and a weak clay layer under ground.; FOS:0.884

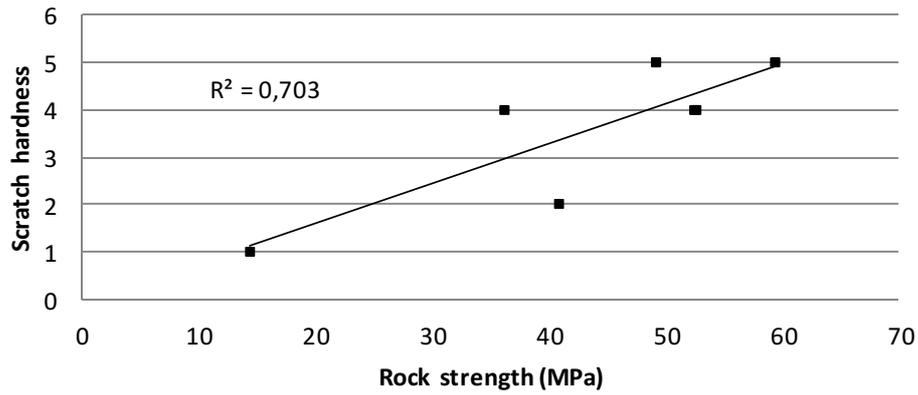
Figure 77: Comparison of scratch hardness and rock strength (measured by Schmidt hammer)
