**A PULL OUT TEST OF PHYLLANTHUS SELLOWIANUS AND SEBASTIANA
SCHOTTIANA AND DEVELOPMENT OF SOIL BIOENGINEERING
CONSTRUCTIONS IN SOUTHERN BRAZIL**

Master thesis by
Stephan Hörbinger

Wien, 08.2013

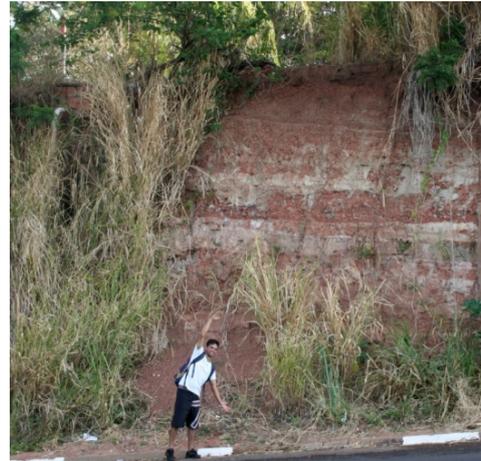
Figure 2: Soil profile of a Latosol with a defuse transition of horizons.

The soil at the test site is a red latosol. It is rich in iron, alumina, silica and, according to DALMOLIN et al. (2008), porous, friable, well structured, normally profound, strongly weathered and presents a defuse transition of the horizons. The profile is Aox-Box-C . It is a type of soil of tropical climates with alternating hot-humid and dry periods. Latosols are formed by the process of leaching. In high temperatures and water surplus, the soluble bases, sesquioxides and silica are removed from the upper layers and deposited in the lower horizons. Residual accumulations of Fe- and Al- Oxides, coagulate irreversibly and harden. Due to strong decay, organic substances are widely decomposed without chelation or displacement of Fe- and Al- Oxides. As a result of the leaching, valuable mineral nutrients are displaced to the lower layers and the soils remain poor. Latosols are good soils for plantation. (STAHR, 1992).

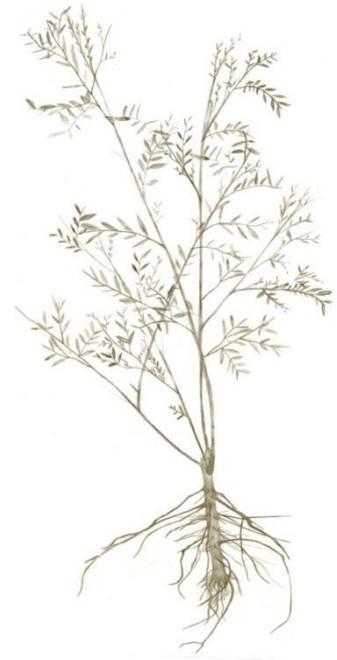
Figure 4: Sketch of a one year old life-stake of *Phyllanthus sellowianus*.

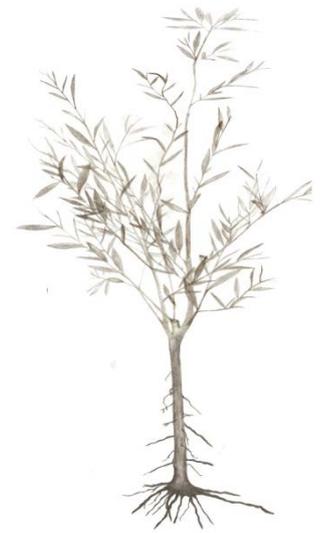
Figure 8: Sketch of a one year old life-stake of *Sebastiania schottiana*.

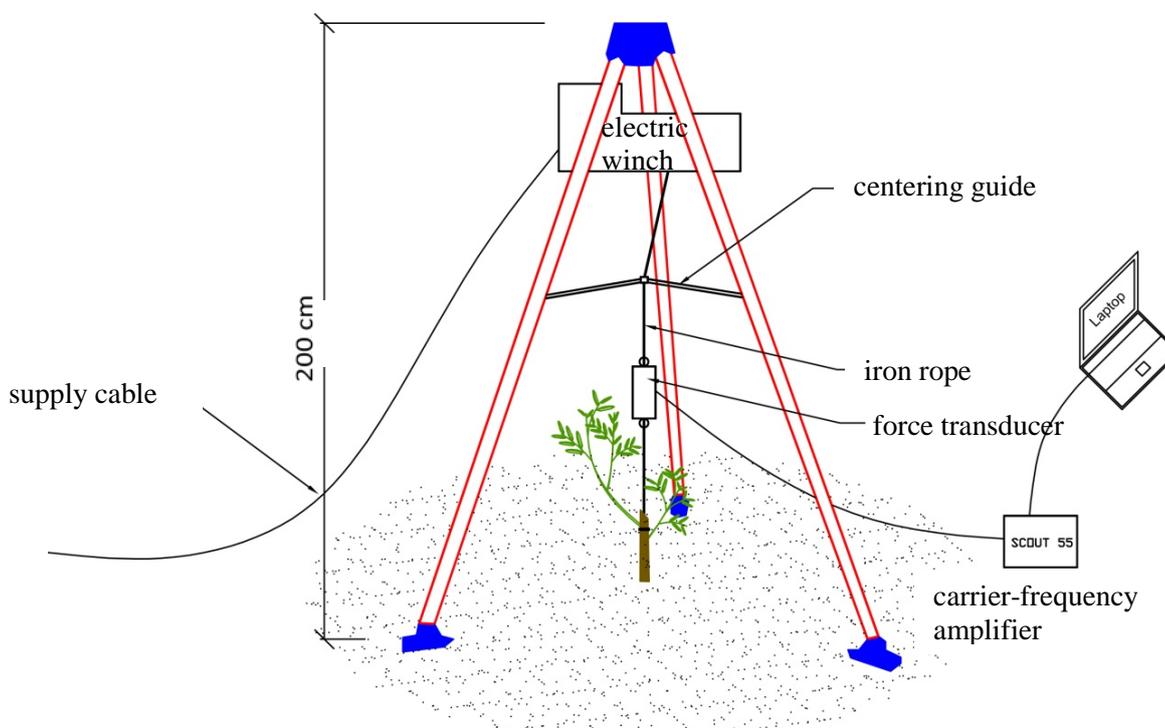
Figure 10: Diagram showing the arrangement of the equipment used for pull out testing (RAUCH, SUTILI, 2009).

To implement the experiment, a special apparatus, based on a tripod supporting a force of up to 168 kN, was designed and fabricated. It is portable and adjustable to irregular surfaces. The tripod supports a continuous-torque electric winch with adjustable lift speed. Since the pulling rate can influence the pull out capacity, it is crucial that the pull out process is performed at a constant rate of uplift. This is ensured by the electronically driven winch instead of manual propulsion. The guy wire of the winch passes through a centering guide which is mounted at the top of the tripod. A force transducer with a max. support of 10 kN, which is installed between the centering guide and the plant, is connected to a carrier frequency amplifier that interprets the signals and sends them to a laptop computer that instantly stores the data and generates a time versus force graph. Afterwards, the time values can be transformed into displacement values, thus generating force versus displacement graphs. The peak in the generated graph indicates the maximum force required for a plant to be uprooted. The arrangement of the apparatus is shown in Figure 10.

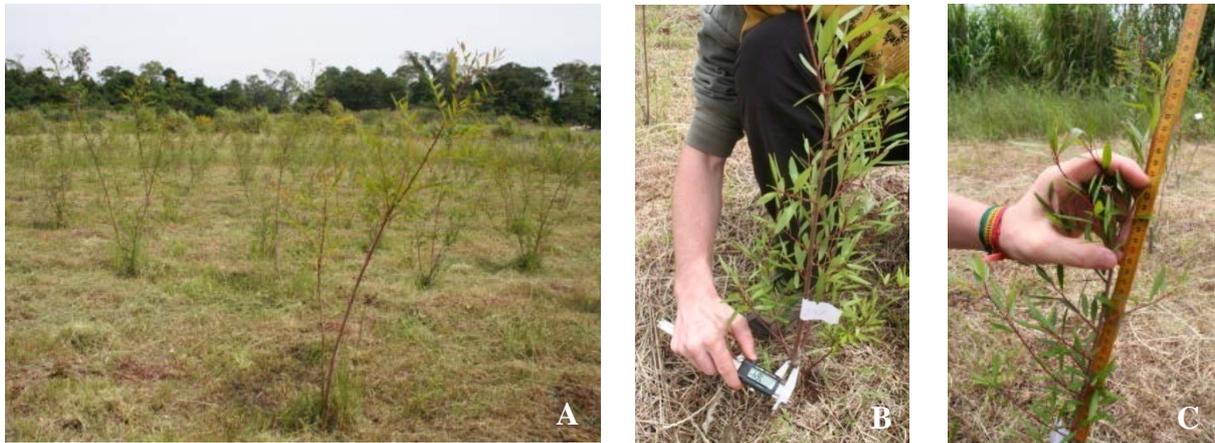
Figure 11: (A) Experimental site after clearing (B) Taking the diameter, using a venire calliper (C) Measuring height, using a yardstick. Campus, UFSM – CESNORS, Frederico Wesphalen, 10.10.2012.

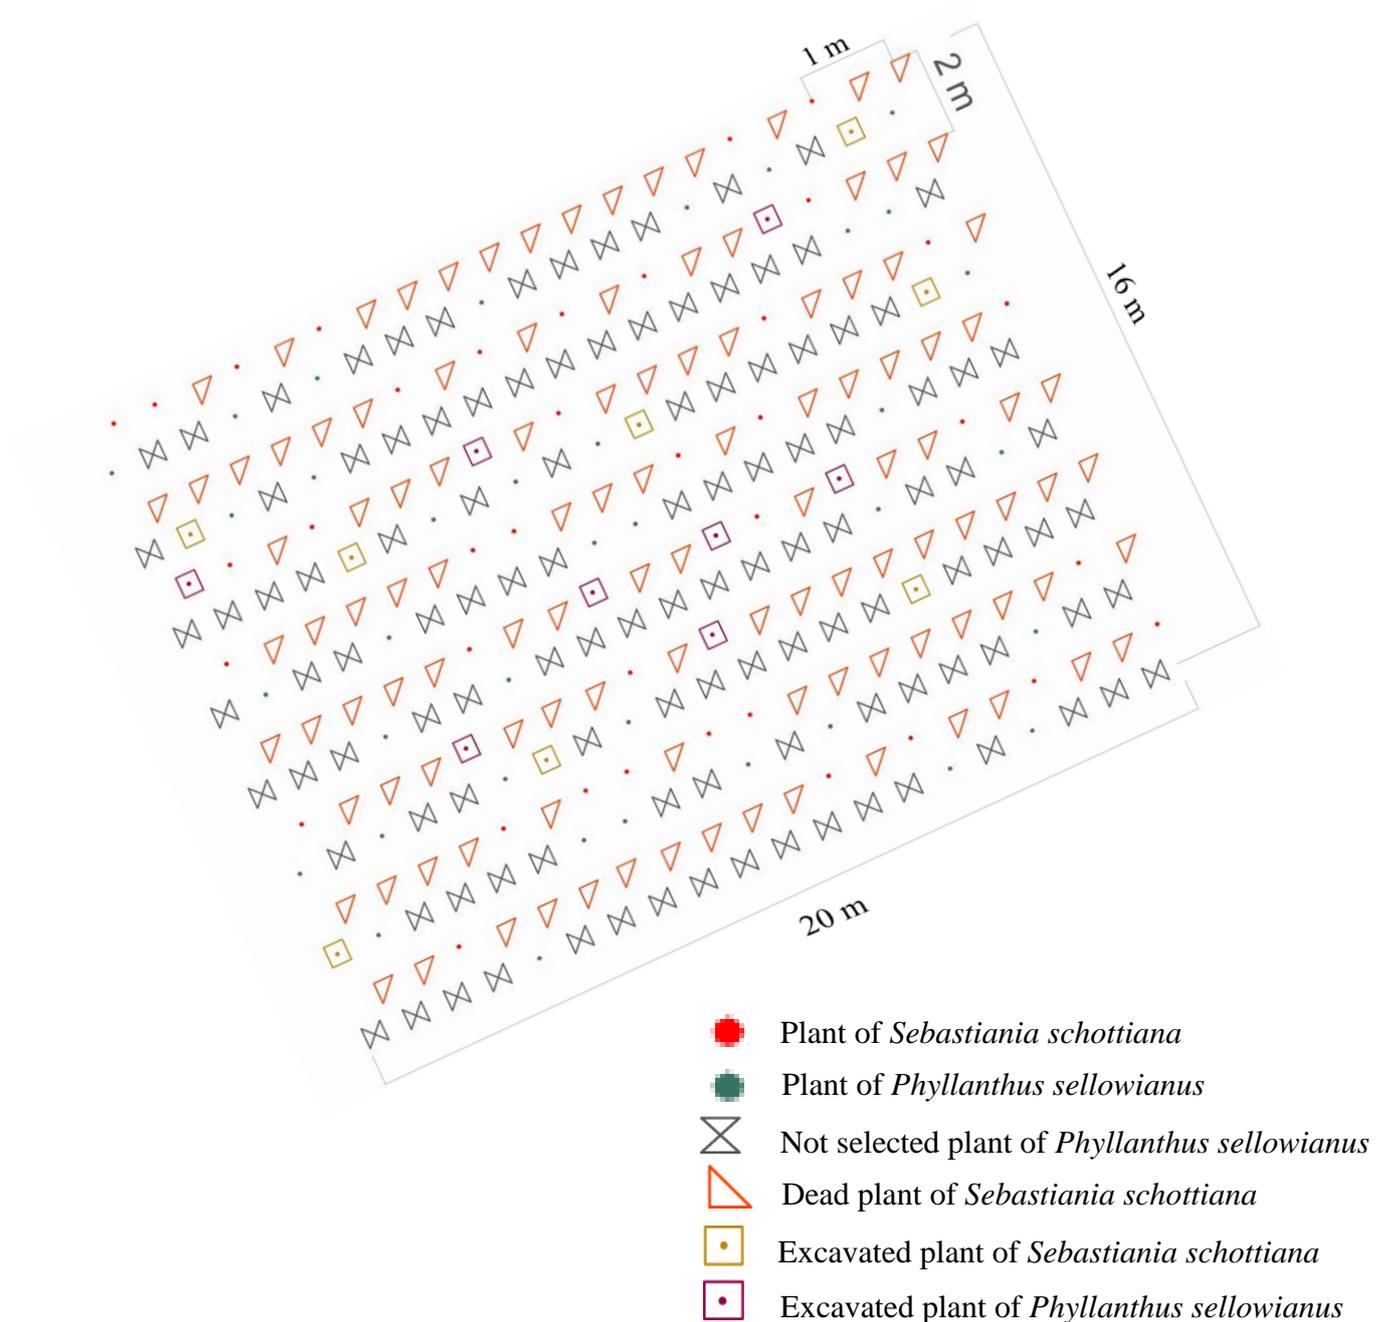
Figure 12: Diagram showing the arrangement of the testing field and the selection of plant individual for pull out tests and excavation method. Campus, UFSM – CESNORS, Frederico Wesphalen, 10.10.2012.

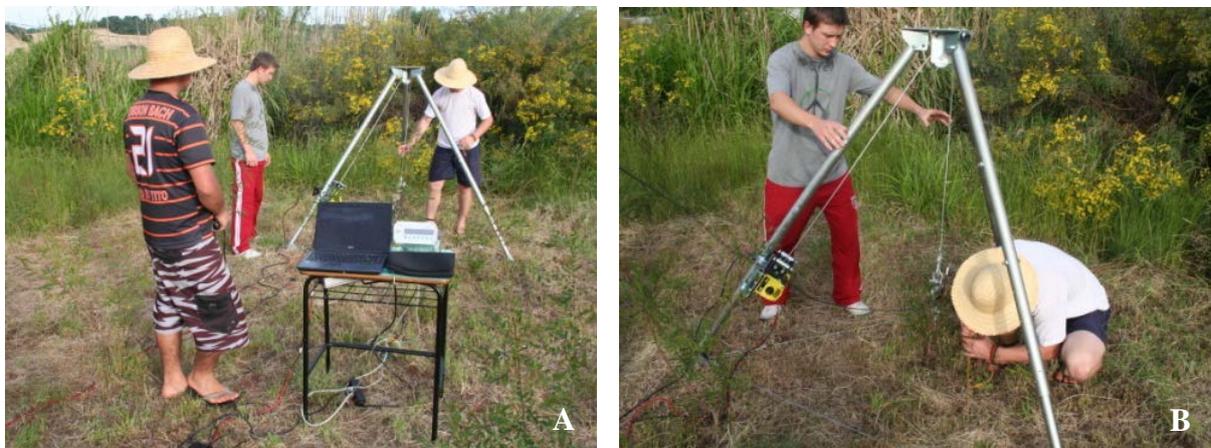
Figure 13: (A) Setting of the equipment. (B) Tying the plant to the apparatus. Campus, UFSM – CESNORS, Frederico Wesphalen, 15.10.2012.

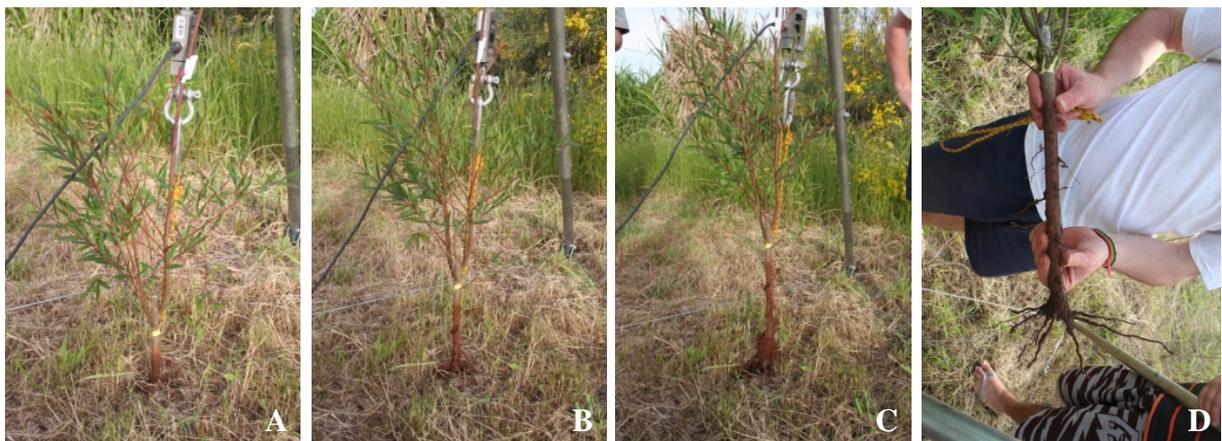
Figure 14: (A, B, C) Uprooting process of a *Sebastiania schottiana* plant and the pulled out root system (D) Campus, UFSM – CESNORS, Frederico Wesphalen, 15.10.2012.

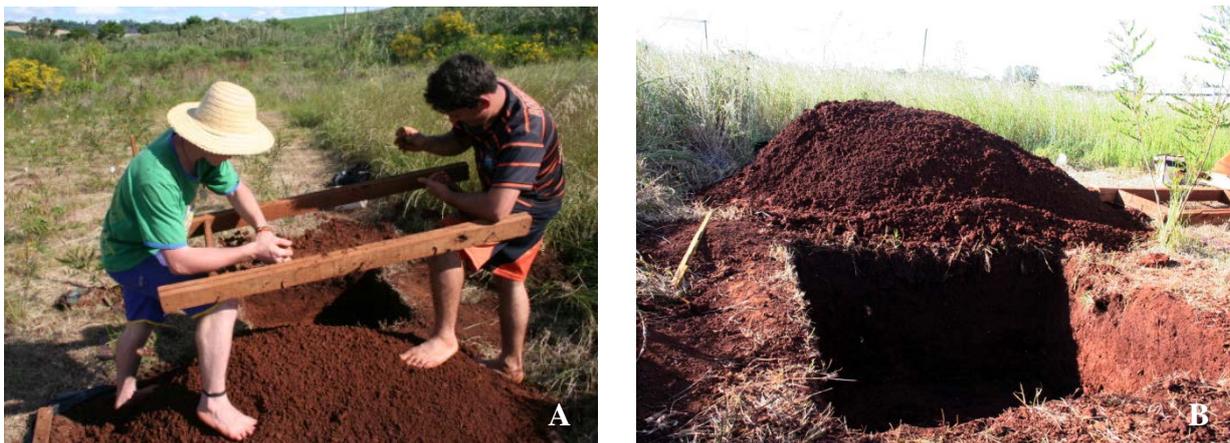
Figure 15: (A) Sieving the stripped earth in order to extract the roots that had remained in soil (B) Soil was excavated in an area of 1 m² and deep as 50 cm. Campus, UFSM – CESNORS, Frederico Wesphalen, 10.12.2012.

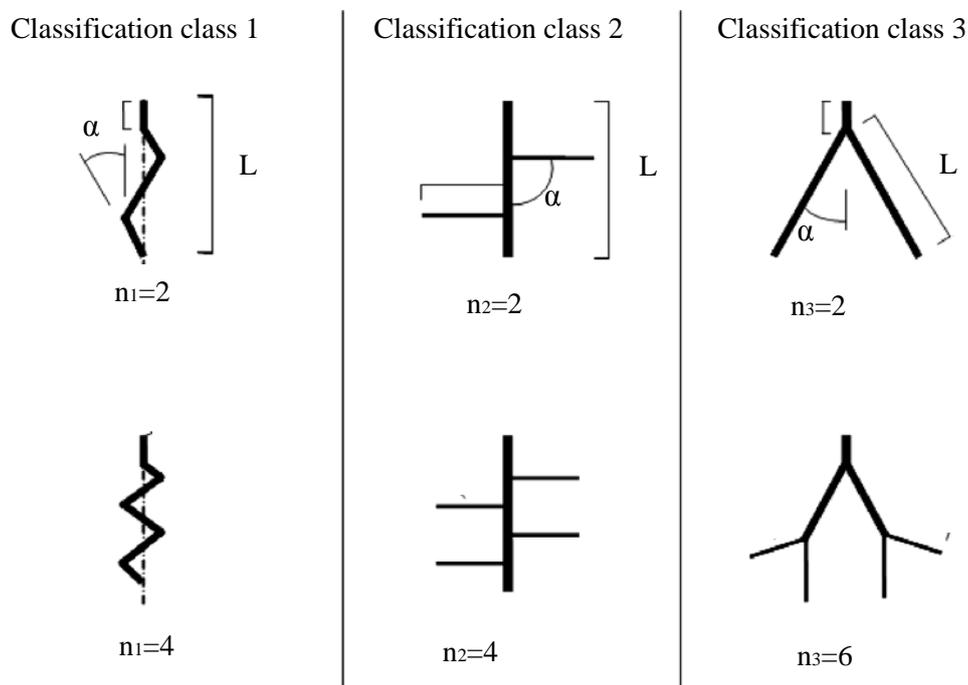
Figure 17: The three classification classes of root patterns by DUPUY et al. (2005). Classification class 1 consists of non-branching structures, classification class 2 of herringbone-like root systems and classification class 3 of dichotomous-like root systems. The quantity n represents the number of secondary segments, L is a reference distance of the secondary segments, and α is the angle between a segment and its bearing axis.

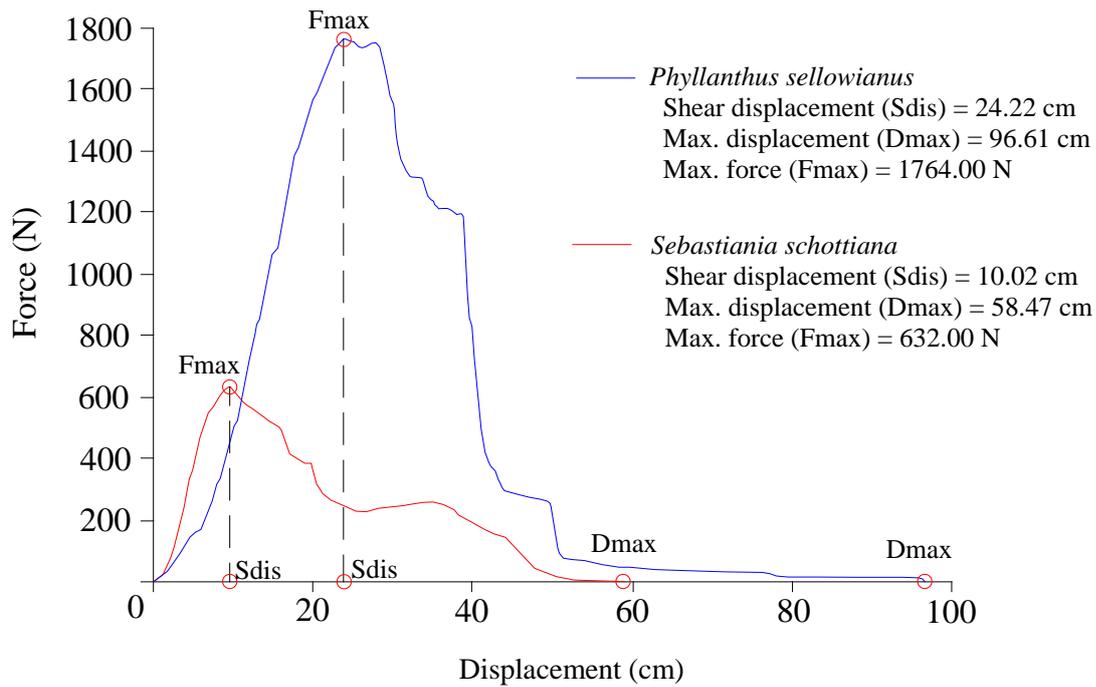
Figure 18: Graphs based on the average test results of *Phyllanthus sellowianus* and *Sebastiania schottiana*. Campus, UFSM – CESNORS, Frederico Wesphalen, 15.10.2012.

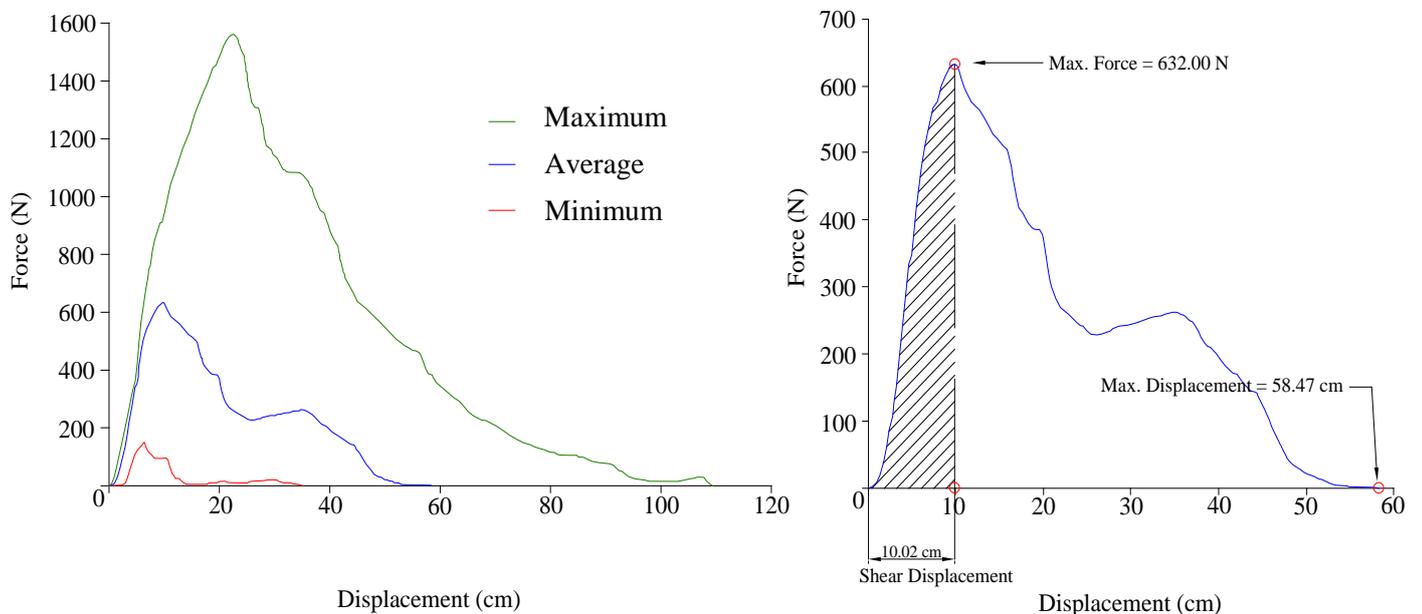
Figure 19: On the left, characteristic graphs, presenting the plant individuals of *Sebastiania schottiana*, which performed the maximum, average (in more detail on the right) and minimum uprooting resistance. Campus, UFSM – CESNORS, Frederico Wesphalen, 15.10.2012.

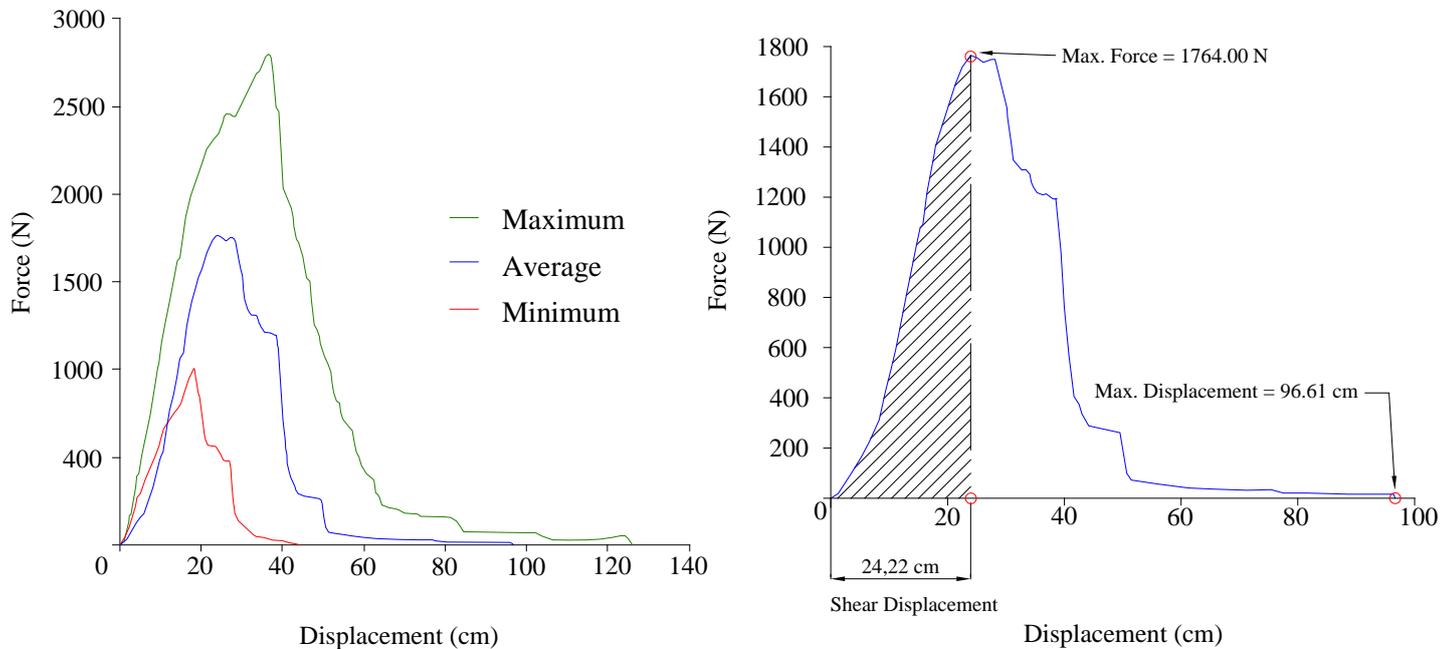
Figure 20: On the left, characteristic graphs, presenting the plant individuals of *Phyllanthus sellowianus*, which performed the maximum, medium (in more detail on the right) and minimum uprooting resistance. Campus, UFSM – CESNORS, Frederico Wesphalen, 15.10.2012.

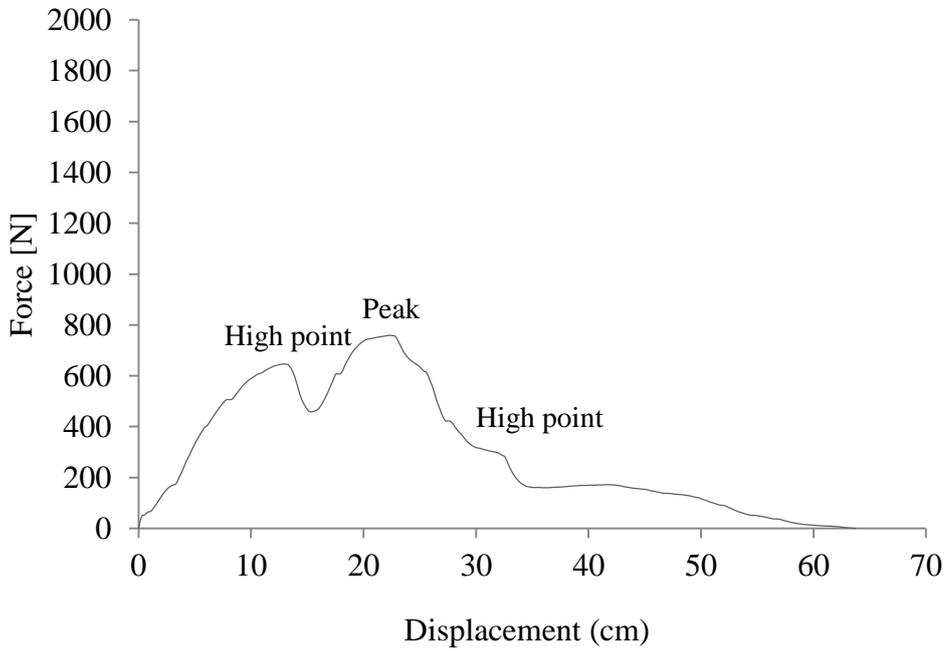
Figure 21: Typical pattern of uprooting - displacement curve for *Sebastiania schottiana*. Campus, UFSM – CESNORS, Frederico Wesphalen, 15.10.2012.

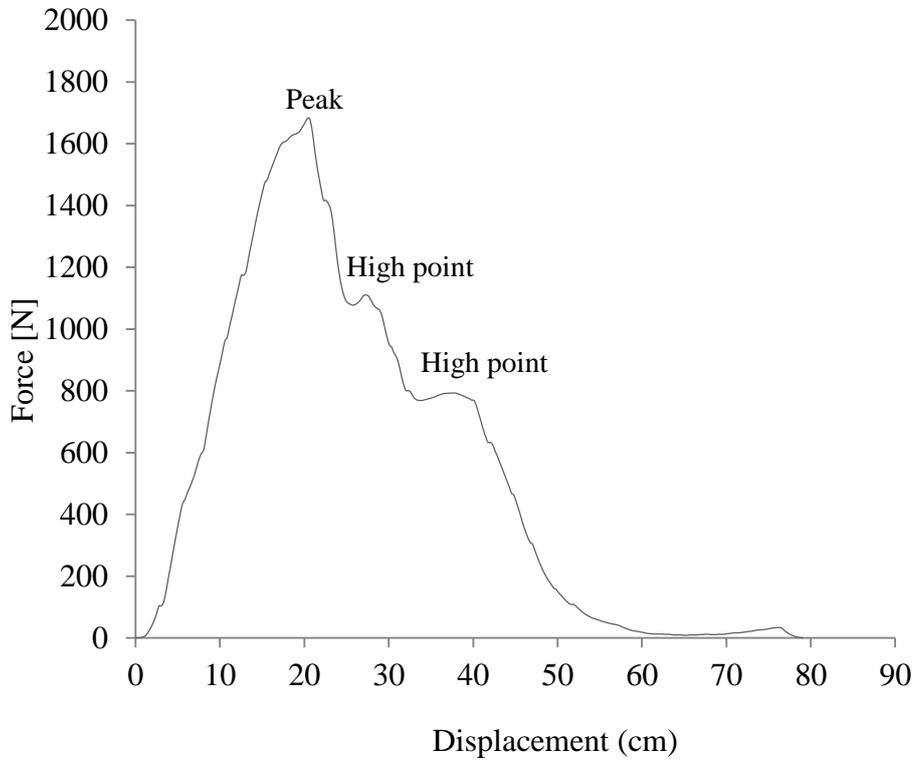
Figure 22: Typical pattern of uprooting - displacement curve for *Phyllanthus sellowianus*. Campus, UFSM – CESNORS, Frederico Wesphalen, 15.10.2012.

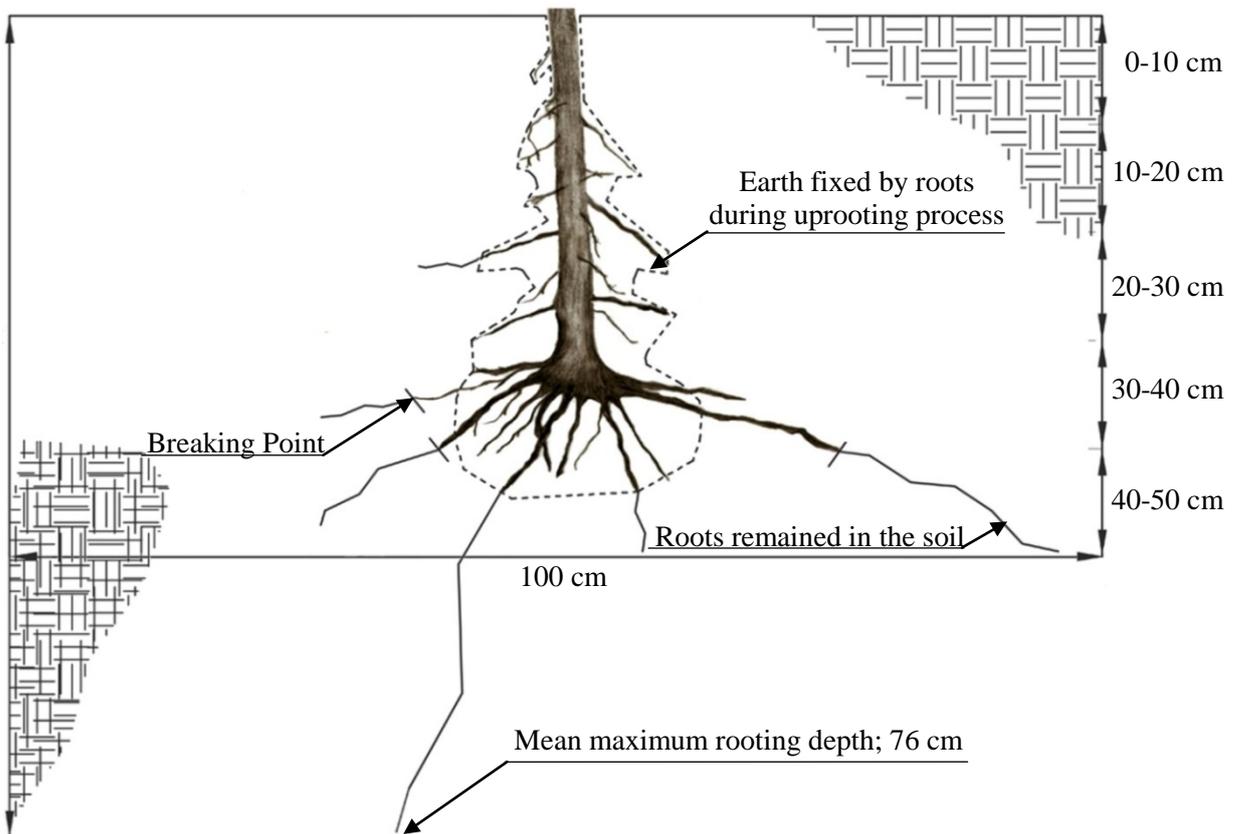
Figure 23: Sketch, illustrating the root system of a *Sebastiania schottiana* plant individual after uprooting, the roots remained in the soil, the soil fixed by the root system, the deepest point reached on average by this species and the divisions for the excavation method. Campus, UFSM – CESNORS, Frederico Wesphalen, 10.12.2012.

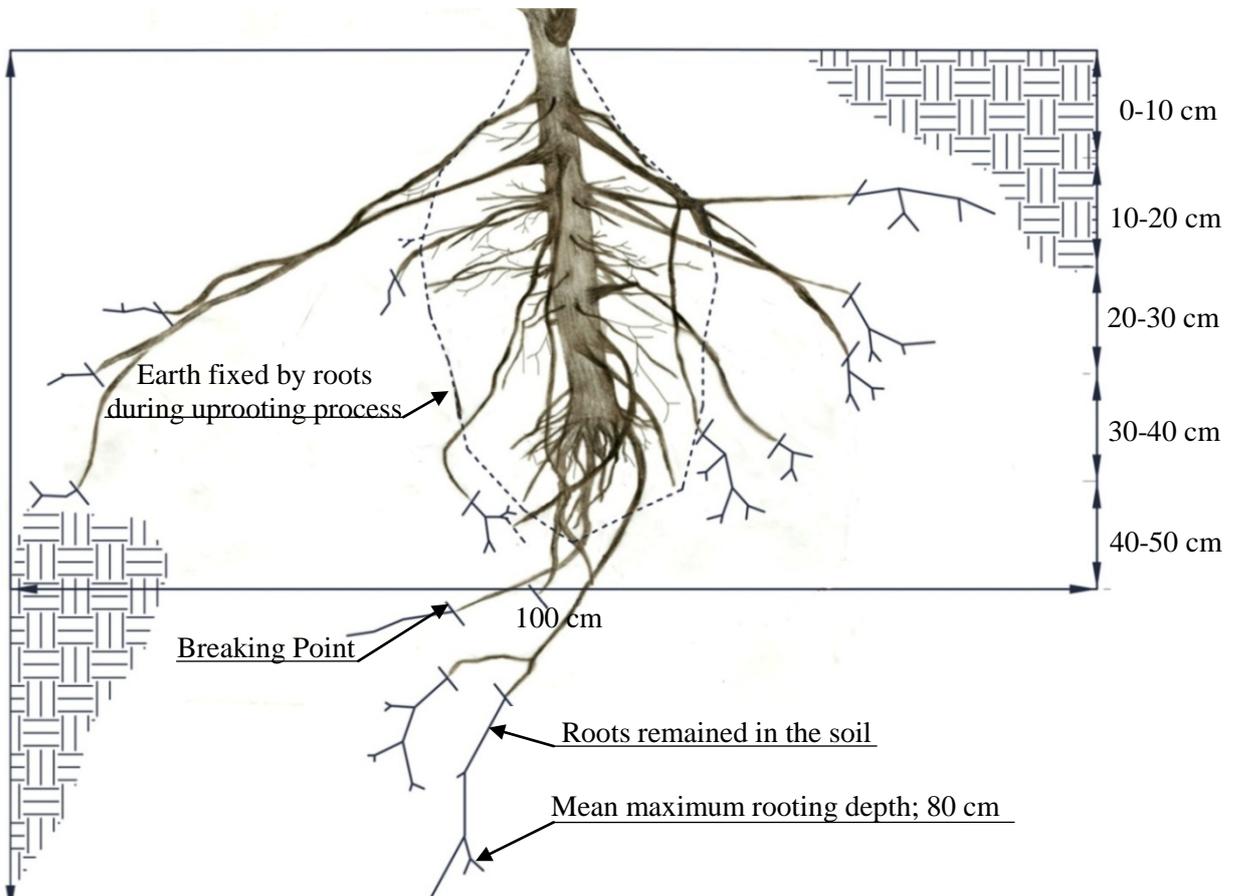
Figure 24: Sketch, illustrating the root system of a *Phyllanthus sellowianus* plant individual after uprooting, the roots remained in the soil, the soil fixed by the root system, the deepest point reached on average by this species and the divisions for the excavation method. Campus, UFSM – CESNORS, Frederico Wesphalen, 10.12.2012.

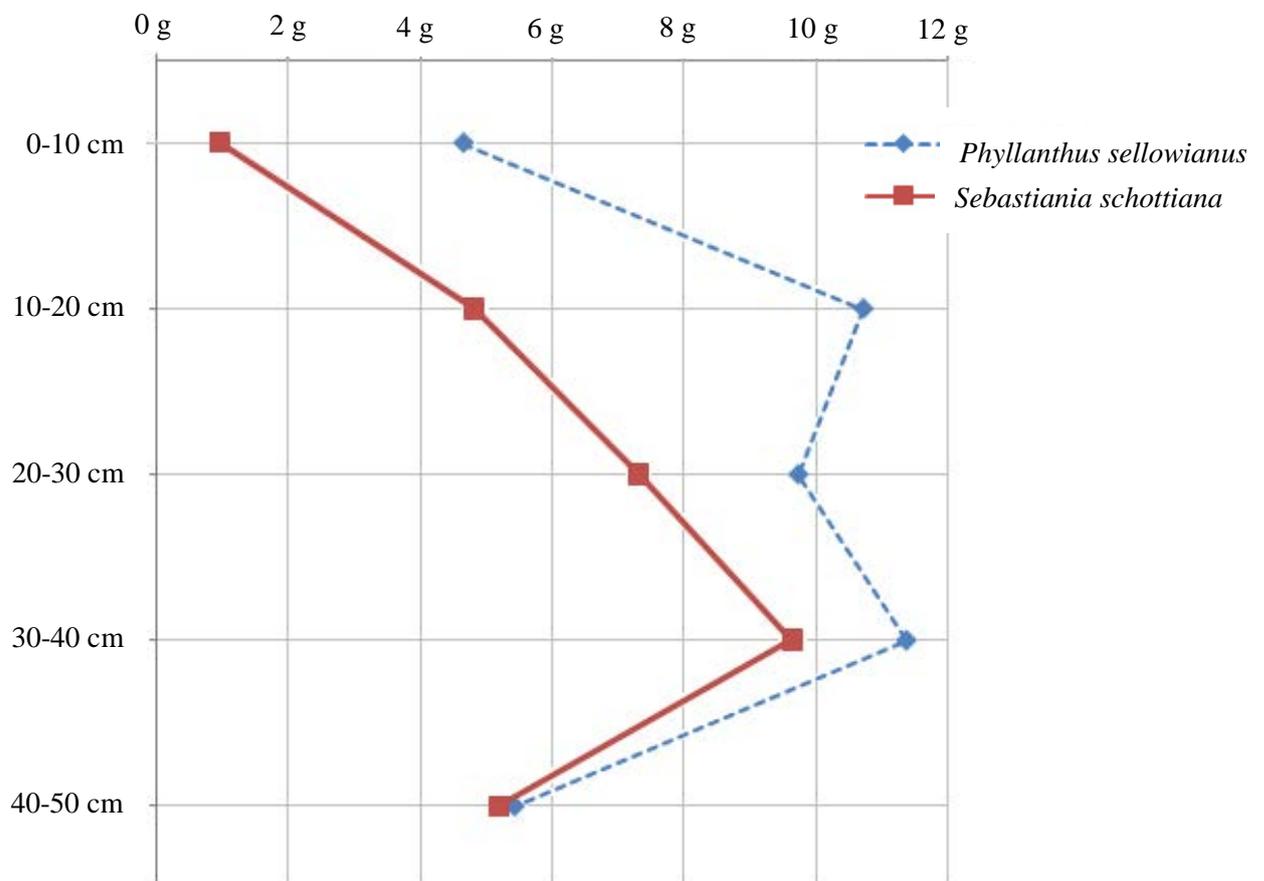
Figure 25: Distribution of root biomass for one year old life-stakes of *Phyllanthus sellowianus* and *Sebastiania schottiana*. Campus, UFSM – CESNORS, Frederico Wesphalen, 10.01.2013.

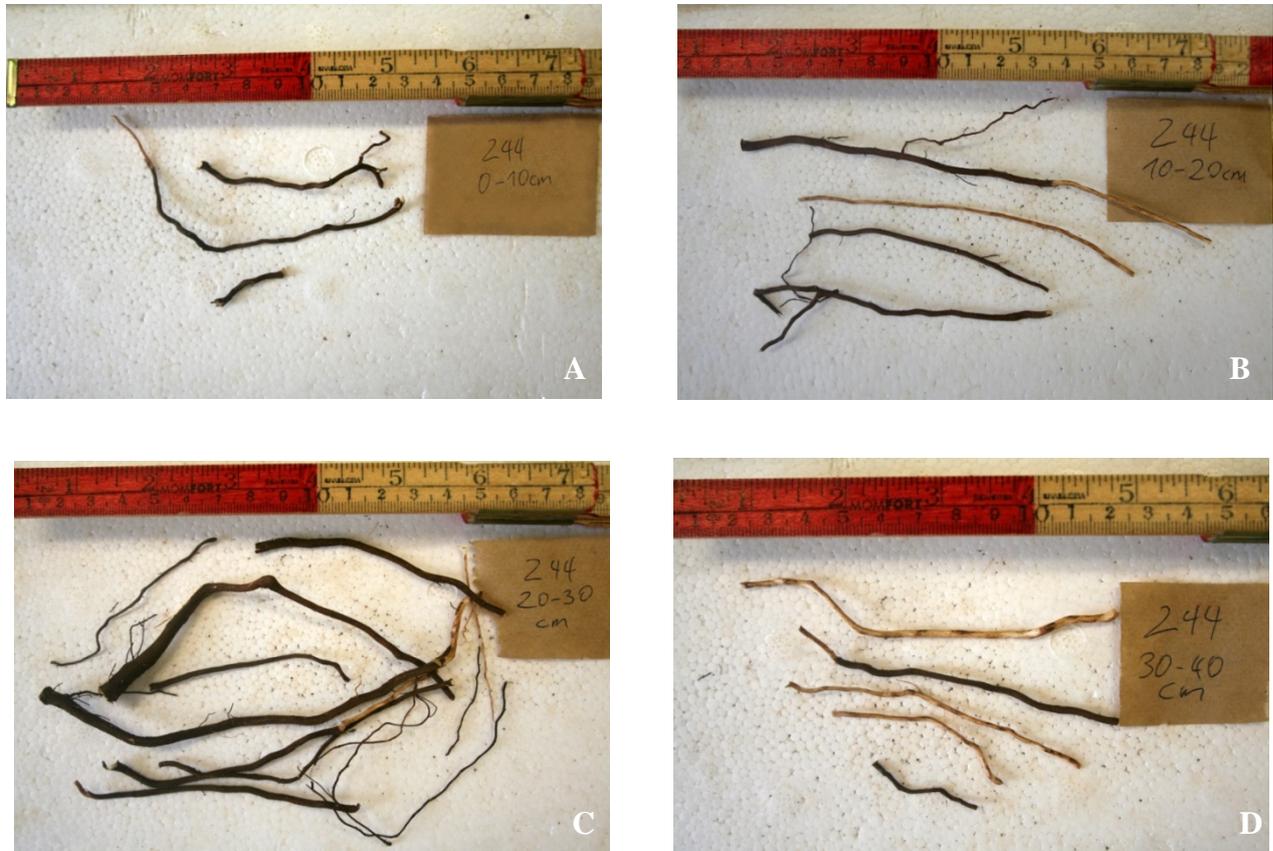
The following pictures were taken after the roots had been cut off the stems. They show the distribution of the roots in depth. Moreover, the different root patterns of the investigated species are visualized.

Figure 26: Pictures, showing the distribution of the roots in depth and the root pattern of a *Sebastiania schottiana* plant individual. Divided in following sections; (A) 0-10 cm (B) 10-20 cm, (C) 20-30 cm, (D) 30-40 cm in depth. This plant individual showed no roots deeper than 40 cm. Campus, UFSM – CESNORS, Frederico Wesphalen, 10.12.2013.

The proportion of fine roots was significantly higher in *Phyllanthus sellowianus*. This is also visible on the pictures of the excavated roots (Figure 26, 27). The roots beyond a diameter of about 1.5 mm were measured and serve as a representative for the proportion of fine roots.

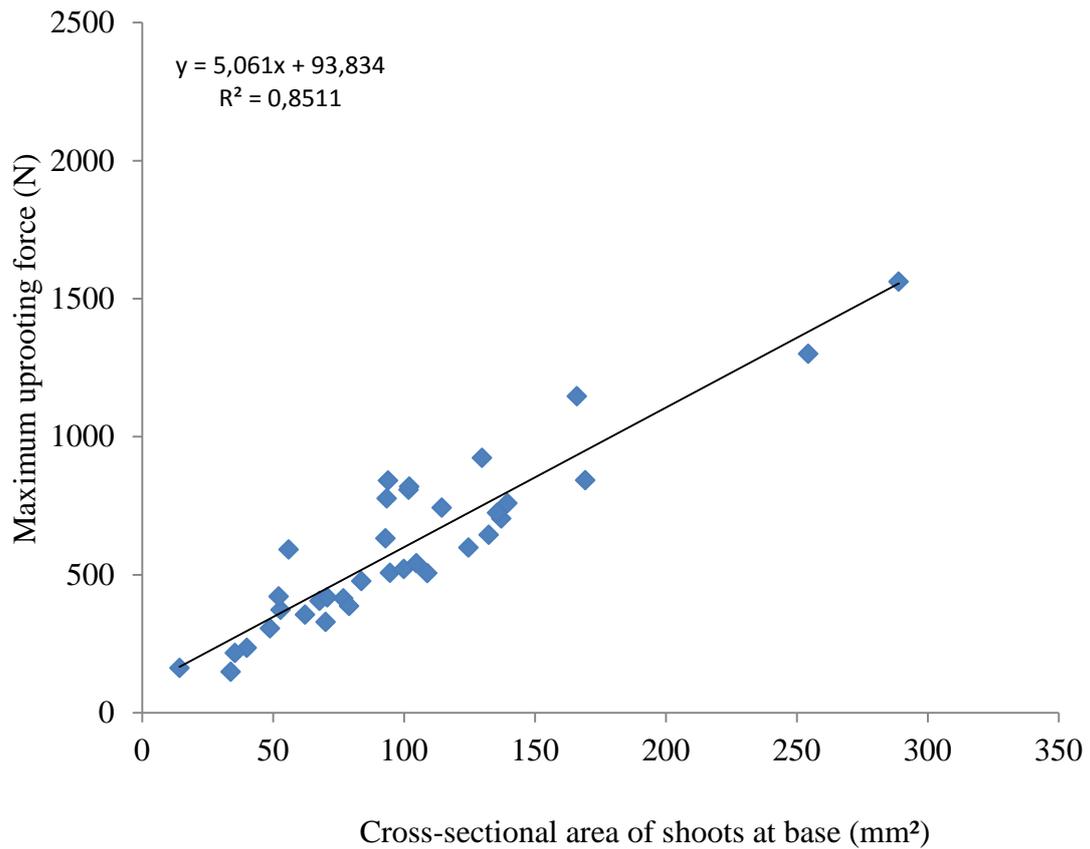
Figure 28: The relation between the maximum uprooting force and the cross sectional area of the shoots at base of *Sebastiania schottiana*. Campus, UFSM – CESNORS, Frederico Wesphalen, 15.10.2012.

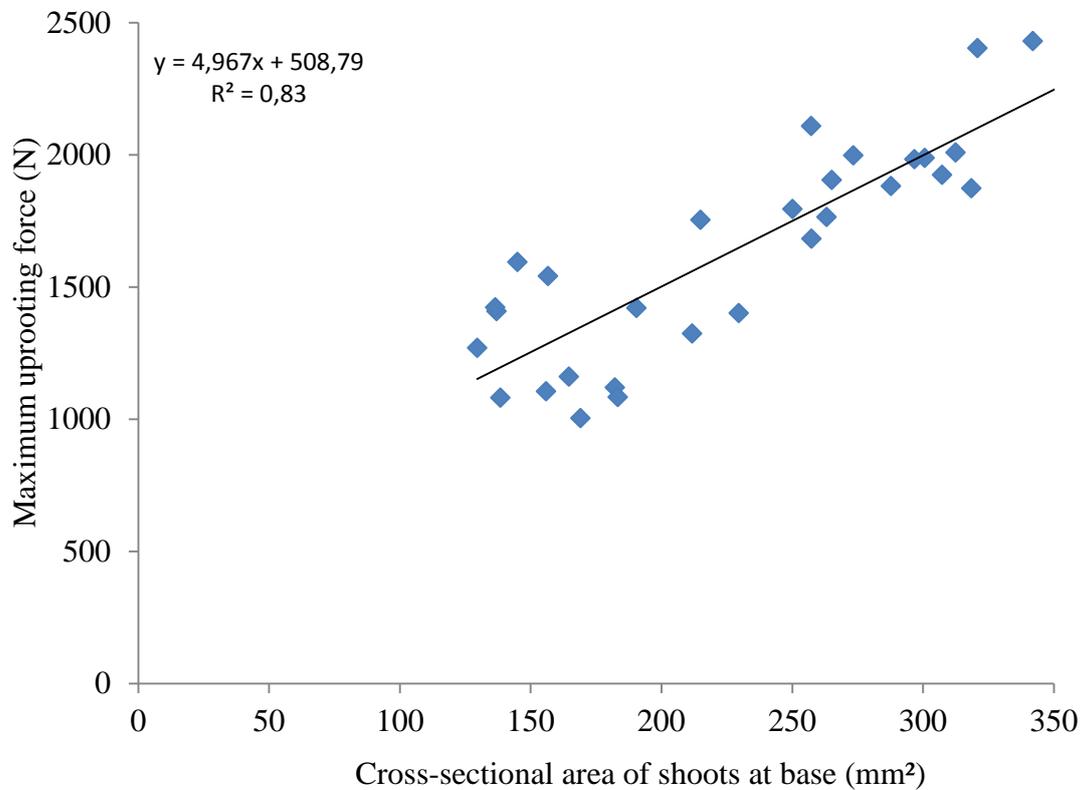
Figure 29: The relation between the maximum uprooting force and the cross sectional area of the shoots at base of *Phyllanthus sellowianus*. Campus, UFSM – CESNORS, Frederico Wesphalen, 15.10.2012.

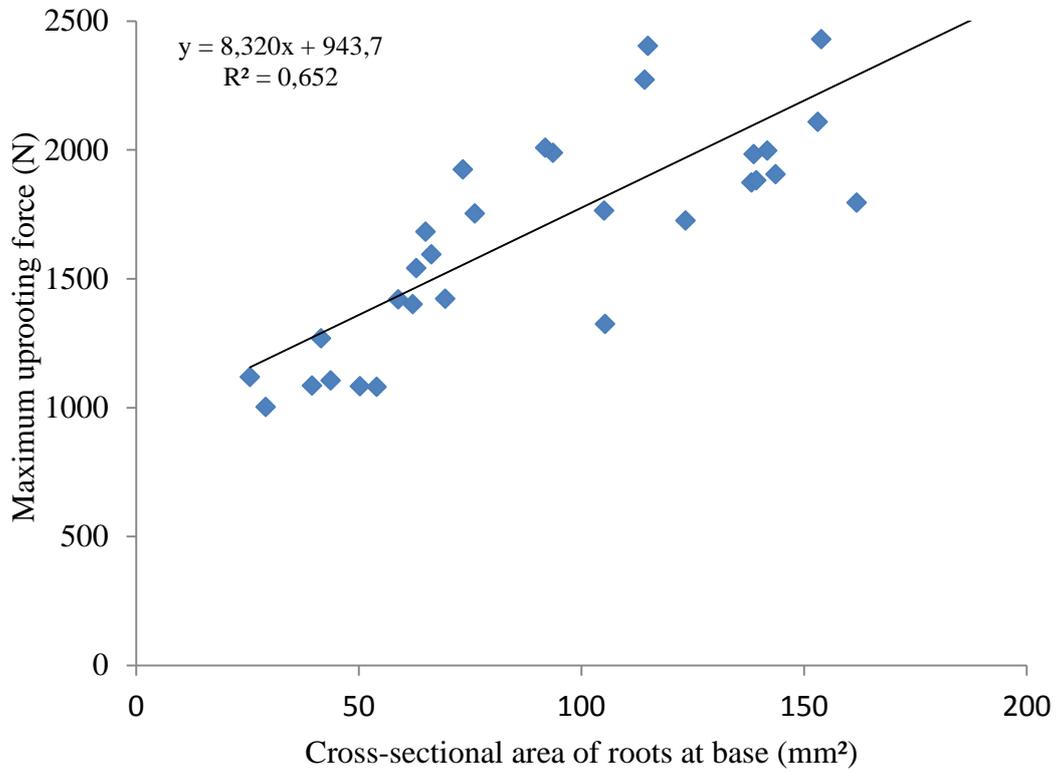
Figure 30: The relation between the maximum uprooting force and the cross sectional area of the roots at base of *Sebastiania schottiana*. Campus, UFSM – CESNORS, Frederico Wesphalen, 15.10.2012.

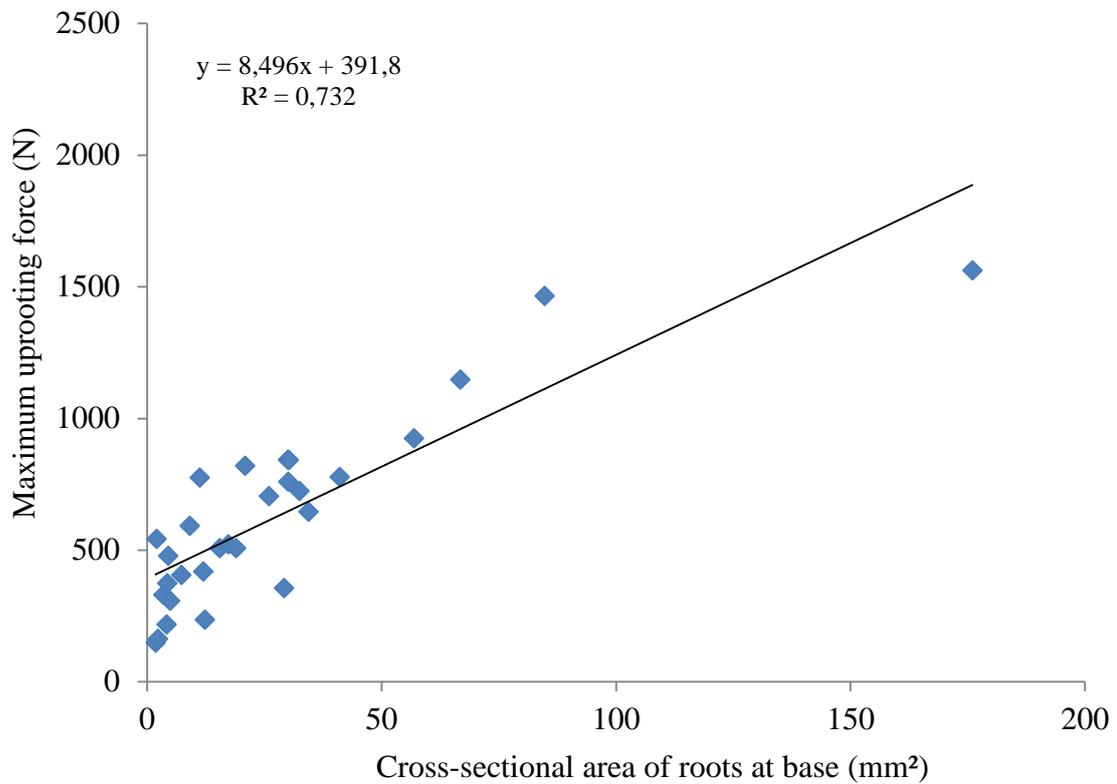
Figure 31: The relation between the maximum uprooting force and the cross sectional area of the roots at base of *Phyllanthus sellowianus*. Campus, UFSM – CESNORS, Frederico Wesphalen, 15.10.2012.

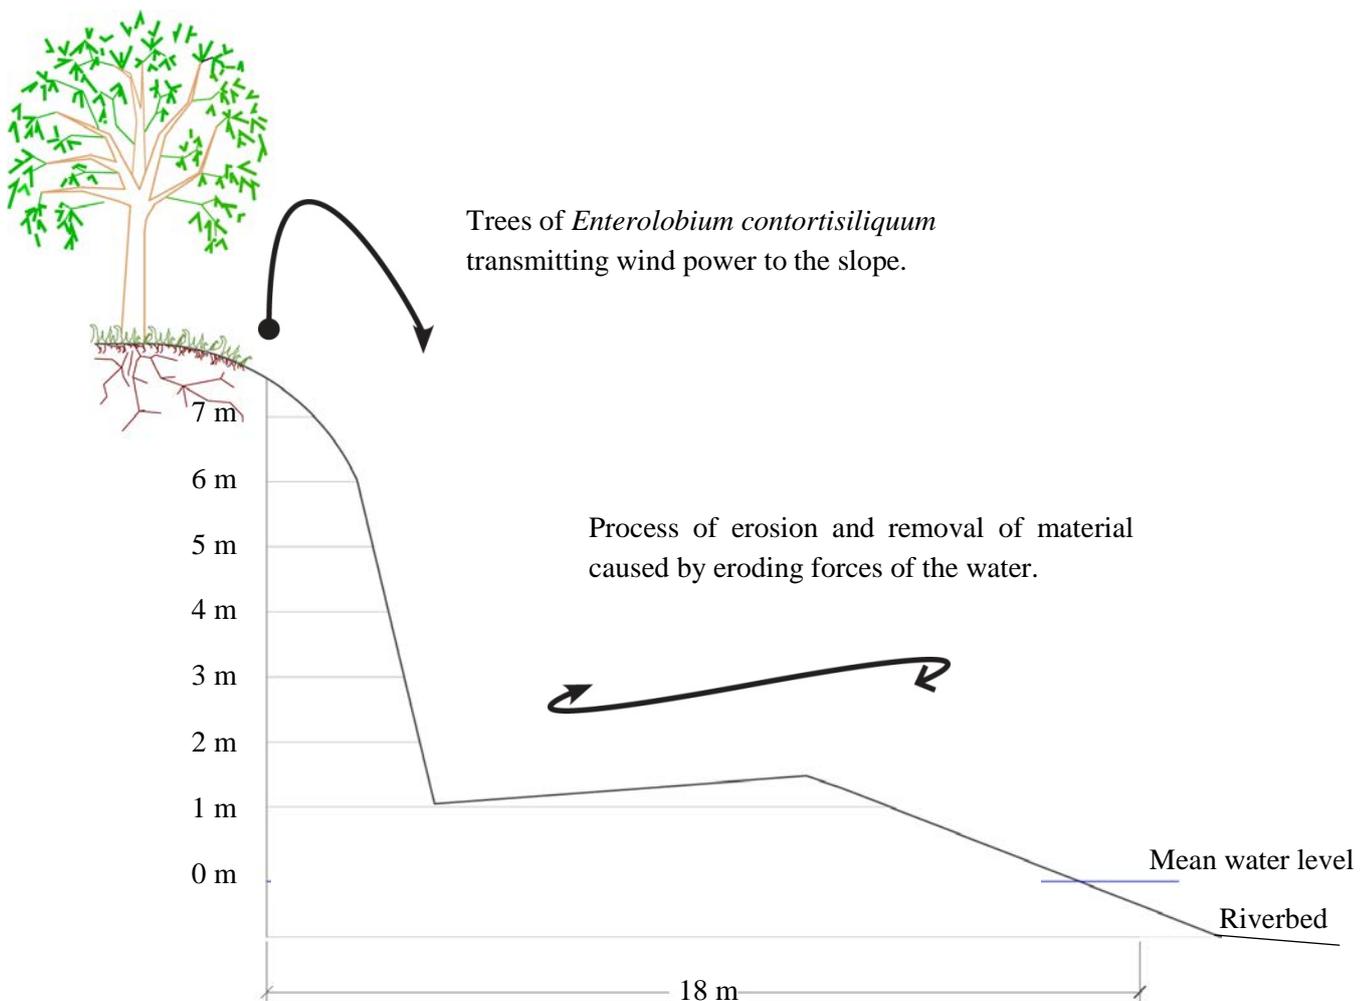
Figure 34: Sectional view, illustrating the eroding process. Rio Pardinho, 08.2010.

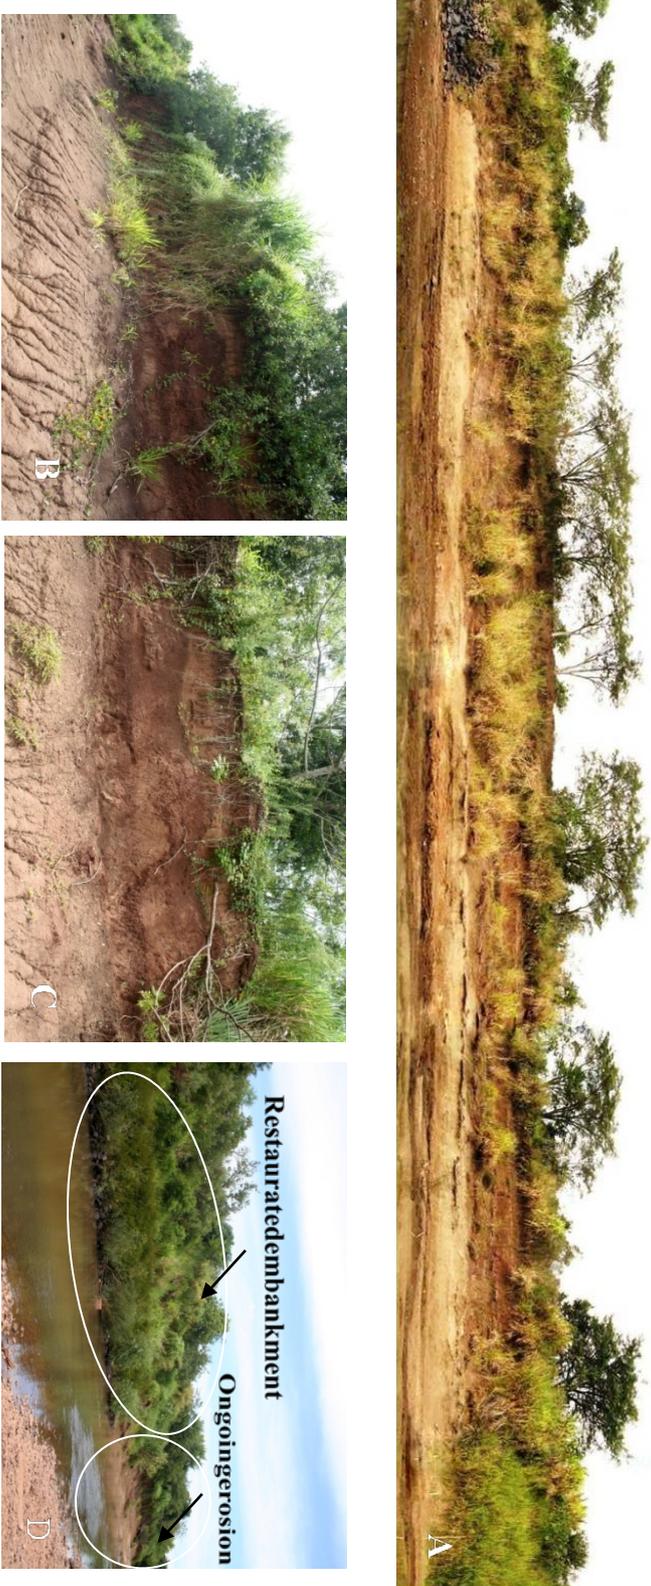
Figure 35: (A) Embankment before implementation of reinforcement works (SUTILI, 2010). (B, C) Erosive process, downstream of the intervention, observed in the year 2013. (D) Intervention and the eroding embankment downstream, in the year 2013, at the rio Pardino. Santa Cruz do Sul (A) 08.2010 (B,C,D) 01.2013.

The following pictures show the initial situation in the embankment and a similar condition, found in the year 2013 downstream of the intervention. The downstream erosive section is not part of the present study but can be shown as a reference section.

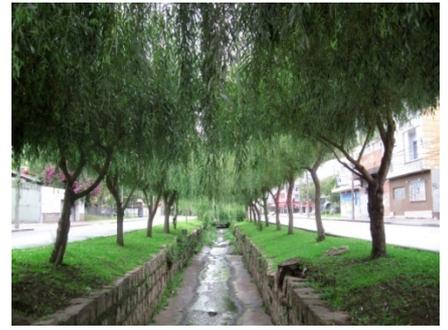
Figure 45: *Salix humboldtiana*, planted along a river channel.

humid, sandy soils. Propagation by cutting is easy (SALAZAR-FIGUEROA, 1999). The peculiarity of the species is its ability to survive in flooded areas throughout several months if the water is running. It is applicable in erosion control and can be used for reforestation on river banks, dams or reservoirs (MOURA, 2002).
