**A PULL OUT TEST OF PHYLLANTHUS SELLOWIANUS AND SEBASTIANA
SCHOTTIANA AND DEVELOPMENT OF SOIL BIOENGINEERING
CONSTRUCTIONS IN SOUTHERN BRAZIL**

Master thesis by
Stephan Hörbinger

Wien, 08.2013

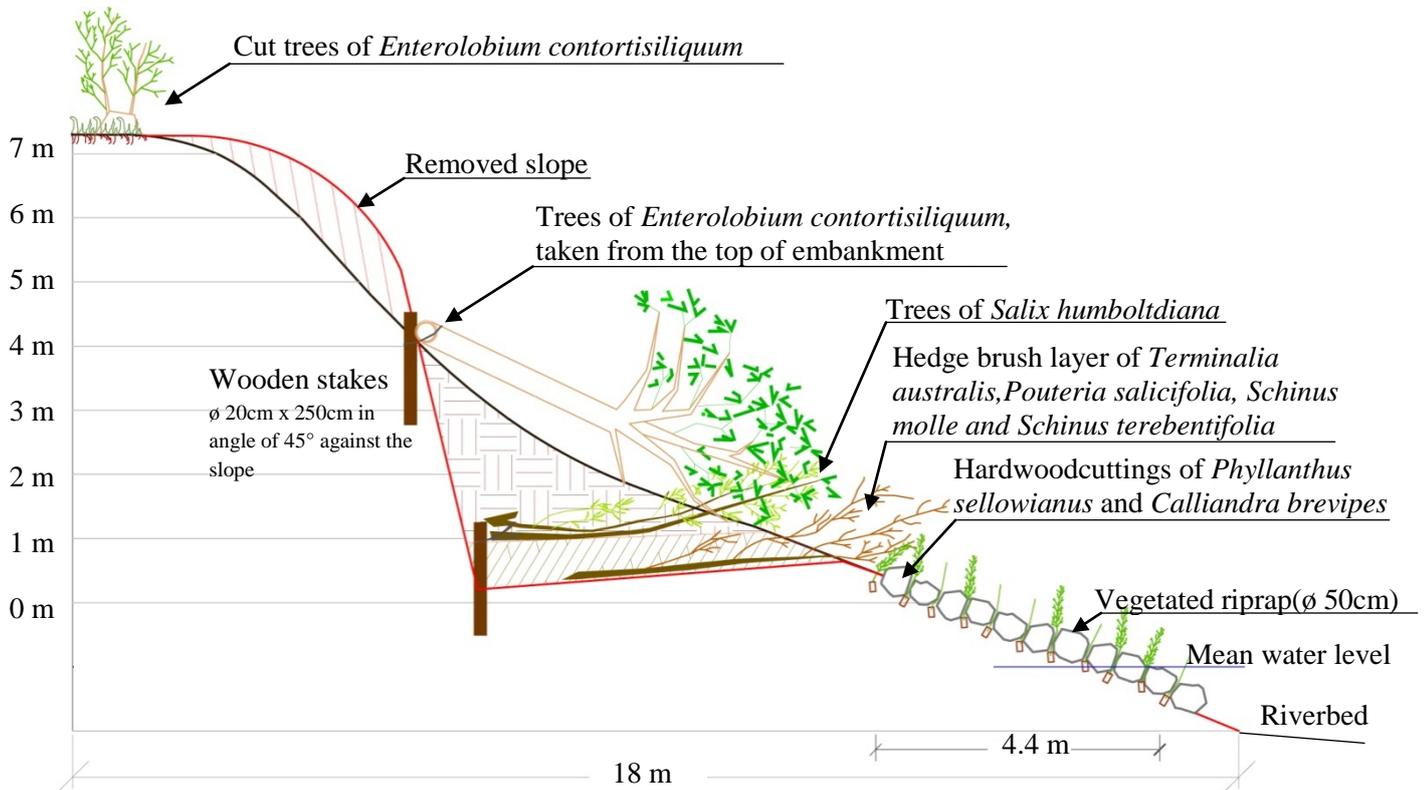
Figure 46: Sectional view, illustrating the first interventions. Rio Pardinho 05.2010. Traced by an original of (SUTILI, 2010).

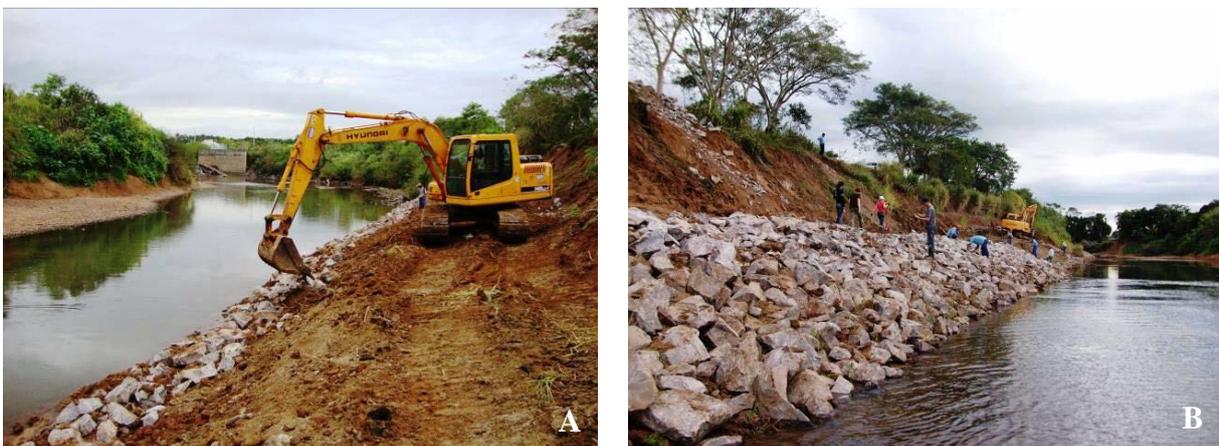
Figure 47: (A, B) Installation of riprap. Rio Pardinho, 04.2010. Picture, SUTILI.

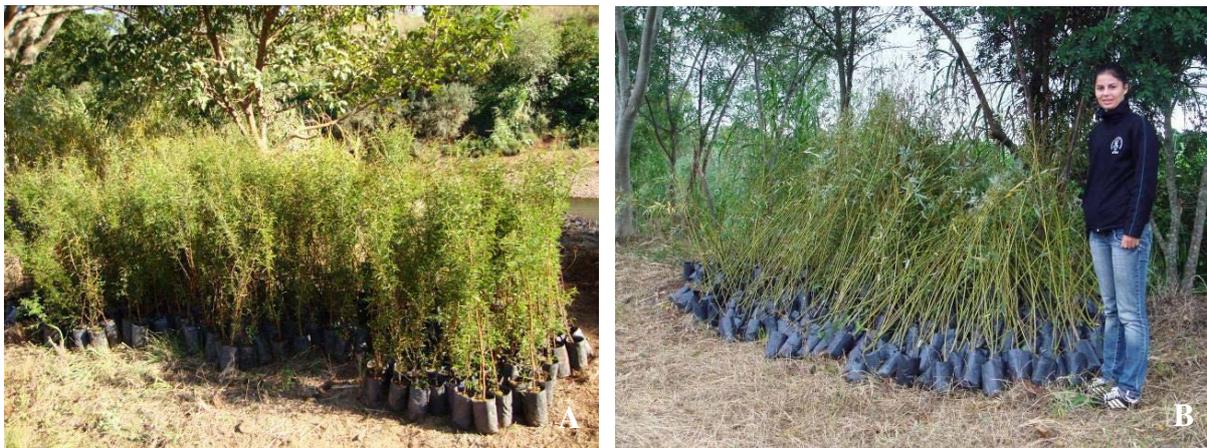
Figure 48: (A) Seedlings of *Calliandra brevipes*. (B) Seedlings of *Salix humboldtiana*. Rio Pardo, 04.2010. Picture, SUTILI.

Above the mean water level, the riprap was planted with seedlings and hardwood cuttings of *Calliandra brevipes* and *Salix humboldtiana*. About 900 seedlings of *Calliandra brevipes*, with a stem diameter at base of 3 – 4 cm and around 1 m in height were used. The seedlings were planted through seeds and were reared in plastic bags of 15 x 18 cm for about one year before being fielded. Approximately 500 seedlings of *Salix humboldtiana* were taken by hardwood cuttings and were reared in the same bags as *Calliandra brevipes*. Subsequently they were sliced in half in order to obtain bigger amount of life stakes. Those plants had a diameter of between 2 and 4 cm and a height of 1 to 2 m.

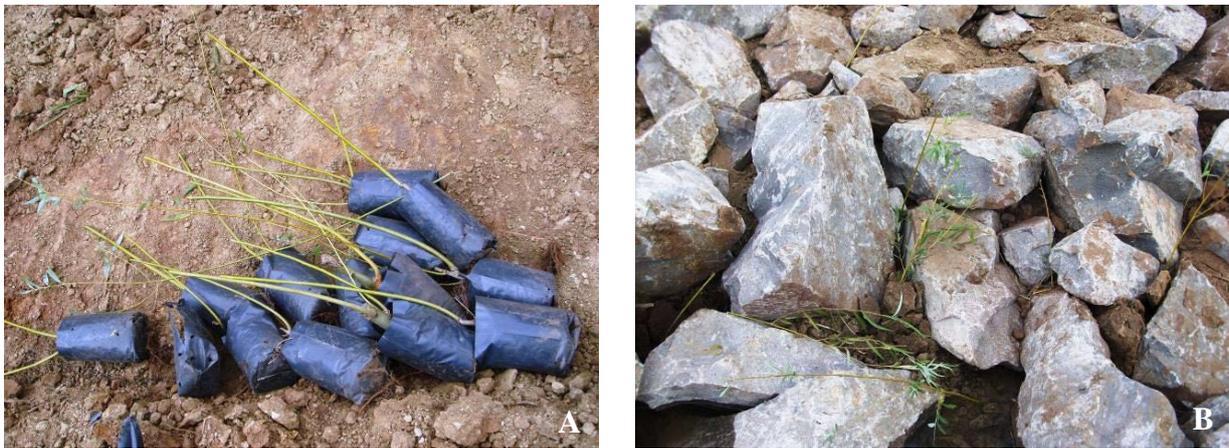
Figure 49: (A) Bisected seedlings of *Salix humboldtiana*. (B) And the same being planted with the bigger side up. Rio Pardo, 04.2010. Picture, SUTILI.

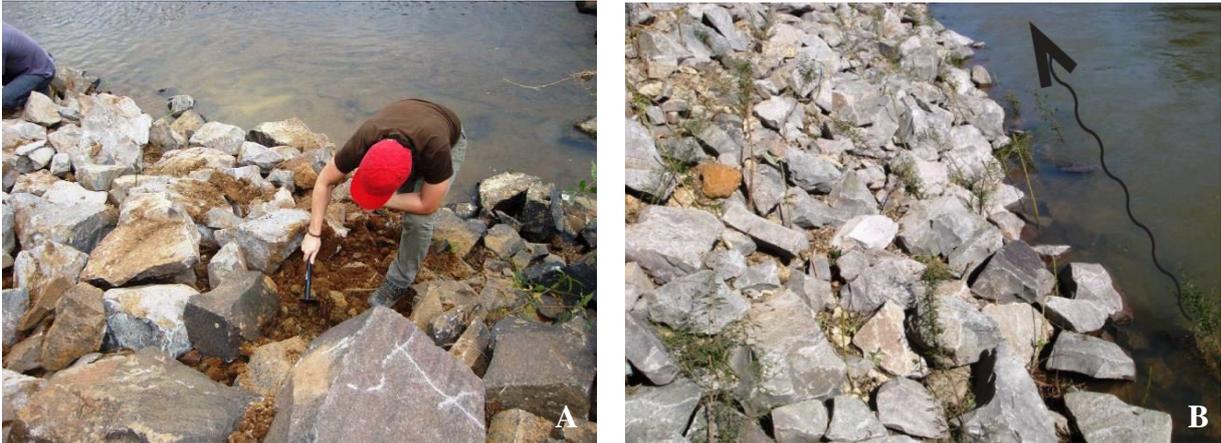
Figure 50: (A) Fielding the seedlings using a hand shovel. (B) Seedlings planted along the water line. Rio Pardinho, 04.2010. Picture, SUTILI.

As soon as the riprap was installed, the planting was done by using hand shovels and digging sticks. To facilitate planting, blocks were removed and replaced in order to fix and protect the seedlings. The hardwood cuttings were planted in a manner to facilitate their alignment with the streaming line. In each square meter of the riprap three to four seedlings were fielded. Whenever necessary, the plants were irrigated by using buckets or a water bowser.

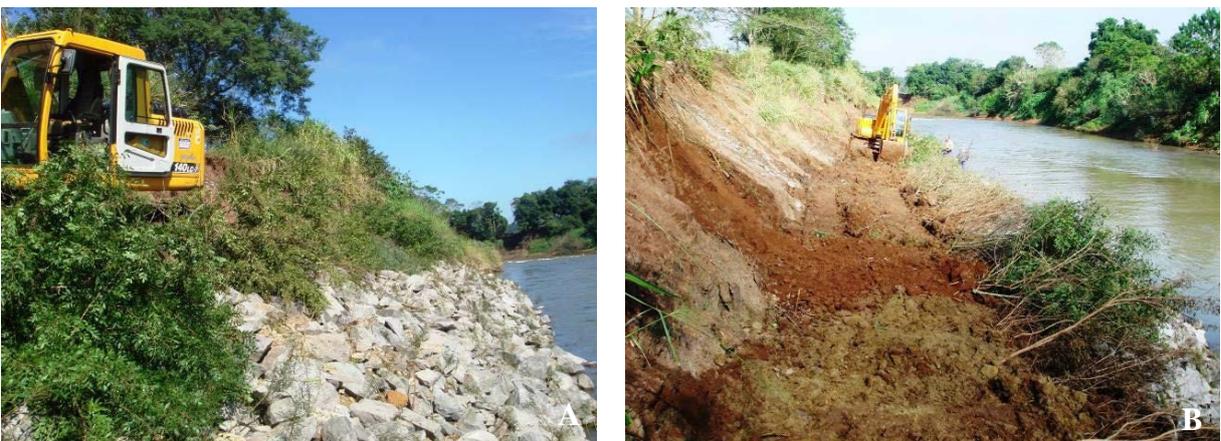
Figure 51: Installation of the hedge brush layer above the vegetated riprap. (B) After the shrubs are mounted, they are covered with a soil layer. Rio Pardinho, 04.2010. Picture, SUTILI.

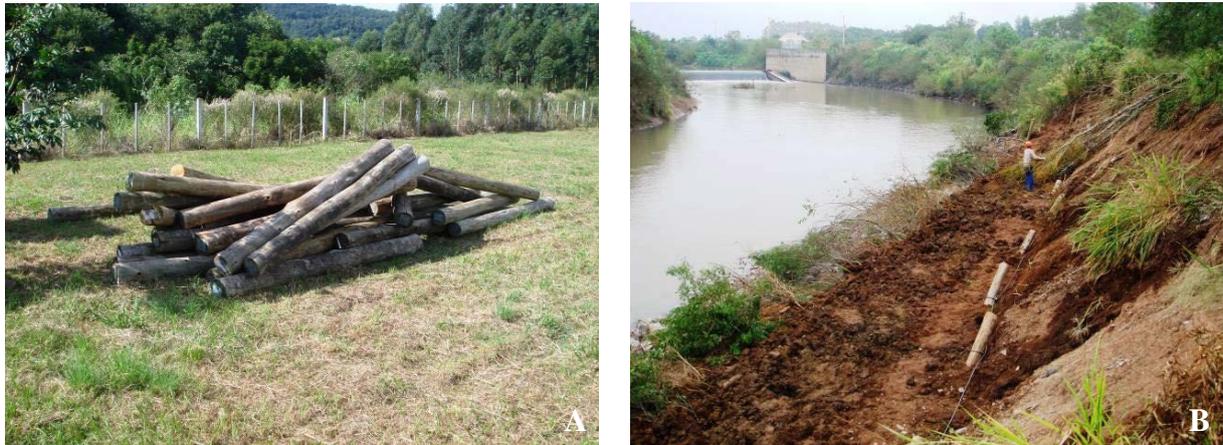
Figure 52: (A) Interconnecting willows with steel wire. (B) Mounting of a soil layer due to expectation of propagation. Rio Pardino, 05.2010. Picture, SUTILI.

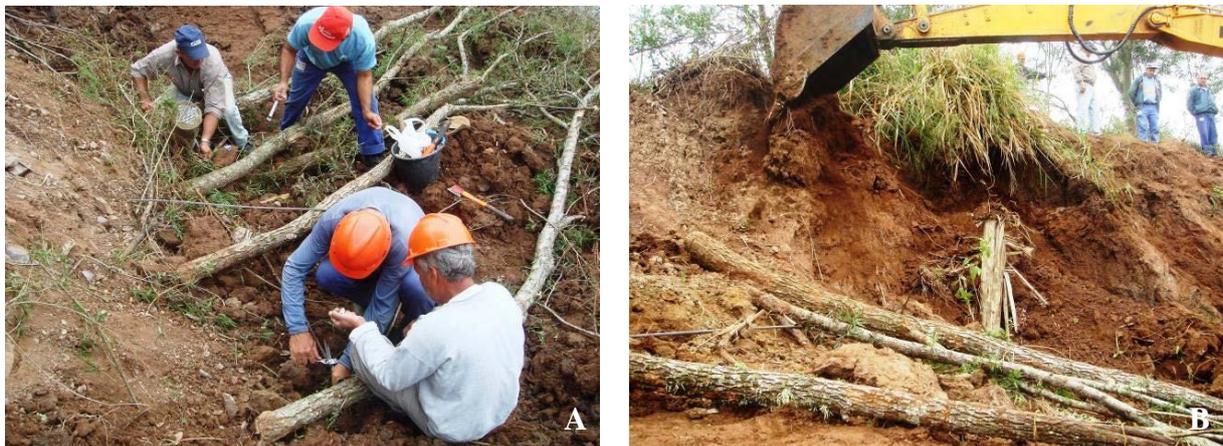
Figure 53: (A) Wooden poles (Eucalyptus). (B) The same stakes being buried 1.5 m deep and at an angle of 45° towards the slope. Rio Pardino, 05.2010. Picture, SUTILI.

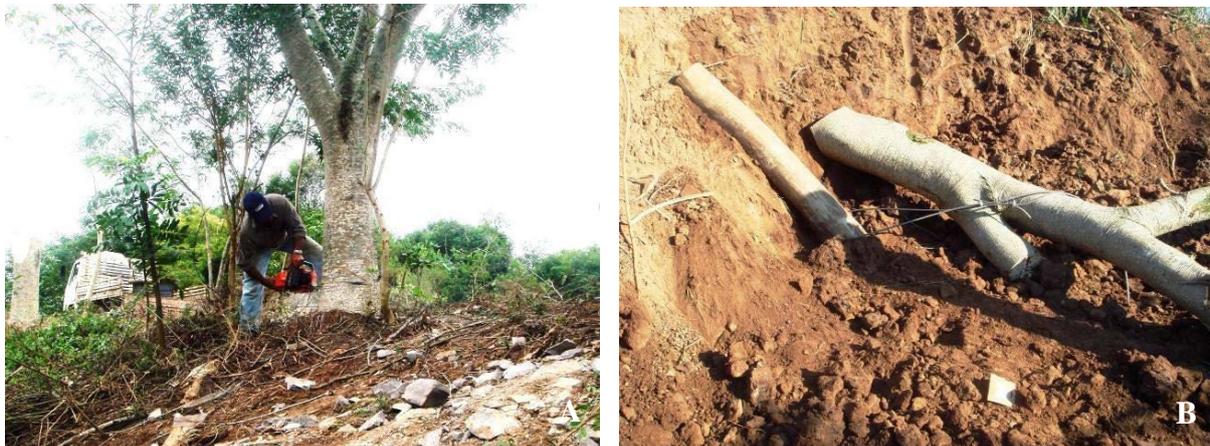
Figure 54: (A) Cutting trees of *Enterolobium contortisiliquum*. (B) Anchoring them to the slope. Rio Pardo, 05.2010. Picture, SUTILI.

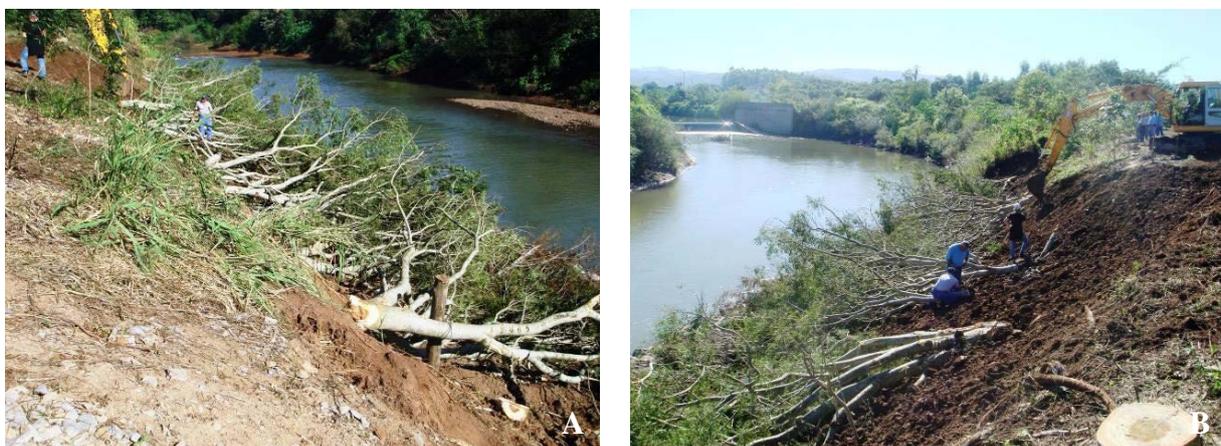
Figure 55: Anchored trees of *Enterolobium contortisiliquum*. (B) Shaping the slope angle. Rio Pardo, 05.2010. Picture, SUTILI.

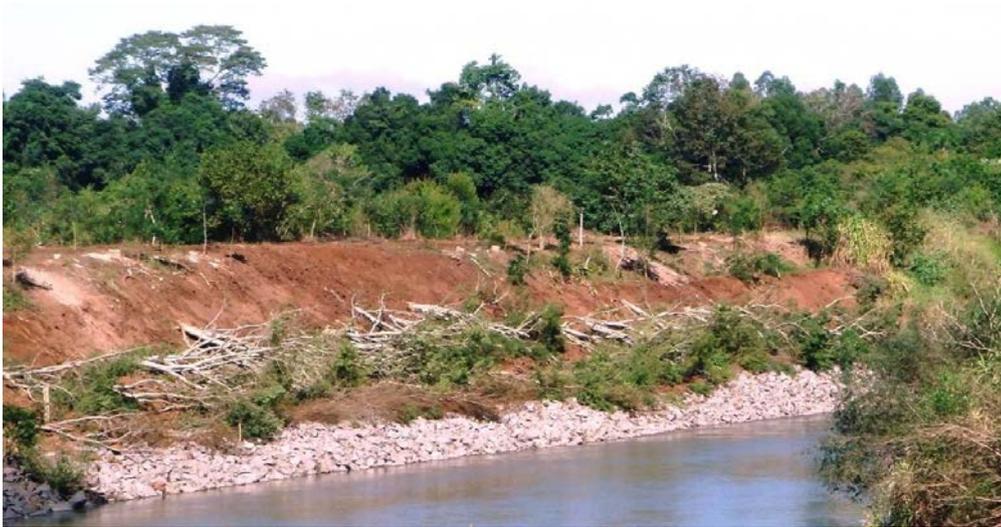
Figure 56: The embankment shortly after the implementation of the structures. Rio Pardinho, 05.2010. Picture, SUTILI.

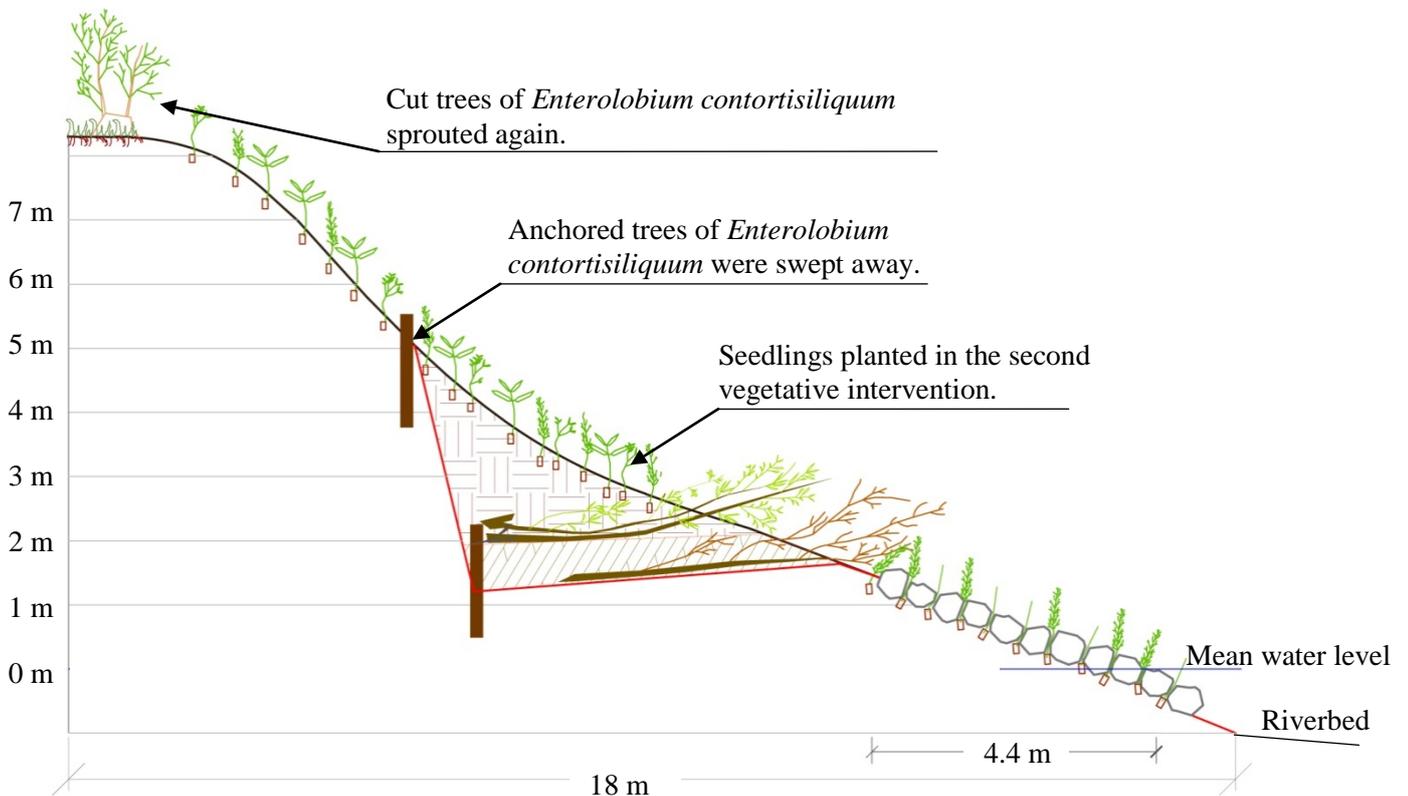
Figure 58: Sectional view of the embankment after the second vegetative intervention. Rio Pardo, 09.2010. Traced by (SUTILI, 2010).

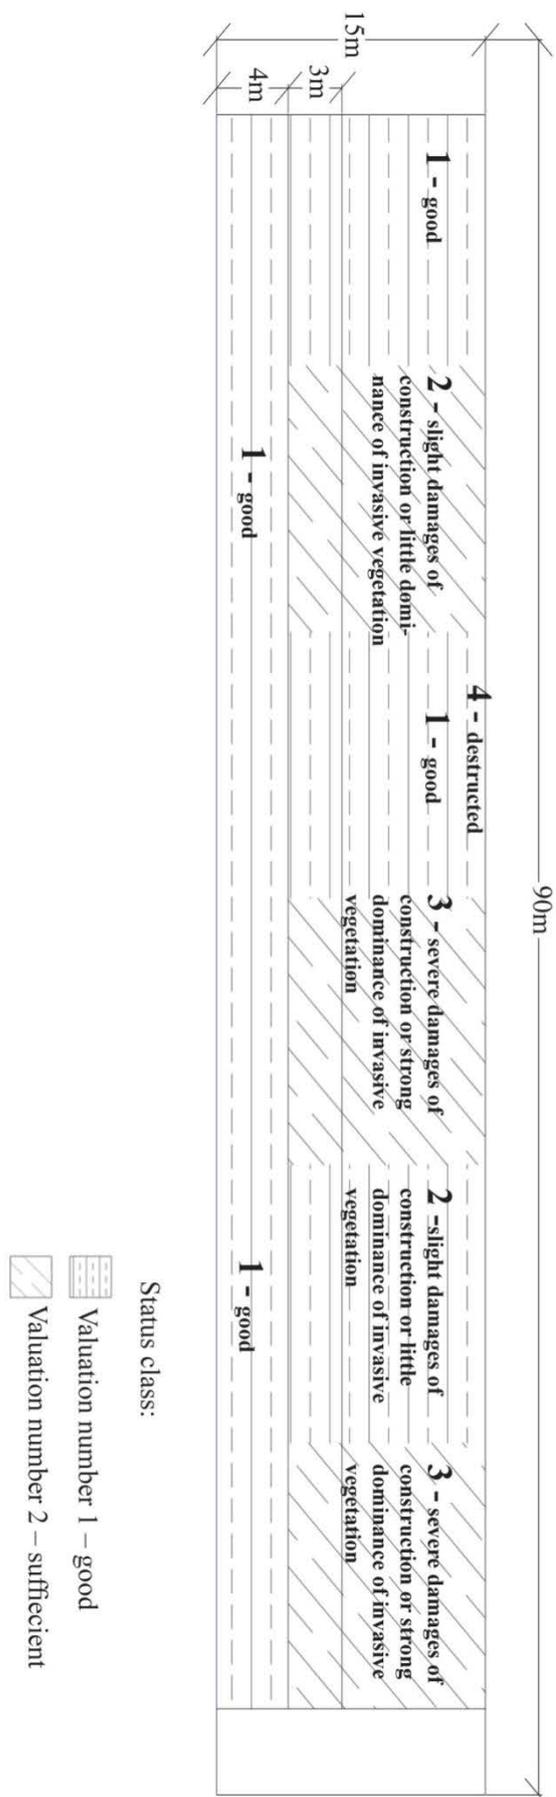
Figure 61: Illustration of the evaluation of structures. All the sections were classified by the valuation number 1 (good) or 2 (sufficient). The classification class for the status of the constructions varied from 1 (good) to 4 (destroyed). The intervention using anchored trees of *Enterolobium contortisiliquum* was classified with 4 (destroyed) because they were swept away shortly after their installation. Rio Pardiniho, 01.2013.

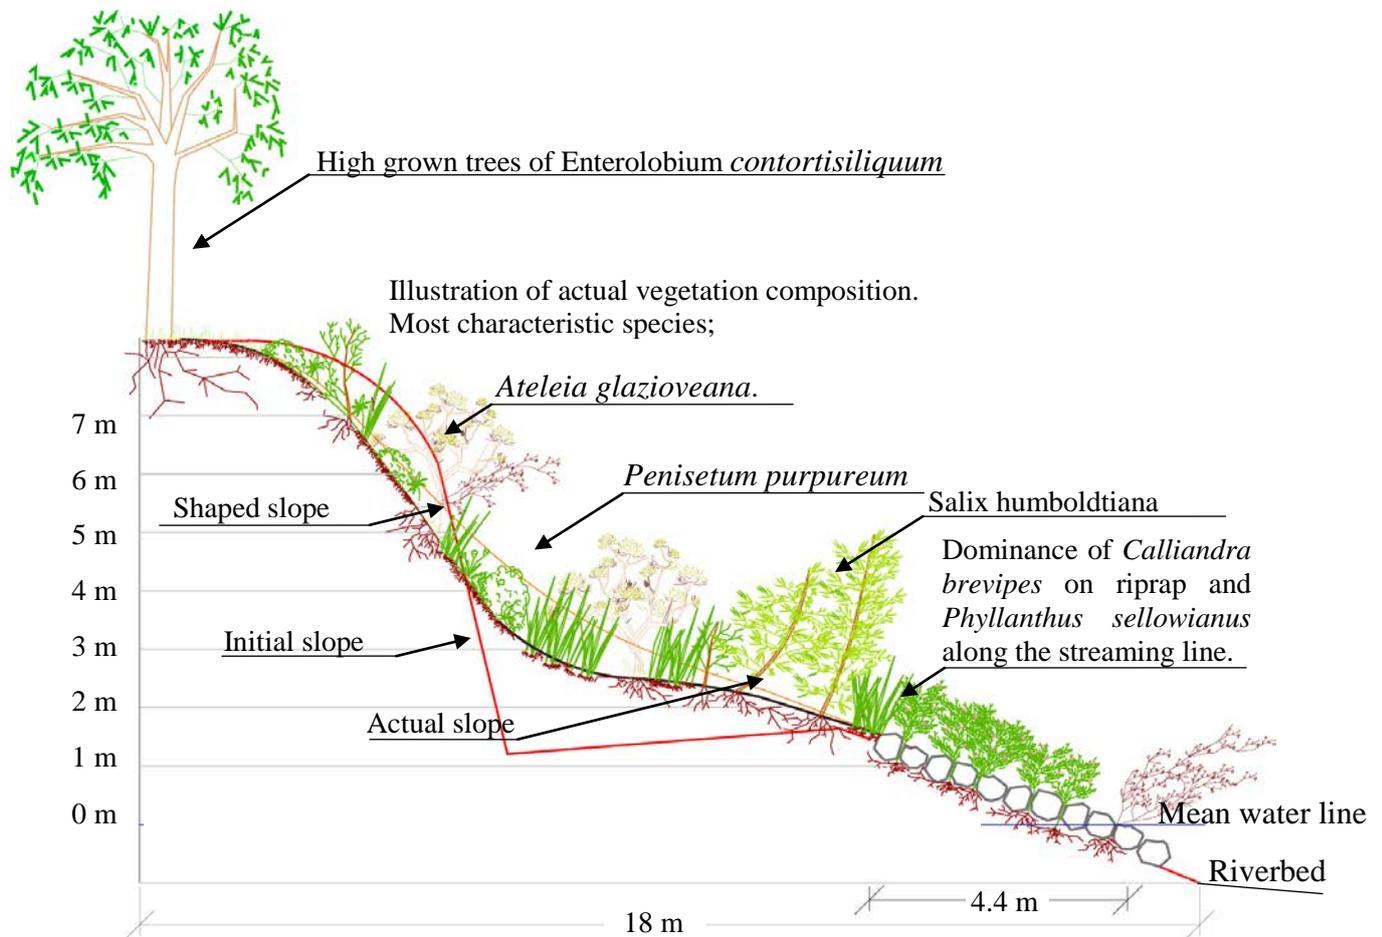
Figure 63: Sectional view of the embankment at the time of the second vegetation survey, in 2013. Rio Pardo, 01.2013.

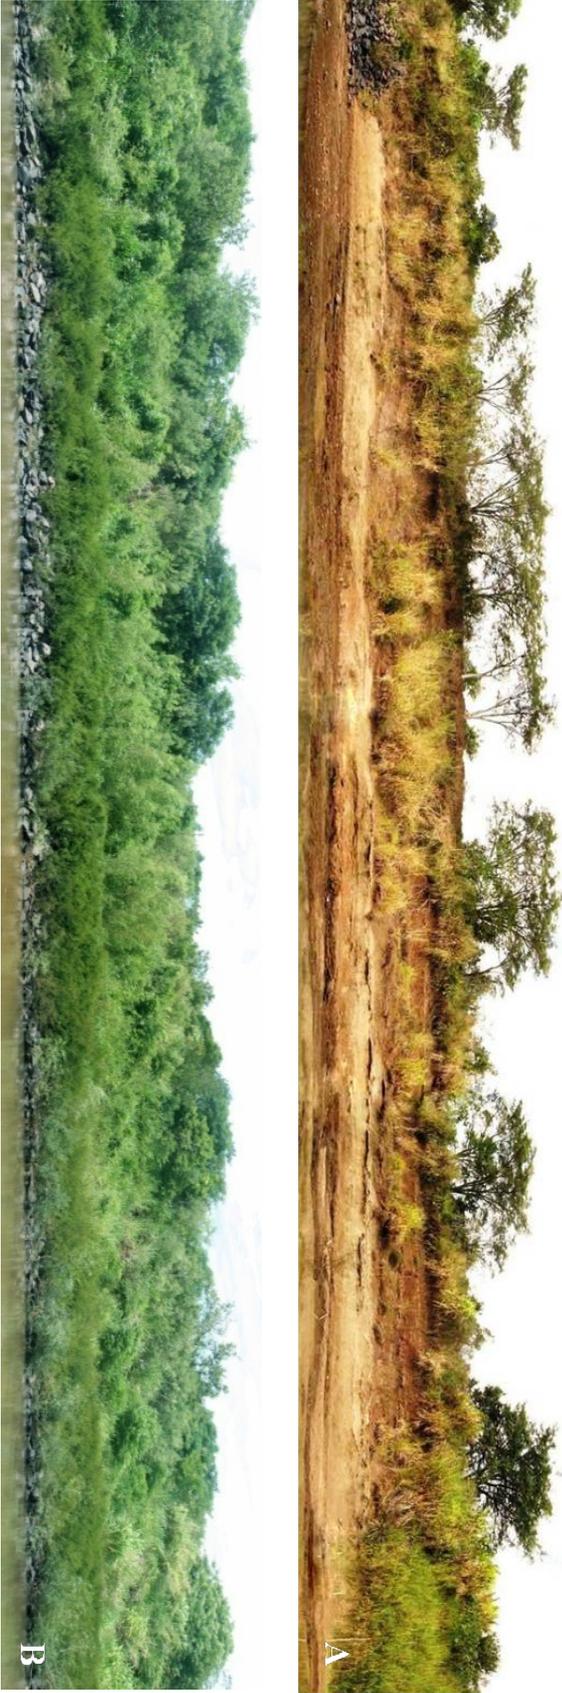
Figure 64: (A) Embankment before implementation of reinforcement works (SUTILI, 2010), and (B) two years after its completion – 2013. Rio Pardinho, (A) 03.2010, (B) 01.2013.
