Masterarbeit

Investigation of glass panel failure
of a high rise building through
monitoring based system identification

Felix Wenzel

Wien, Mai 2015

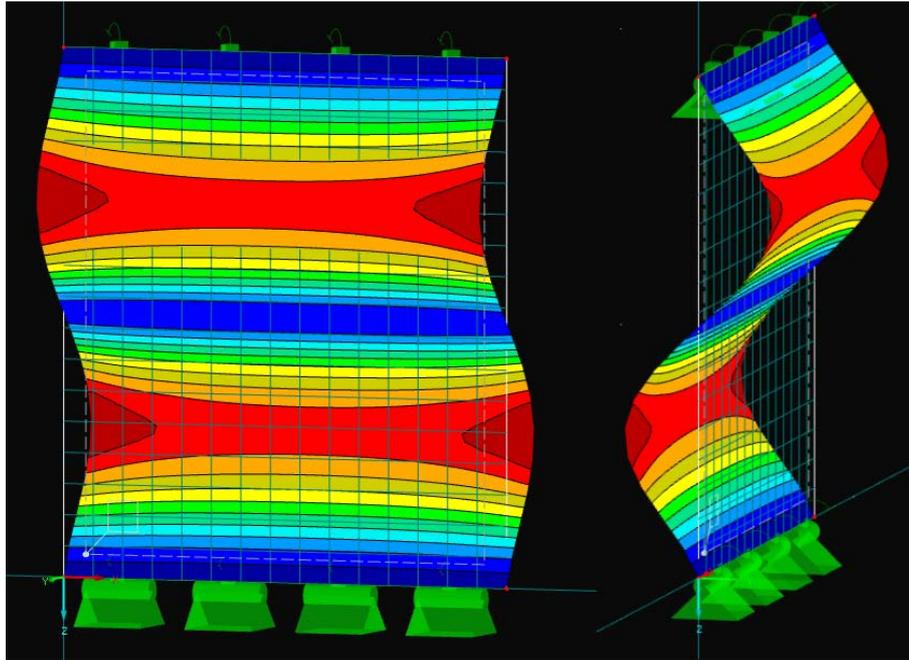
The first model has no fixing of the side edges. This kind of fixing occurs when two glass elements are connected via thick elastic glue.

Figure 25: 4th mode shape (numerical simulation) – 2nd bending around the local transversal axis

It is easy to see that this simulation does not correlate to the measurement (seen in 4.2.3) therefore has to be discarded. The second bending mode shape occurs at the 4th eigenfrequency and additionally the frequency is much lower than the measured one ($28\text{Hz} < 38\text{Hz}$).

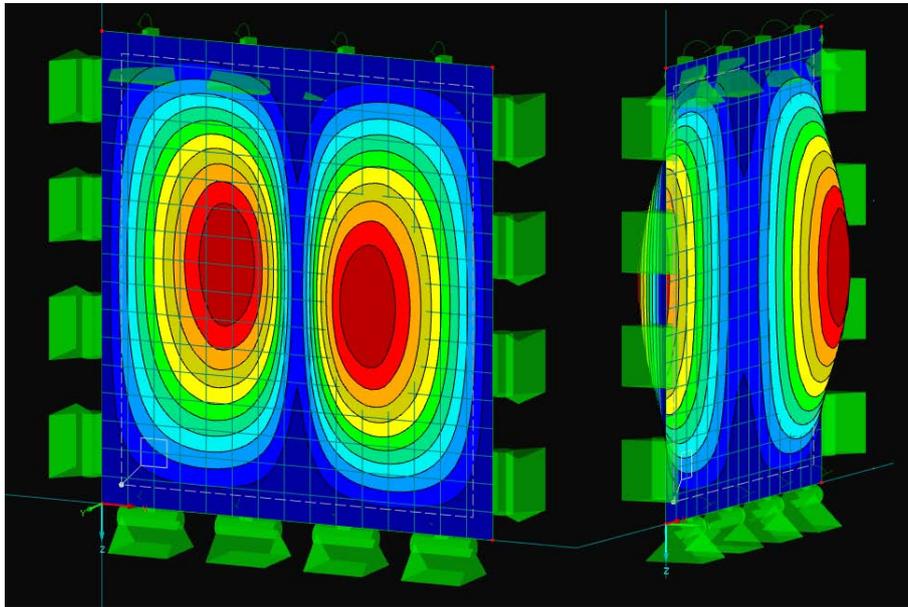
The second model shows the glass behaviour when the very stiff fixing (rotational sprigs) is only attached to the top and bottom edge of the glass element. Again representing a kind of fixing where the element is loosely fixed to its neighbour.

Figure 26: 2nd mode shape (numerical simulation) – 2nd bending around longitudinal axis

Later on it is easy to see that this, modelled second bending, does not correlate with the measurement (seen in 4.2.3) and therefore the model is discarded. The loosening of the side edges changed the eigenfrequency of the 2nd bending around transversal axis to the 3rd eigenfrequency.

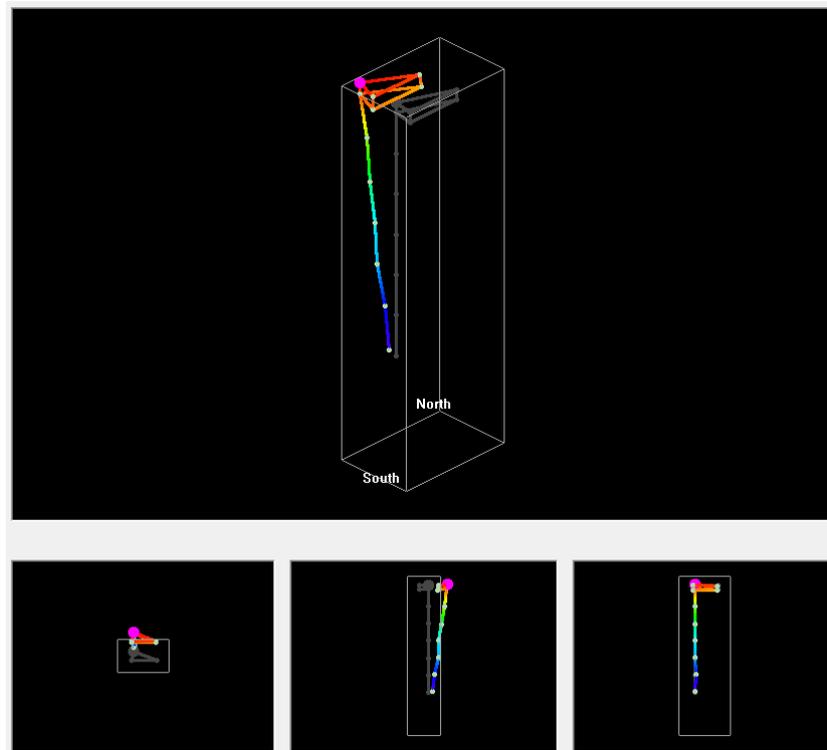
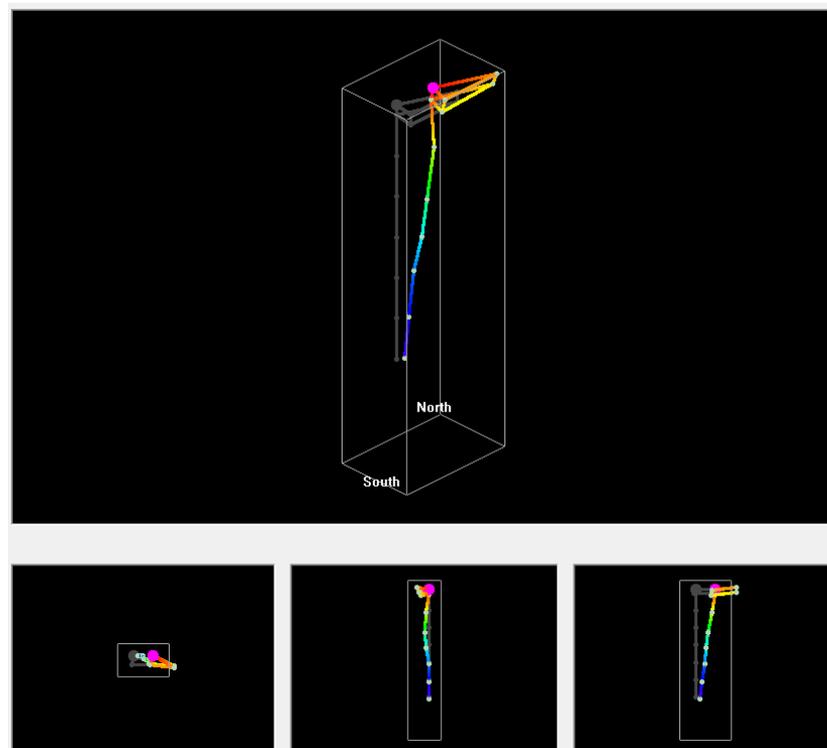
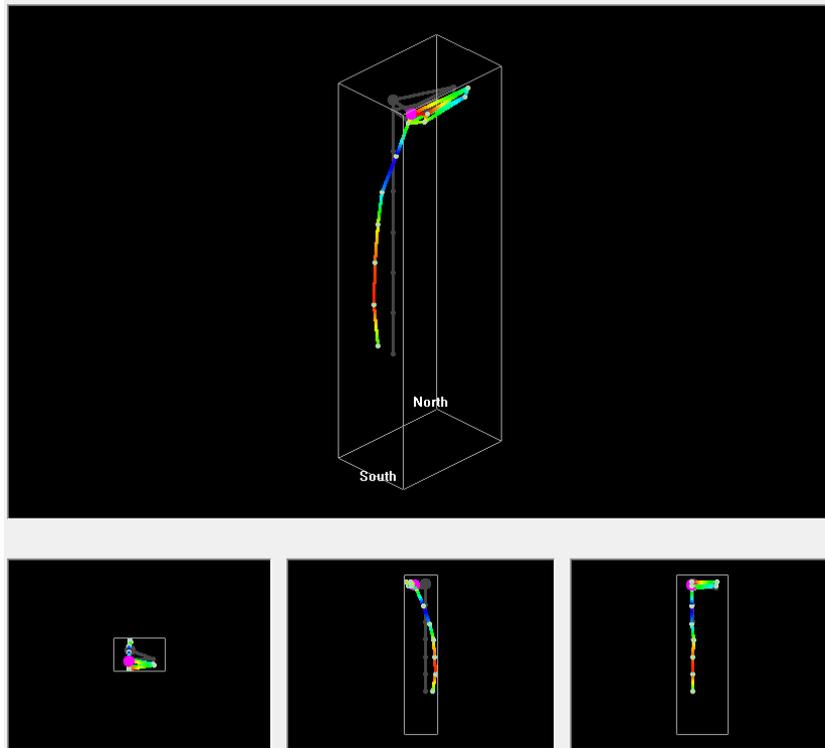
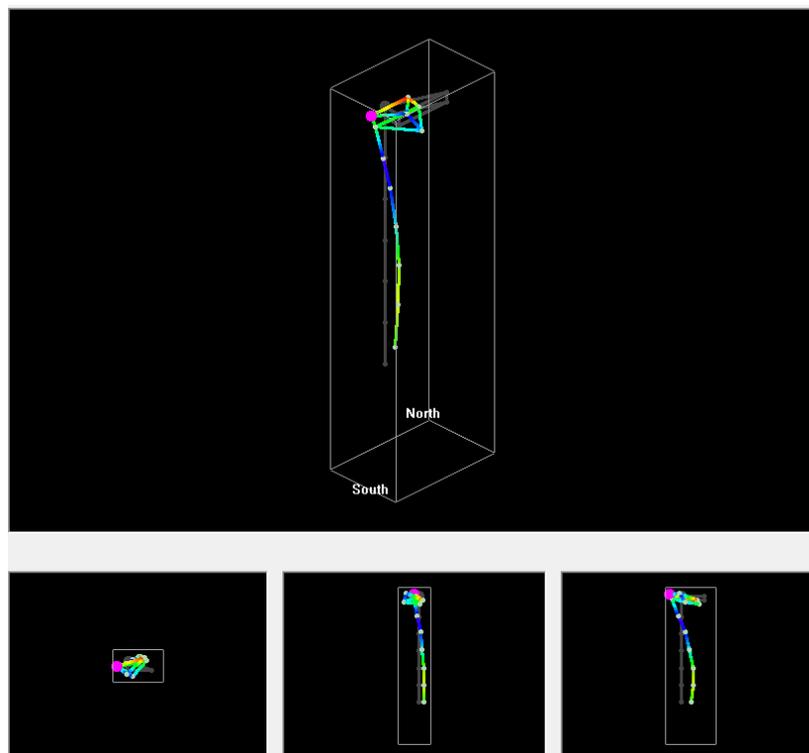
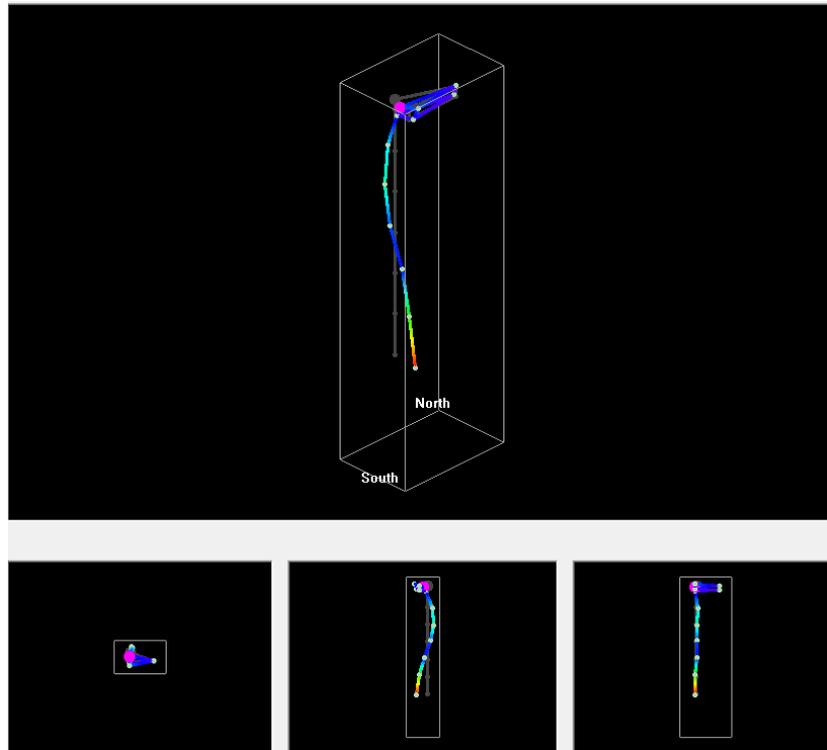
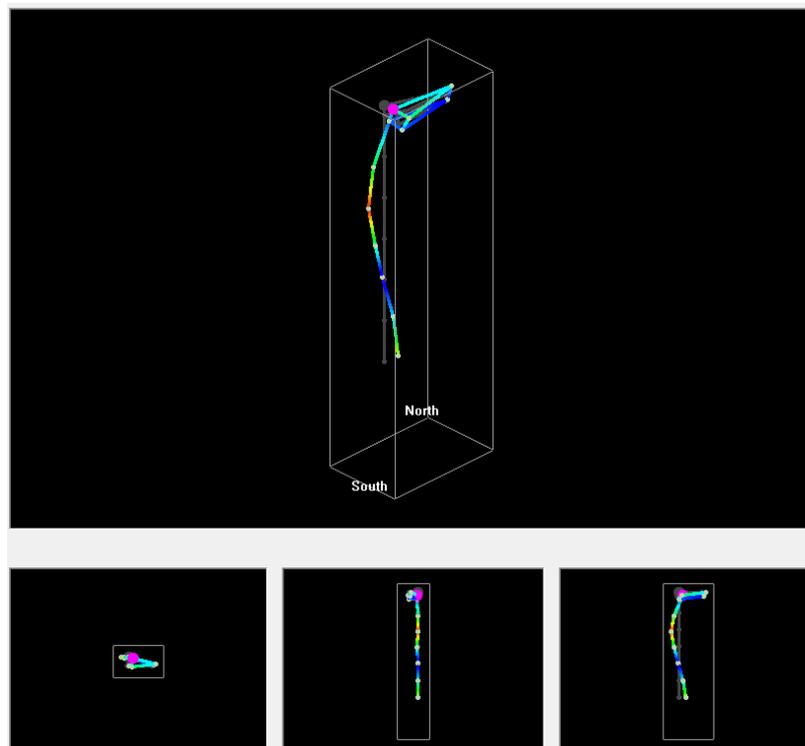
The determined mode shapes indicate **regular operability**.

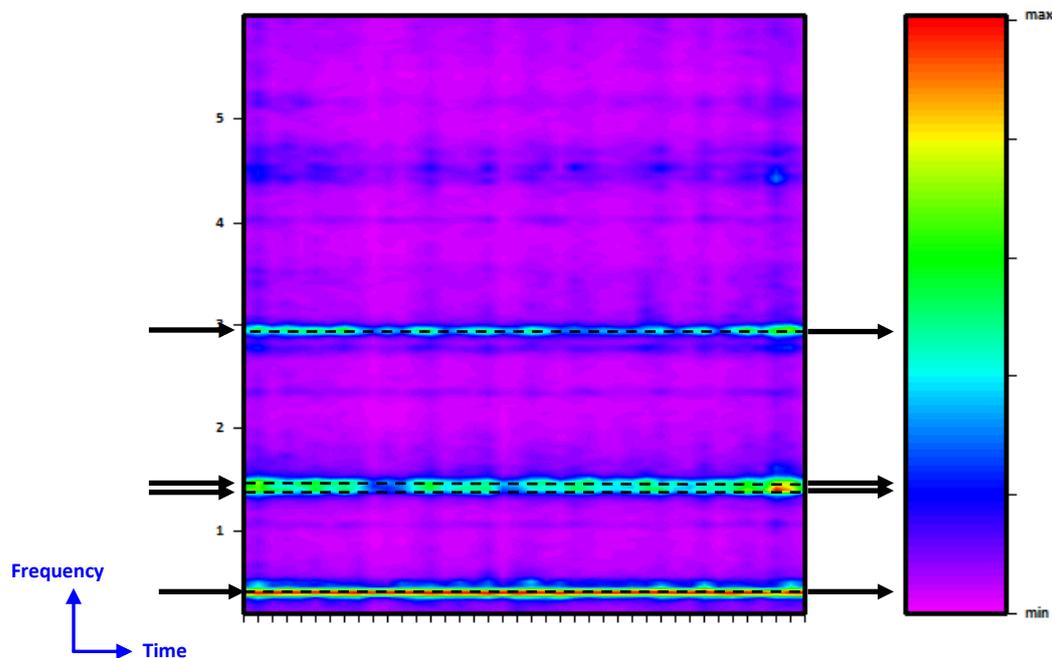
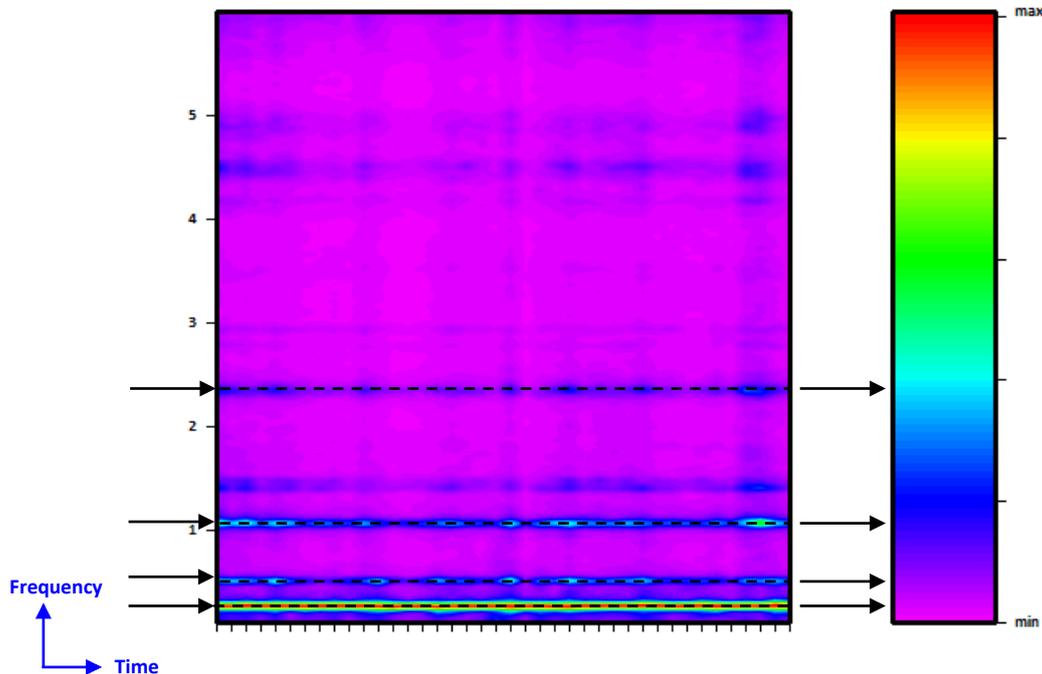
Figure 52: Trend of stiffness distributed over time (entire measurement period), 0,3-6 Hz, longitudinal

Figure 53: Trend of stiffness distributed over time (entire measurement period), 0,1-6 Hz, transversal

In trend cards for such a short time period there is no global trend visible. High rise buildings are usually climate controlled so the loadbearing structure has always the same temperature and therefore no day temperature impact.

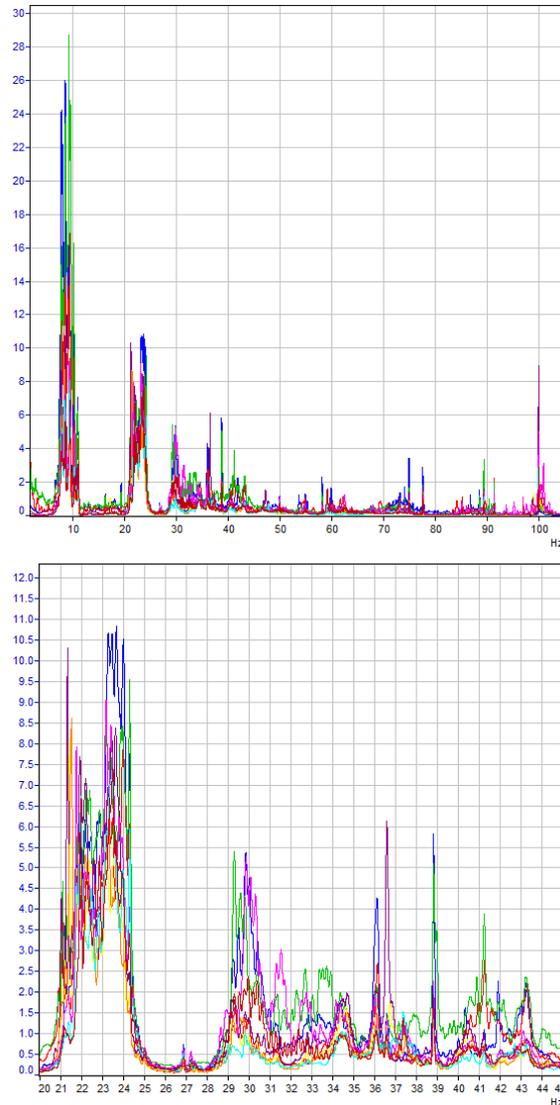
As before the signal must be transformed into a spectrum to give values for the eigenfrequencies. The measured spectra show a satisfactory characteristic in the measured dimension (out of plane). The relevant eigenfrequencies are in a range of 20 – 45 Hz of that spectrum.

Due to the given glass-steel composite frame several resonance frequencies with almost the same type of motion but differing frequency values are observed what is to be expected for this type of multi-component structural member (VCE ZT GmbH., 2014).

Figure 55: Spectral analysis (ANPSD) for all measurement files (in-depth measurement), out-of-plane; 2-100 Hz (left) and 20 – 45 Hz (right) – Panel 2 (37th floor) exemplarily

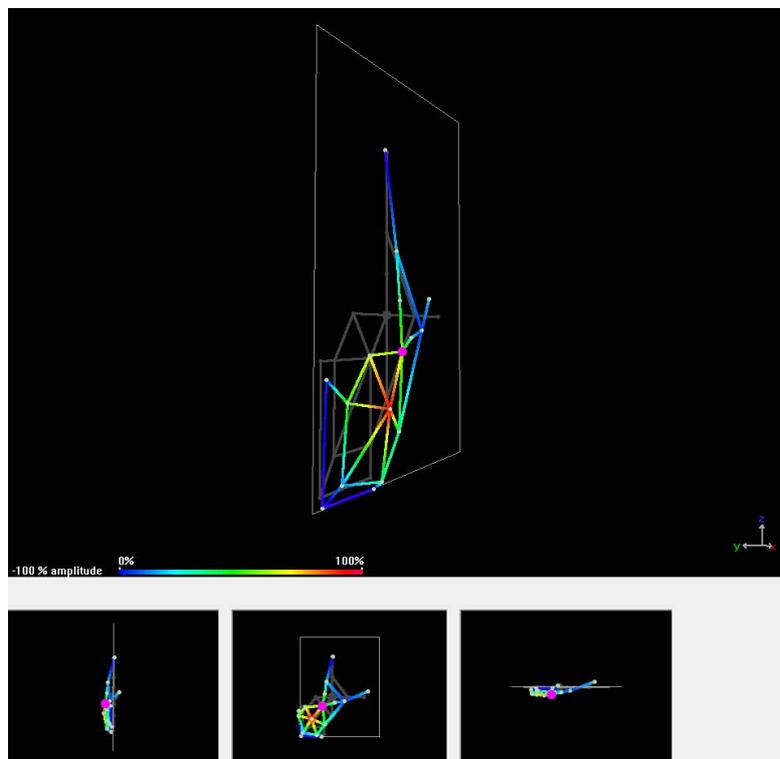
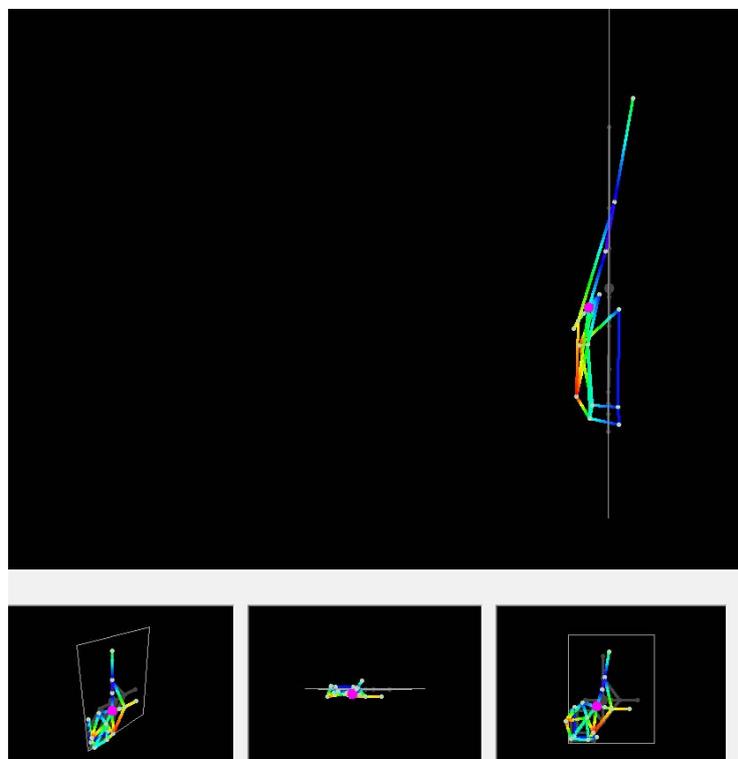
The determined mode shapes indicate **regular dynamic behaviour** of the glass steel composite frame.

Figure 56: 1st bending mode Panel 2 at 37th floor – 21,94 Hz, 1BT

Figure 57: 2nd bending mode Panel 2 at 37th floor – 40,04 Hz, 2BT

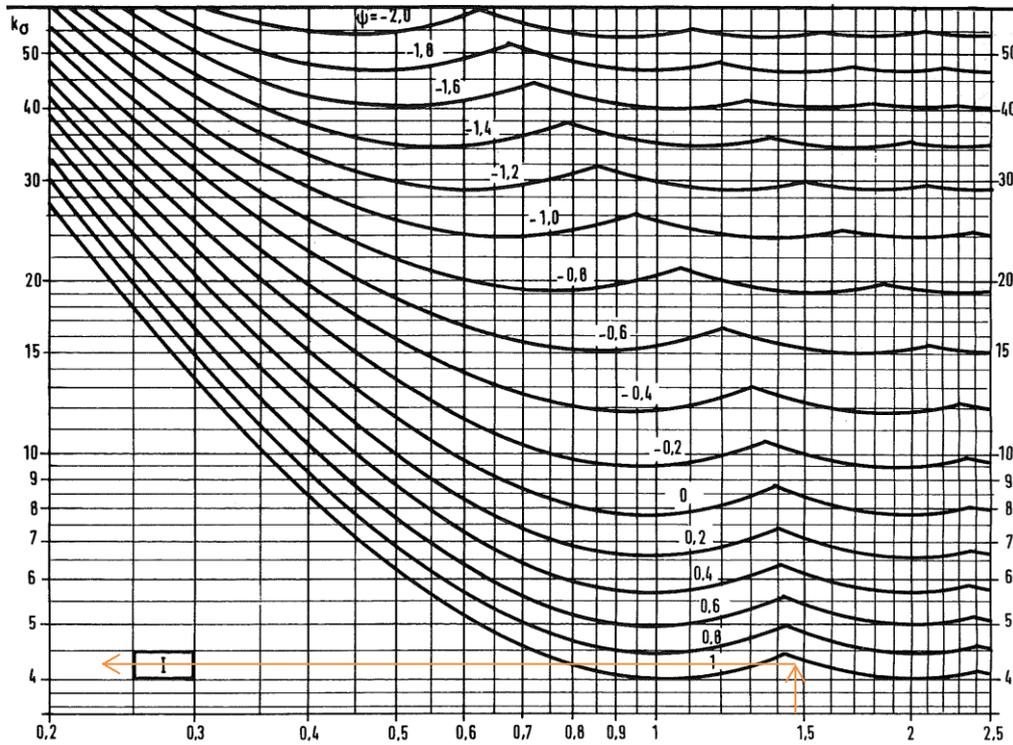
Figure 60: Buckling value k (Petersen, 1980)

Both glass panels hit the curve at the first negative apex which means, the first buckling shape (similar to the first mode shape) is critical. Also the buckling resistance of the smaller glass element located in ground floor has lower resistance. This information is now implemented in the further calculation.
